Classification:
AN18-007A

INFINITI; MICROPHONE DOES NOT WORK

APPLIED VEHICLES: 2018 QX60 (L50)
2018 QX80 (Z62)

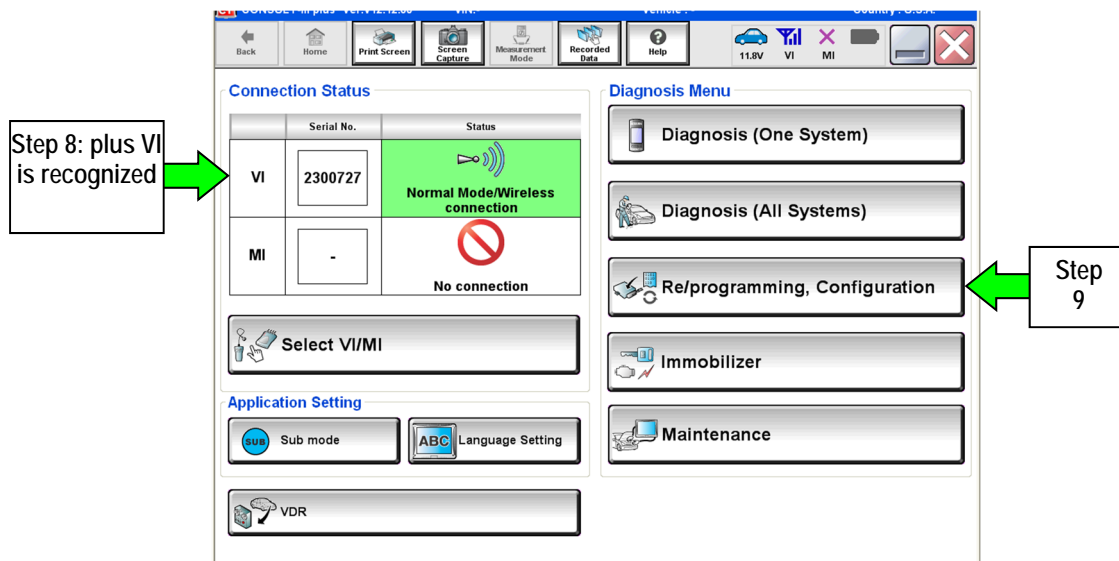
Figure 1

5. Turn the ignition ON with the engine OFF.
6. Turn the hazard lights ON.
7. Start C-III plus.
8. Wait for the plus VI to be recognized.
 - The serial number will display when the plus VI is recognized.
9. Select Re/programming, Configuration.

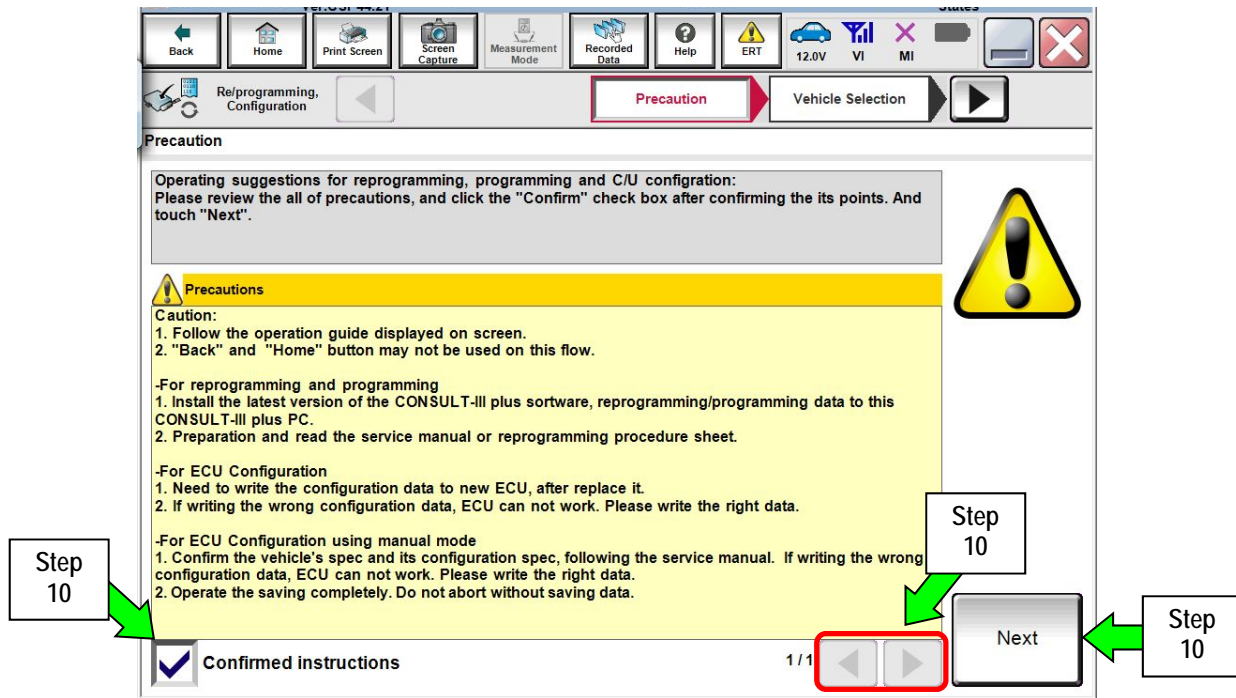
Figure 2

- Use the arrows (if needed) to view and read all precautions, check the **Confirmed Instructions** box, and then select **Next**.

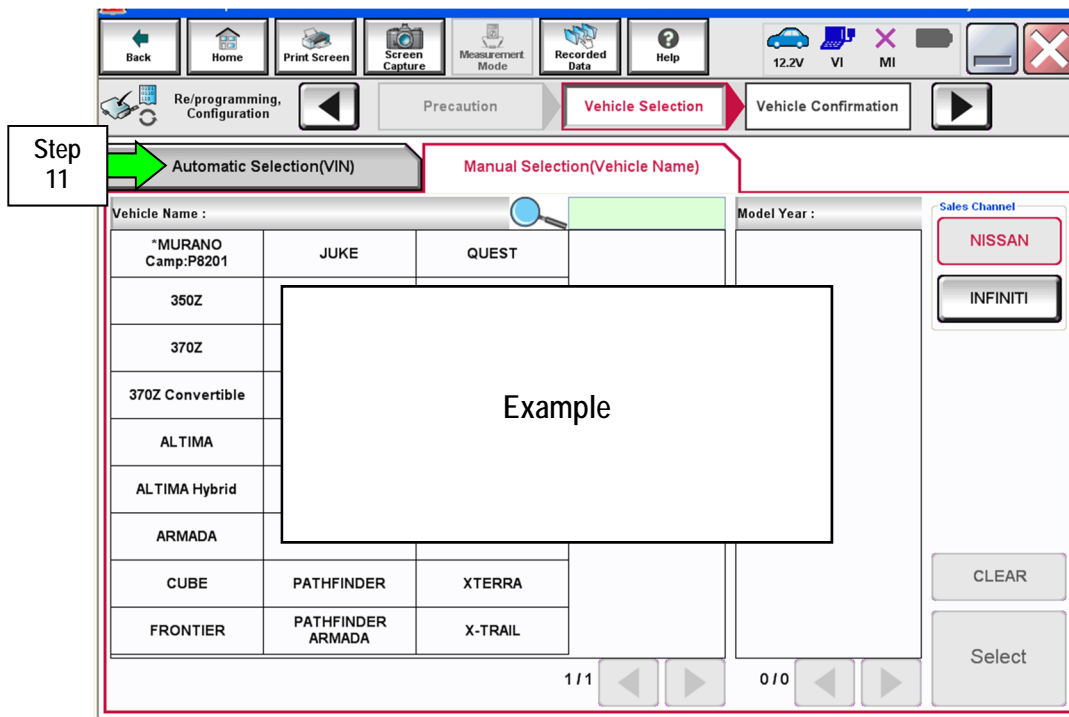
Figure 3

- Select **Automatic Selection(VIN)**.
 - If the screen in Figure 4 does not display, skip to step 12.

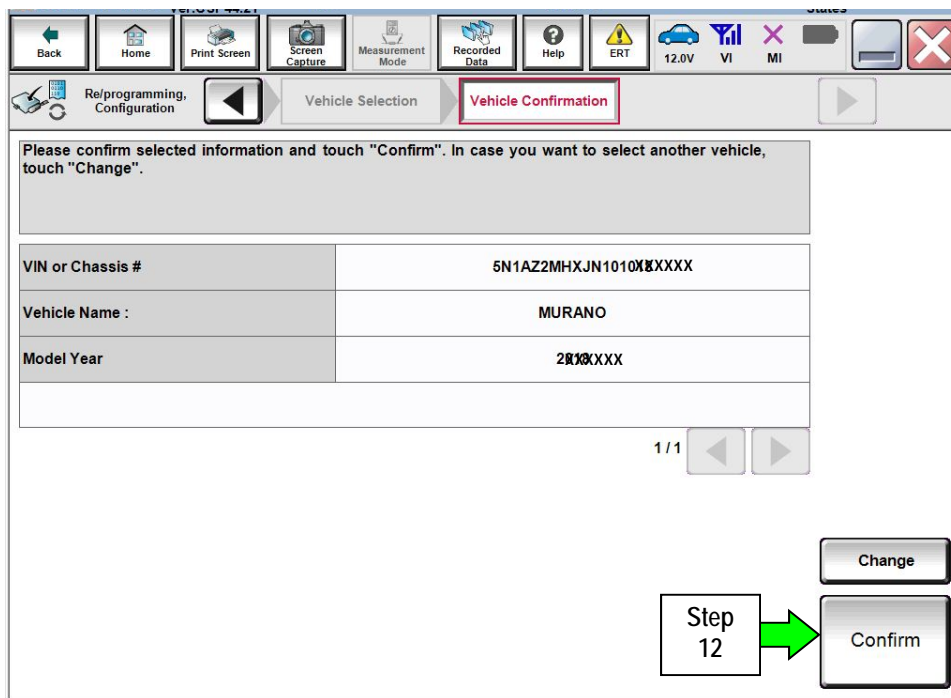
Figure 4

12. If the VIN or Chassis # matches the vehicle's VIN, select Confirm.

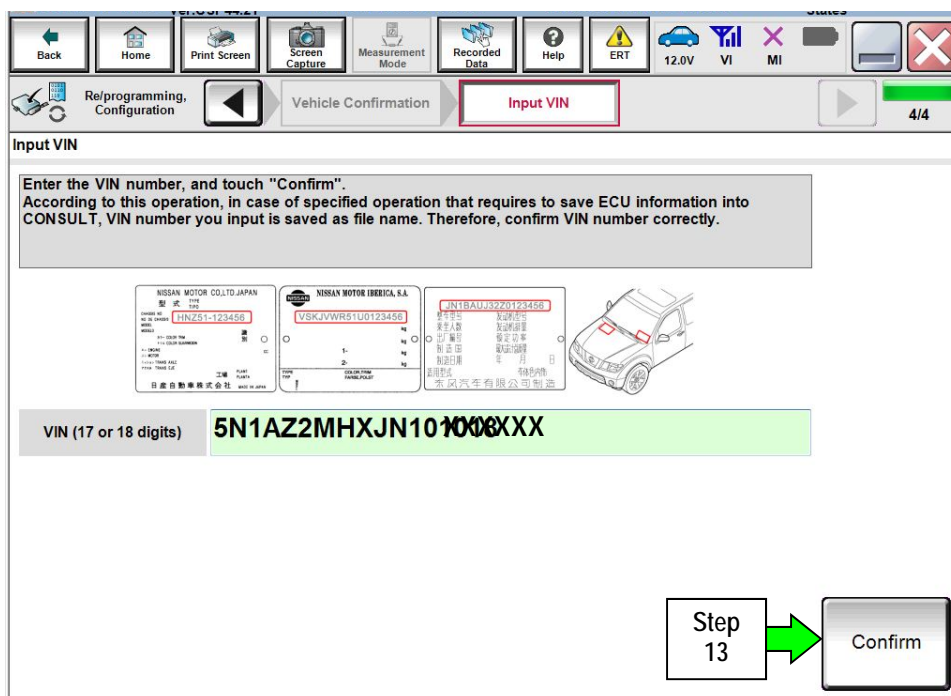
Figure 5

13. Select Confirm.

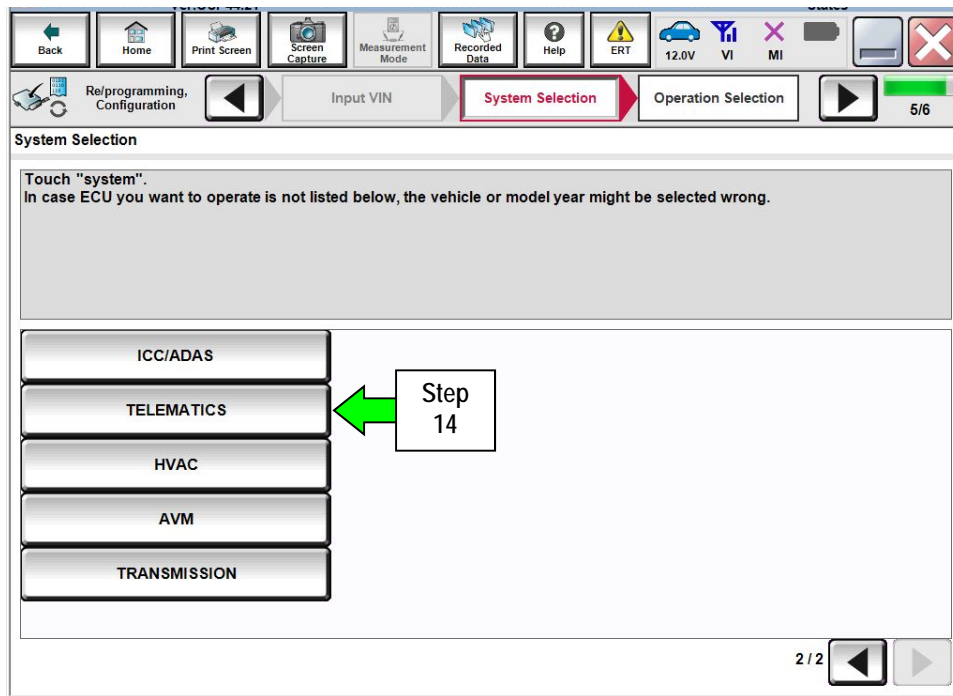
Figure 6

14. Select TELEMATICS.

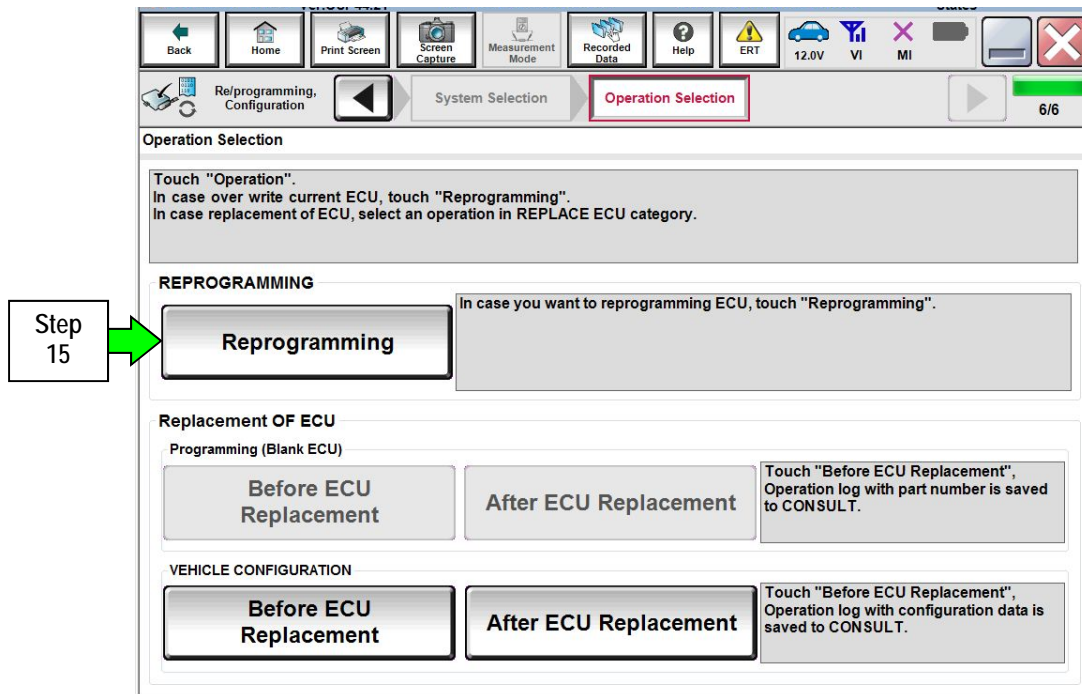
Figure 7

15. Select Reprogramming.

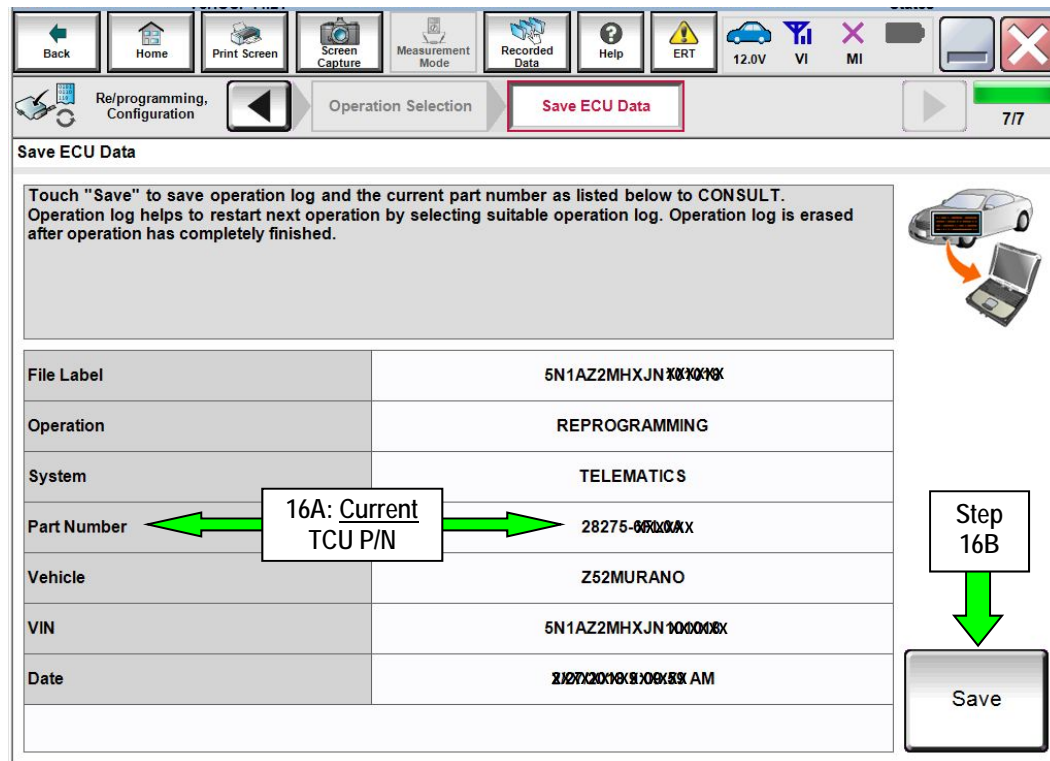
Figure 8

16. When you get to the screen shown in Figure 8, confirm this bulletin applies as follows.

A. Find the TCU Part Number and write it on the repair order.

NOTE: This is the current TCU Part Number (P/N).

B. Compare the P/N you wrote down to the numbers in the **Current TCU Part Number** column in Table A below.

- If there is a match, select **Save**, and then continue with the reprogramming procedure on page 7.
- If there is not a match, this bulletin does not apply. Refer to ASIST for further diagnostic and repair information.

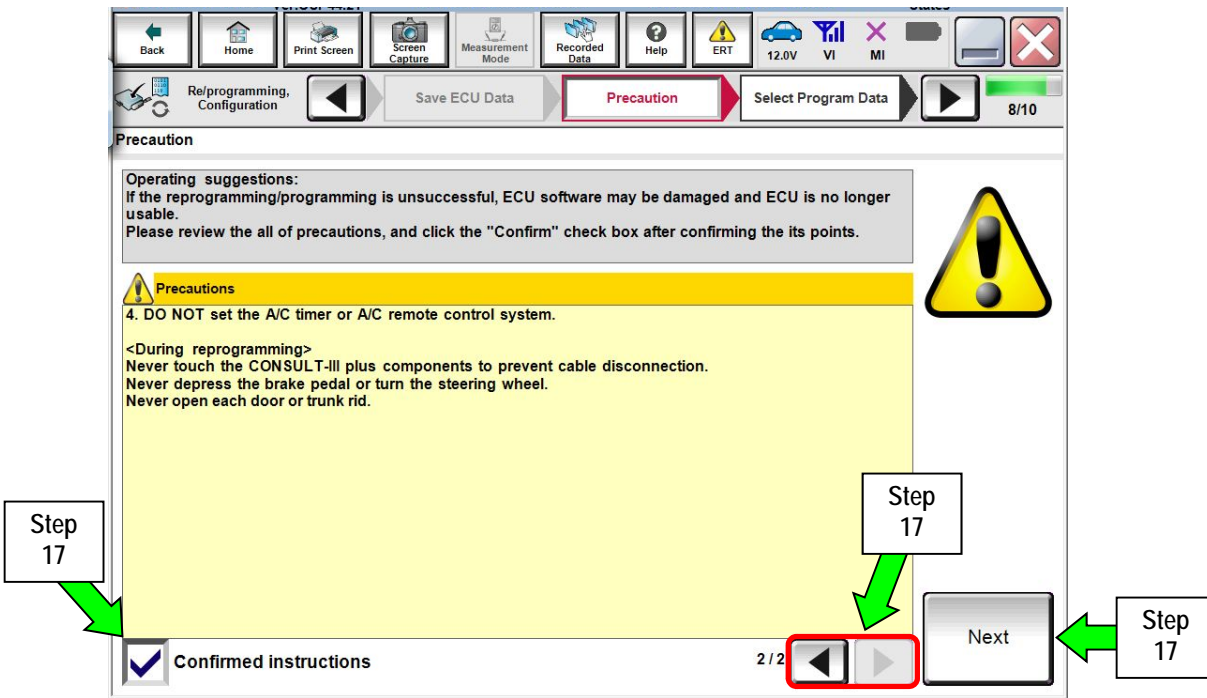
Figure 9

- Use the arrows (if needed) to view and read all precautions, check the **Confirmed Instructions** box, and then select **Next**.

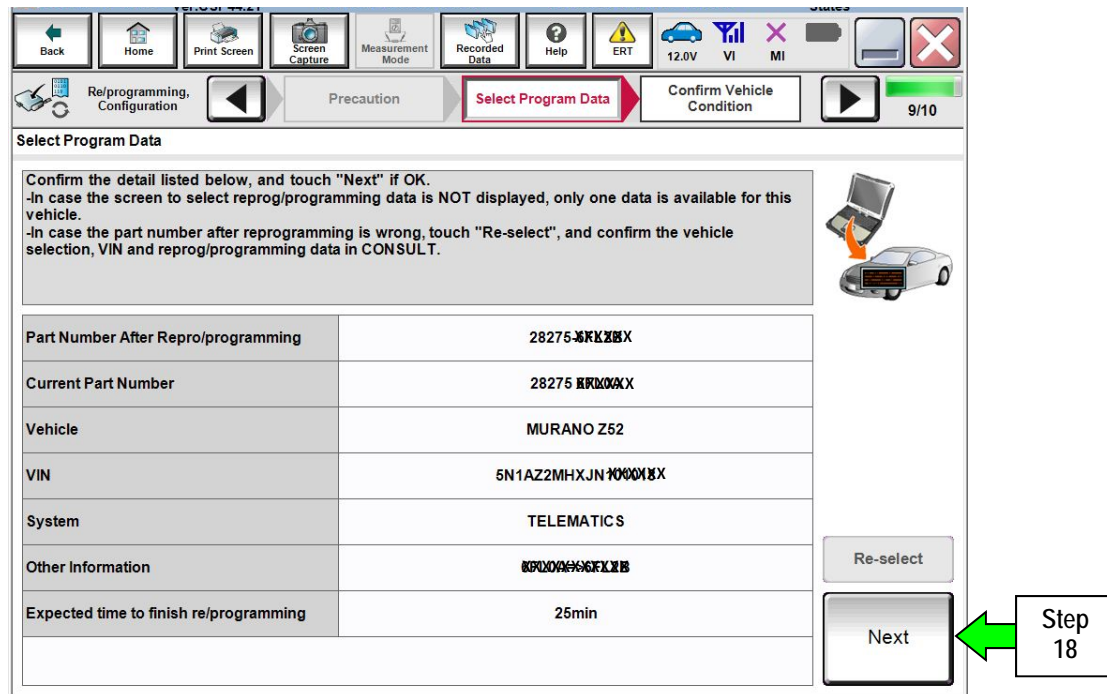
Figure 10

- Verify the **Current Part Number** and **Part Number After Reprogramming** are different, and then select **Next**.

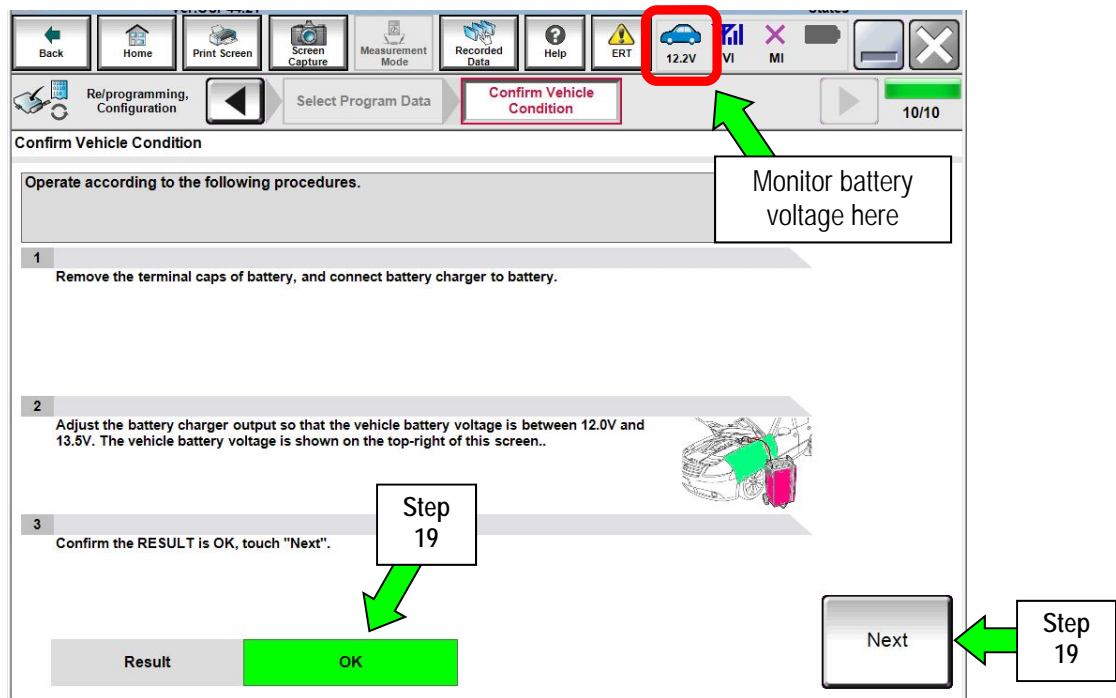
Figure 11

- Verify OK is highlighted green (battery voltage must be between 12.0 and 15.5 volts), and then select Next.

IMPORTANT: Battery voltage must stay between 12.0 and 15.5 volts during reprogramming. If not, reprogramming may be interrupted and the TCU may be damaged.

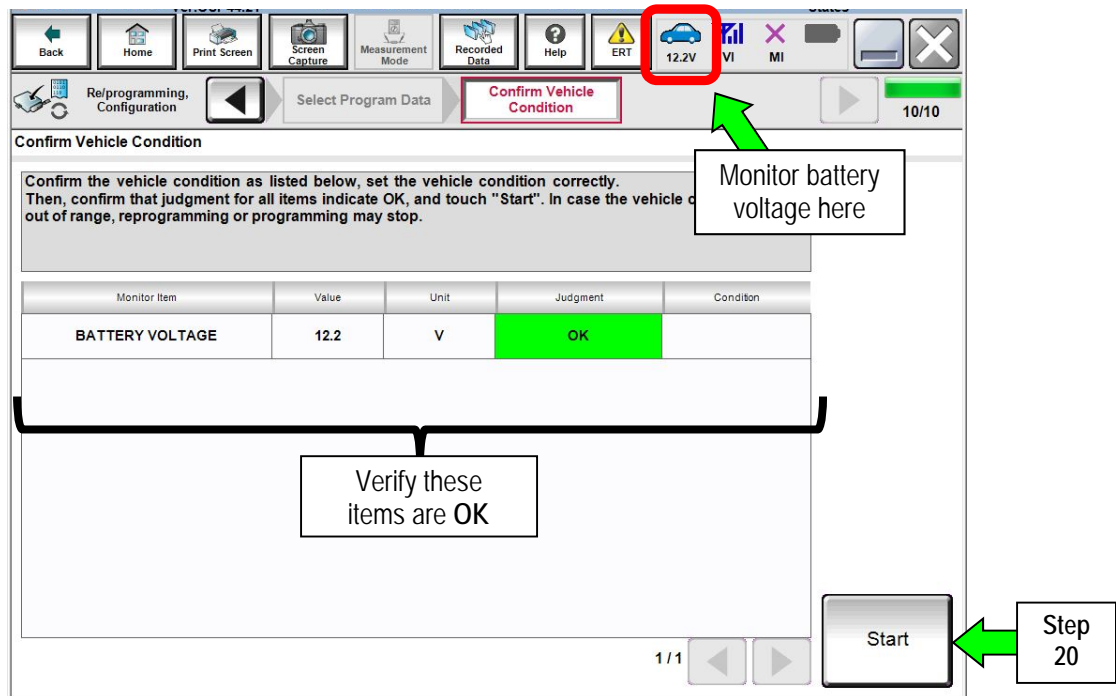
Figure 12

- Verify all items listed under Confirm Vehicle Condition are OK, and then select Start.

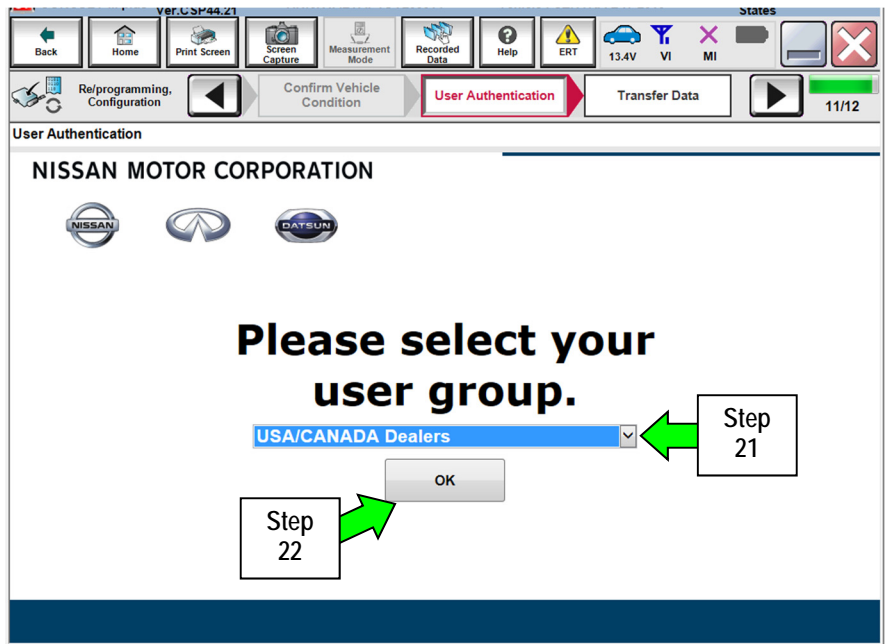
Figure 13

21. Select USA/CANADA Dealers.
22. Select OK.

- The above screen may not display if the CONSULT PC has remained ON since the last reprogramming.
- If the CONSULT PC is not connected to the Internet, the screen in Figure 14 will display.

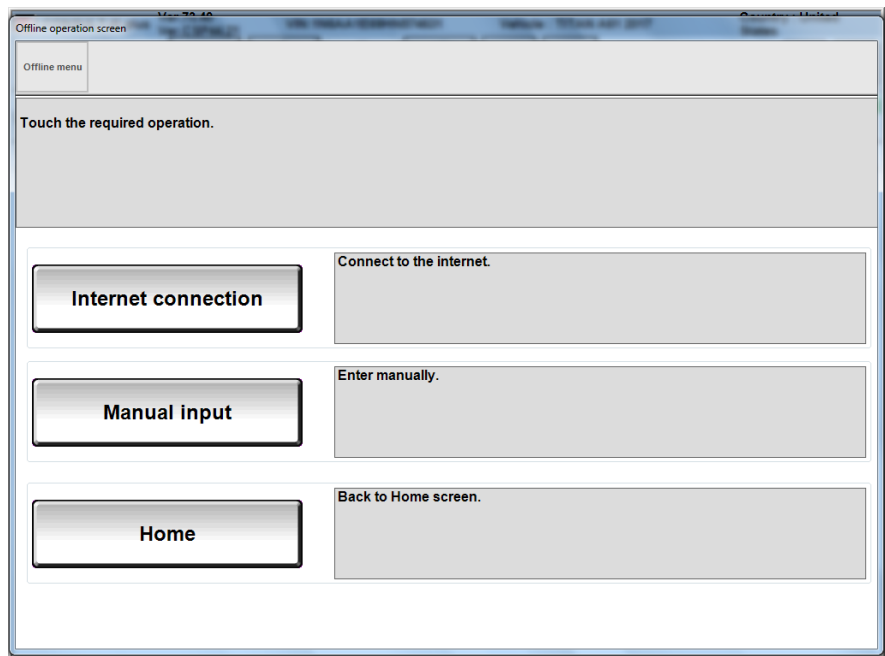
Figure 14

- Before reprogramming will start, you will be required to enter your **Username** and **Password**.
- The CONSULT PC must be connected to the Internet (Wi-Fi or cable).
- If you do not know your **Username** and **Password**, contact your service manager.

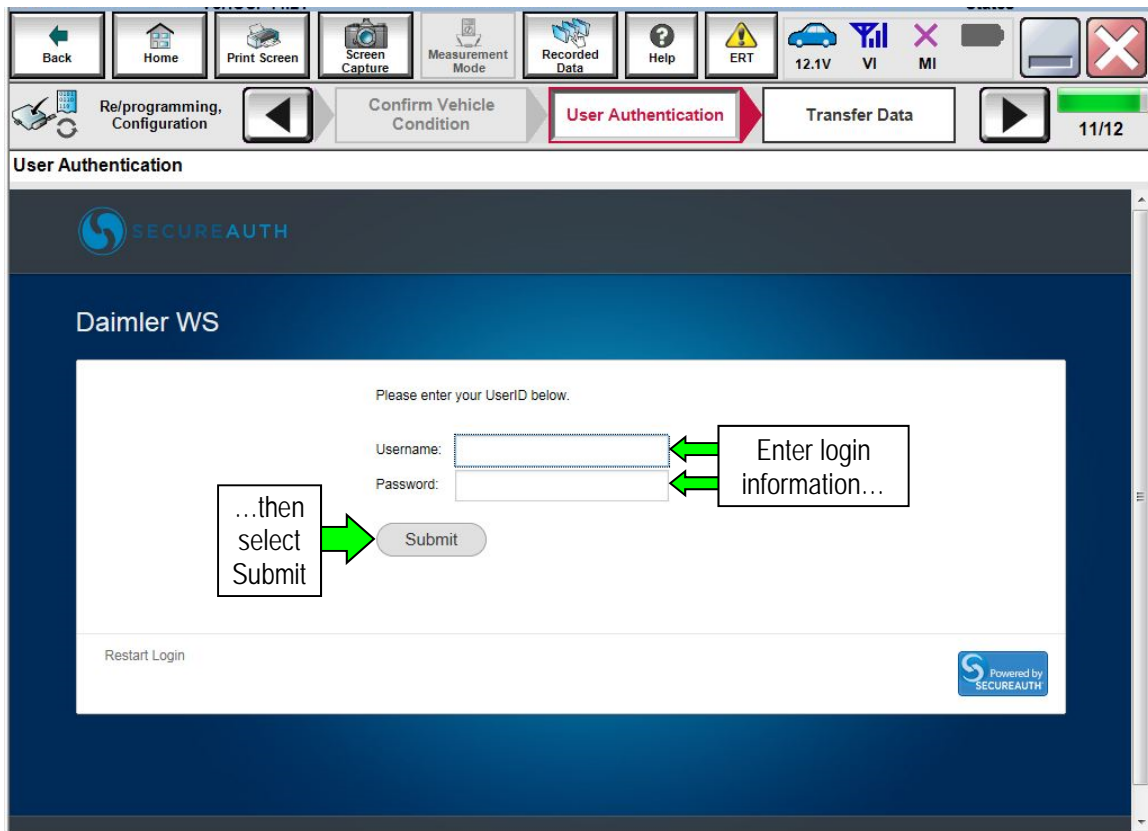
Figure 15

23. Start the reprogramming process by selecting **Submit**.

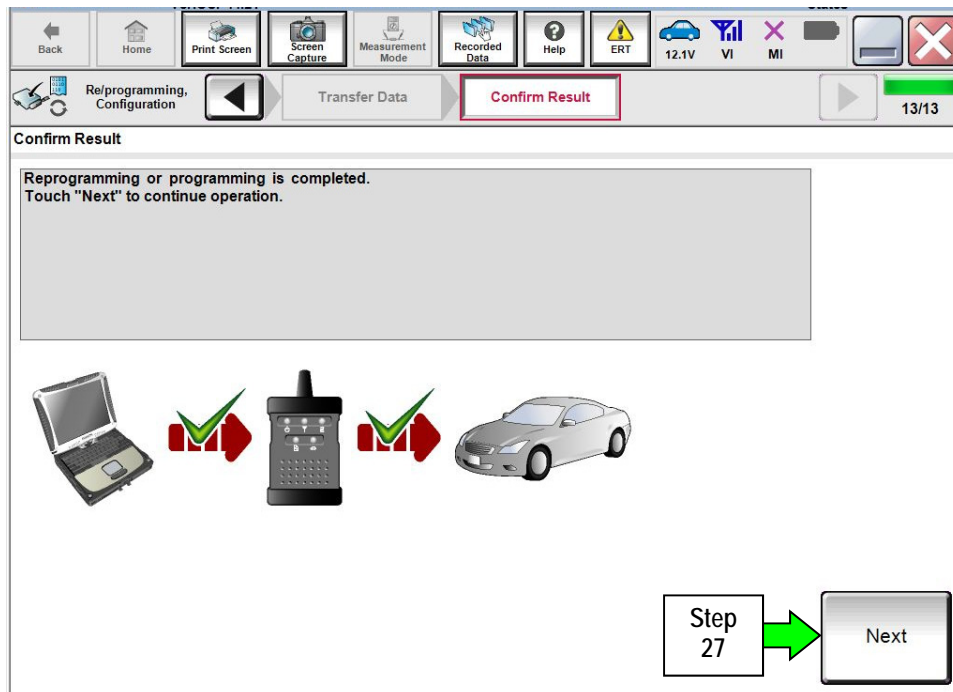
25. When the screen in Figure 17 displays, TCU reprogramming is complete.

NOTE: If the screen in Figure 17 does not display (indicating that reprogramming did not complete), refer to the information on the next page.

27. Select **Next**.

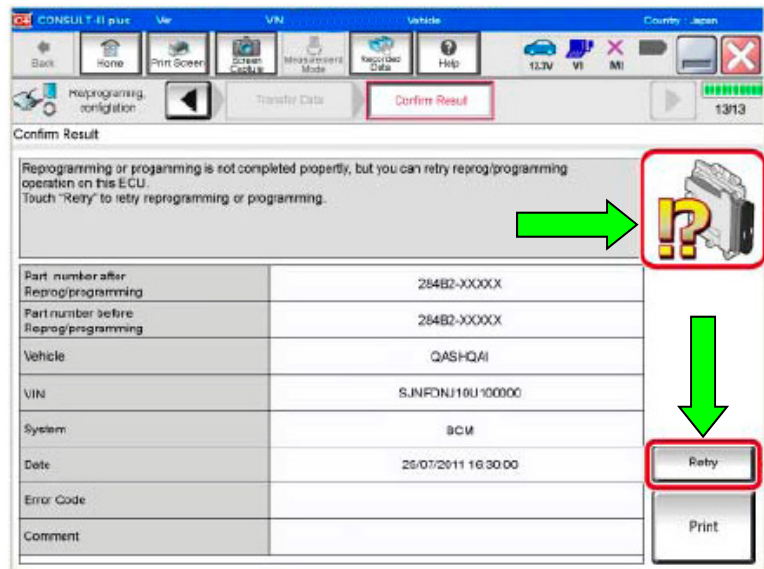
Figure 18

If reprogramming does not complete and the “!” icon displays as shown in Figure 18:

- Check battery voltage (12.0–15.5 V).
- Ignition is ON, engine OFF.
- External Bluetooth® devices are OFF.
- All electrical loads are OFF.
- **Select retry and follow the on screen instructions.**
- “Retry” may not go through on first attempt and can be selected more than once.

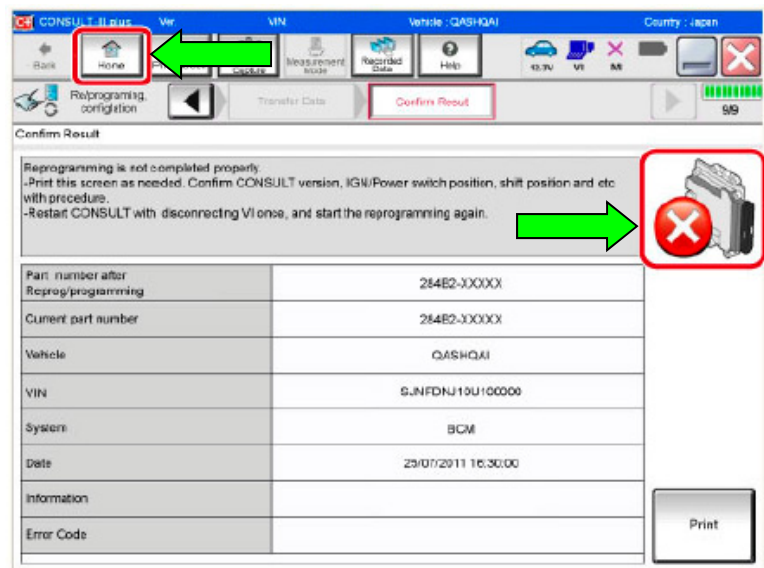
Figure 19

If reprogramming does not complete and the “X” icon displays as shown in Figure 19:

- Check battery voltage (12.0 – 15.5 V).
- CONSULT A/C adapter is plugged in.
- Ignition is ON, engine OFF.
- Transmission is in Park.
- All C-III plus / VI cables are securely connected.
- All C-III plus updates are installed.
- **Select Home, and restart the reprogram procedure from the beginning.**

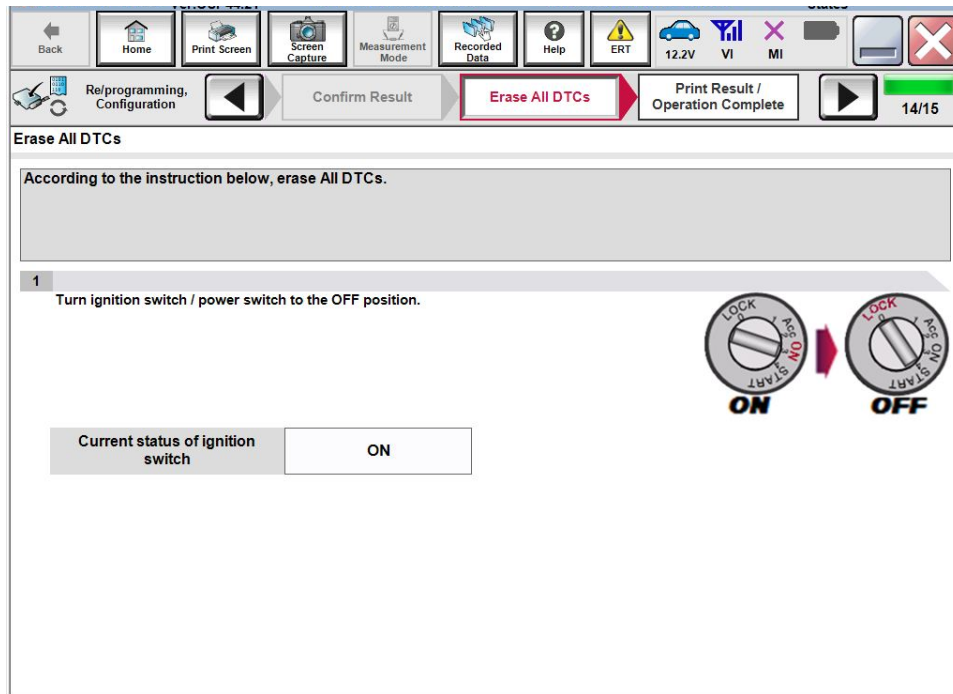
Figure 20

28. Erase all DTCs as follows:

a. Turn the ignition OFF.

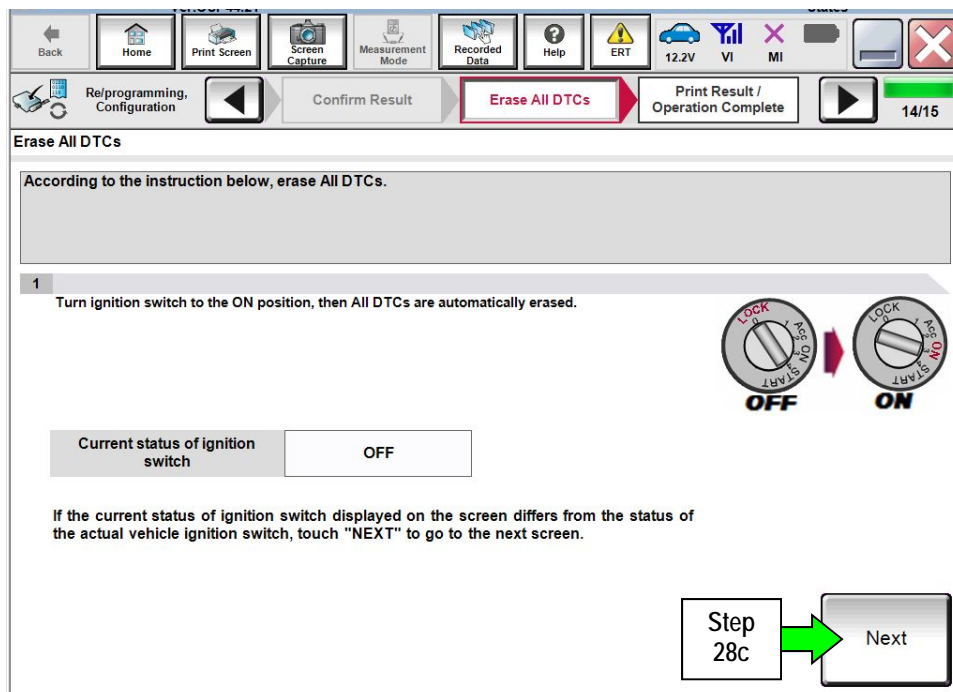
Figure 21

b. Turn the ignition ON.

c. Wait for DTC erase to complete, and then select **Next**.

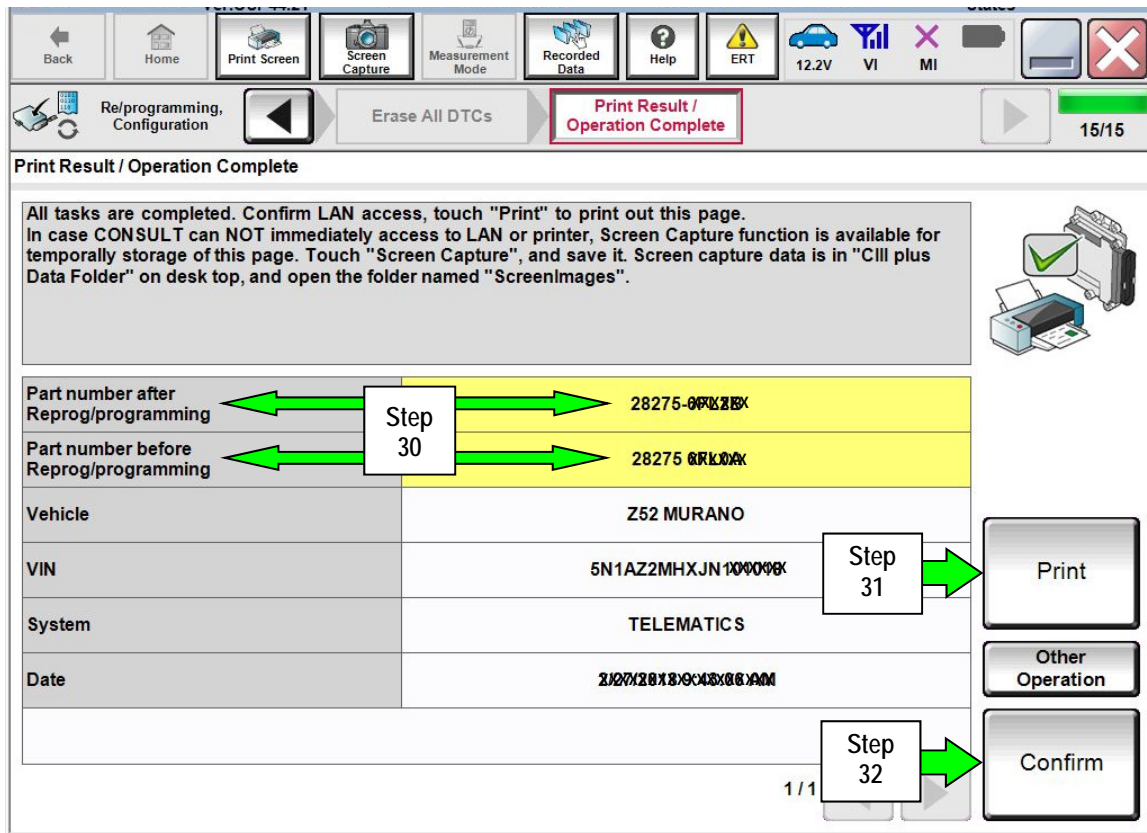
29. When the entire reprogramming process is complete, the screen in Figure 22 will display.
30. Verify the before and after part numbers are different.
31. Print a copy of this screen (Figure 22) and attach it to the repair order for warranty documentation.
32. Select **Confirm**.
