SERVICE BULLETIN

Classification: EL12-078a	Reference: NTB12-105a	Date: December 19, 2012
------------------------------	--------------------------	----------------------------

2011-13 MURANO & 2010-13 370Z WITH NAVIGATION SYSTEM HANDS-FREE PHONE POOR SOUND QUALITY

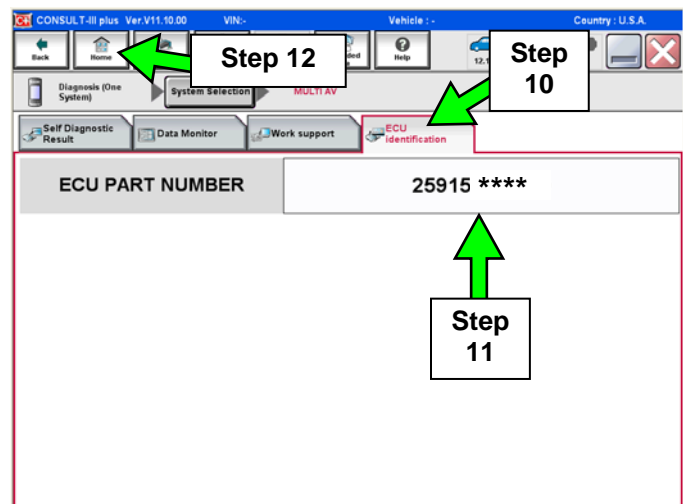
Figure 3

10. Select **ECU Identification**.

11. Print or write down the **ECU PART NUMBER** for Warranty Information.

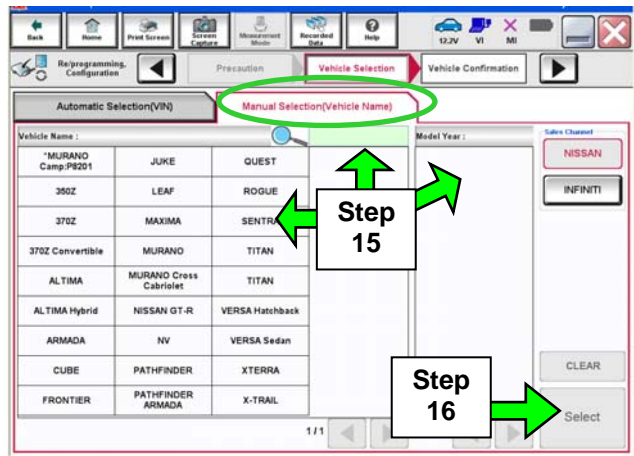
15. Use **Manual Selection (Vehicle Name)**, then select correct **Make**, **Model** and **Year**.

16. Click on **Select**.

NOTE: If the screen in Figure 6 does not display, skip to step 17.

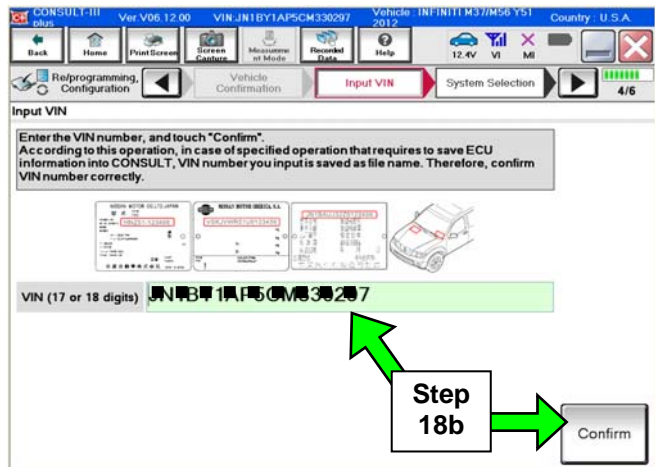
Figure 8

b. Correct the **VIN**, and then select **Confirm**.

a. Select **Change** then refer to Figure 8.

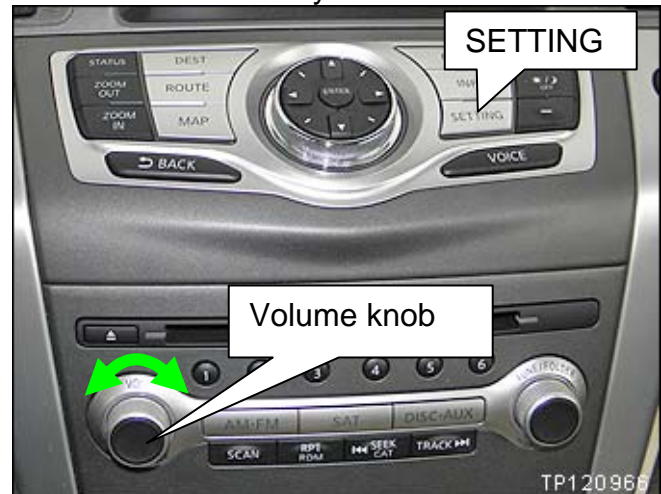
Figure A1

2. Put the AV system into System Diagnostic Mode as follows:

- a. Press and hold the SETTING button.
- b. While holding the SETTING button, turn the volume control knob 40 clicks or more.
 - The volume control knob can be turned either direction.
 - When the system goes into the System Diagnostic Menu, the screen in Figure A2 will display.

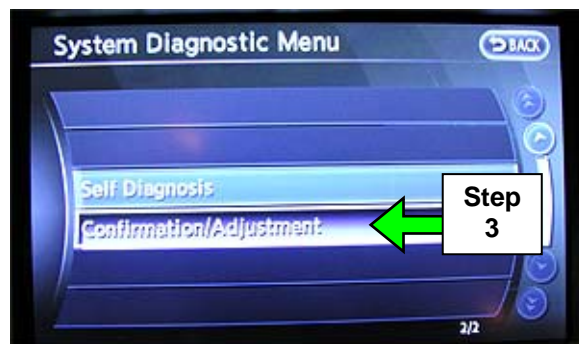
Figure A2

3. Select **Confirmation/Adjustment**.

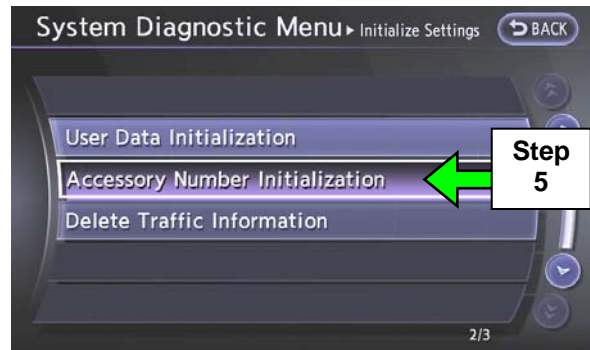
Figure A4

5. Select **Accessory Number Initialization**.

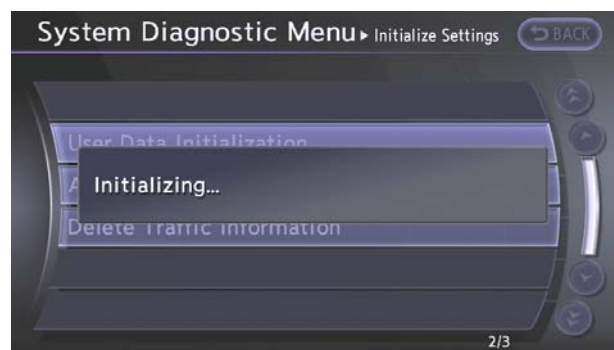
8. The screen in Figure A7 will display while initializing.

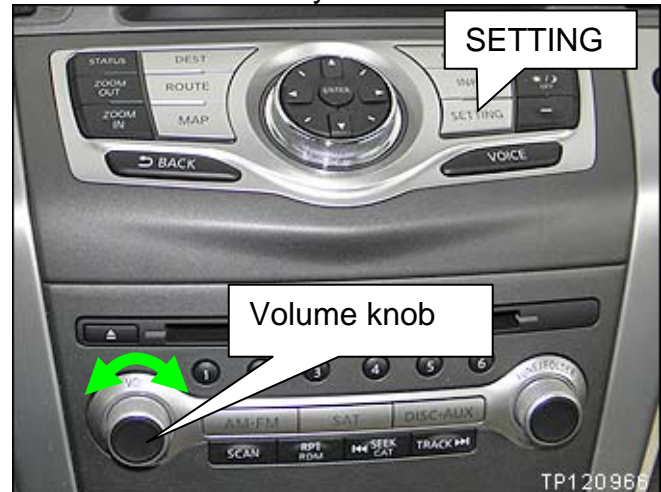
Figure M1

2. Put the AV system into System Diagnostic Mode as follows:

- a. Press and hold the SETTING button.
- b. While holding the SETTING button, turn the volume control knob 40 clicks or more.
 - The volume control knob can be turned either direction.
 - When the system goes into the System Diagnostic Menu, the screen in Figure M2 will display.

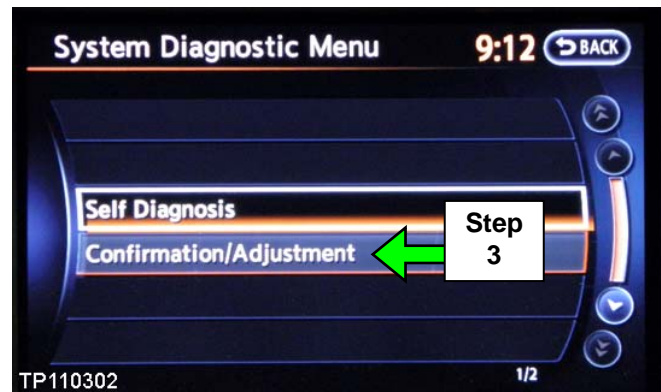
Figure M2

3. Select **Confirmation/Adjustment**.

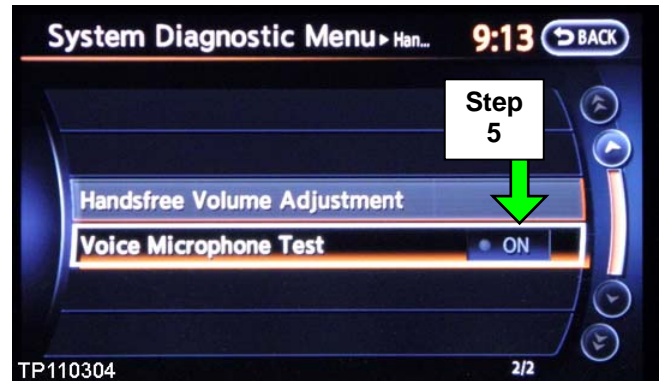
Figure M4

5. Select **Voice Microphone Test**.

- A “feedback” noise will come from the system speakers as confirmation that the microphone is operating.
- If you speak, you should hear your voice coming from the system speakers. This is further confirmation that the microphone is operating.

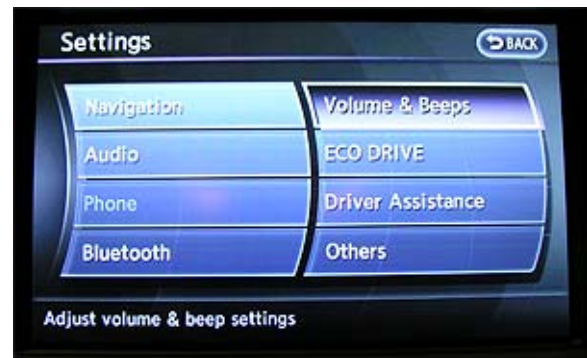
Figure M5

A. Press the **SETTING** button on the control panel.

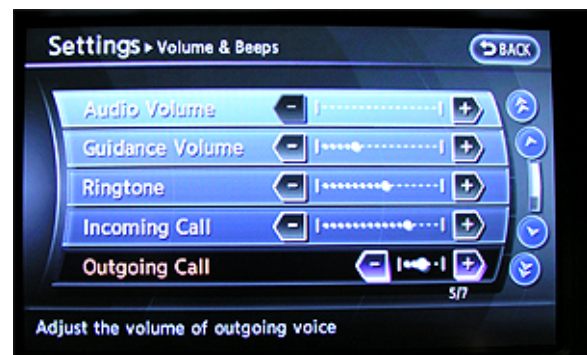
Figure M6

B. Select **Volumes & Beeps**.

C. Adjust the **Outgoing Call** volume to the customer's preference.

- If extremely loud talker, set to level 1 (-).
- If moderately loud talker, set to level 2.
- If normal loud talker, set to level 3.
- If moderately quiet talker, set to level 4.
- If quiet talker, set to level 5 (+).
