## VOLUNTARY SERVICE CAMPAIGN CALL WAITING FUNCTION NAVIGATION UPDATE

**CAMPAIGN ID #:** P1235

**APPLIED VEHICLES:** 2010 G37 Convertible (HV36)  
2010 G37 Coupe (CV36)  
2010 G37 Sedan (V36)  
2011 – QX56 (Z62)  
2010 – 2011 FX35/50 (S51)  
2010 – 2011 EX35 (J50)  
2011 – 2012 M37/56 (Y51)  
2012 M35h Hybrid (Y51HV)

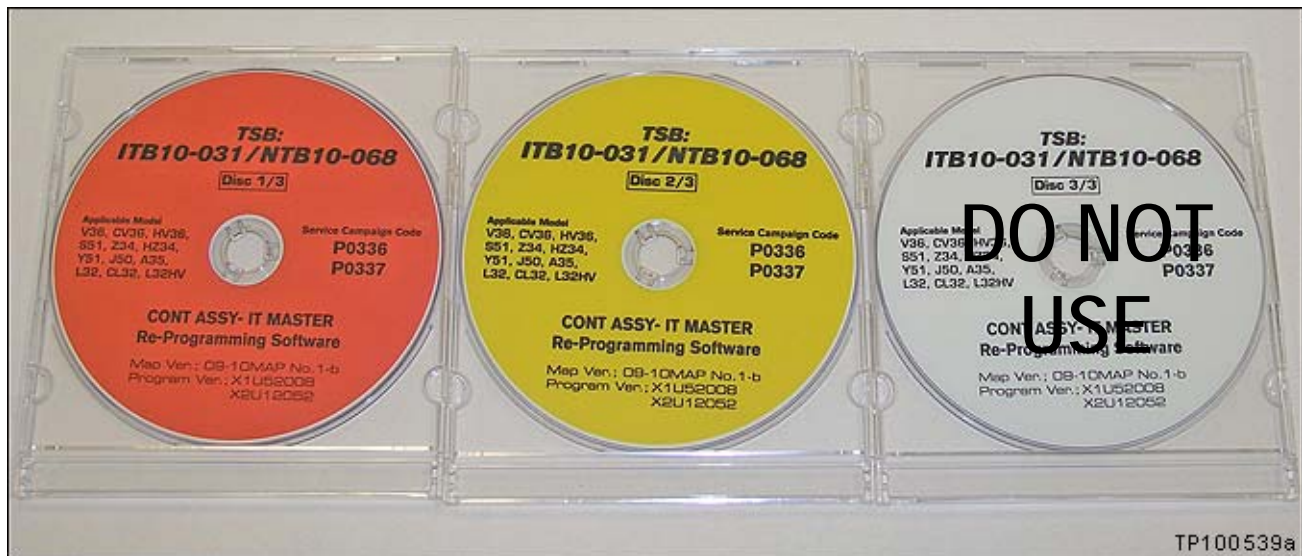
- Discs 1/3 and 2/3 of the set shown in Figure A are used for 2010 models in this campaign.
- Do not use disc 3/3.

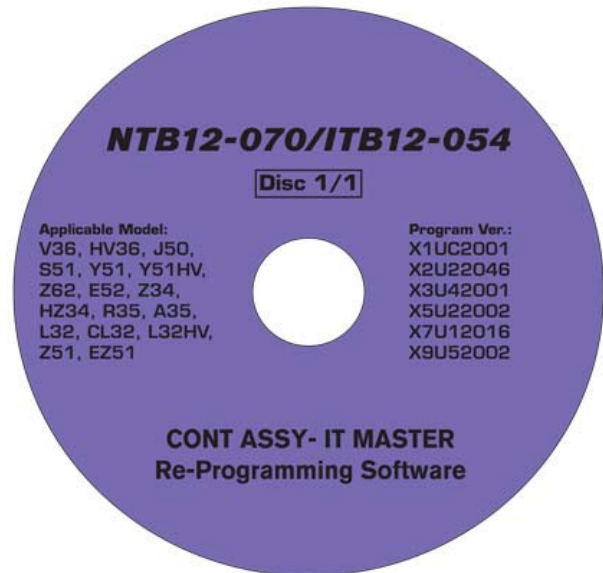
Figure B

- This NEW disc (Figure B) is required for all applied models in this campaign.
- This disc replaces disc 3/3 above.
- This disc also replaces disc NTB10-125b/ITB10-066b (disc 1/1).

**NOTE:** Numbers on these discs do not match this bulletins reference number or the campaign ID #.

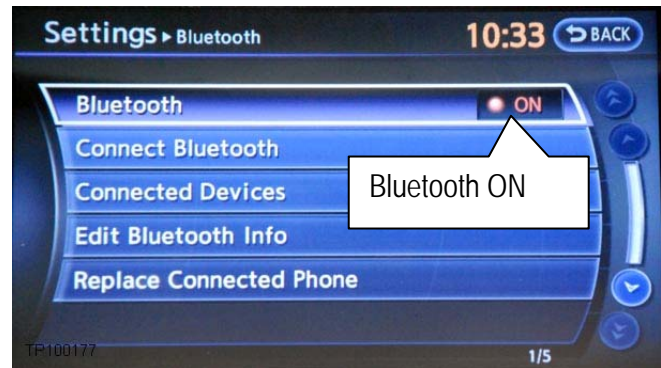
Figure 2

6. Make sure Bluetooth is OFF.

- Touching Bluetooth will change the setting ON > OFF or OFF > ON.

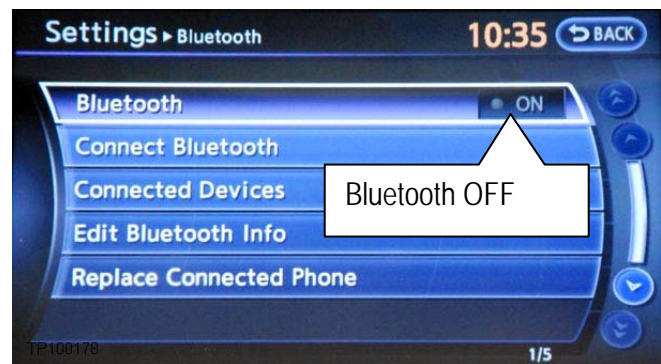
Figure 3

- Bluetooth is OFF when the ON indicator is "grayed" out.

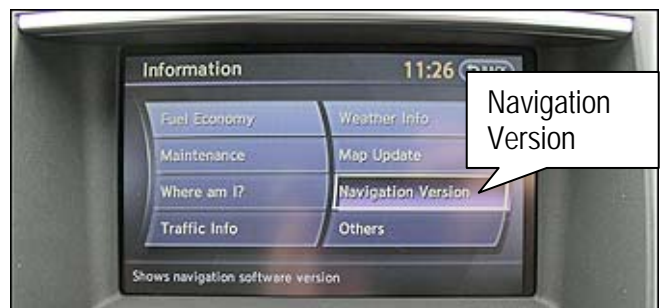
Figure 4

4. Select “Navigation Version” on the display screen.

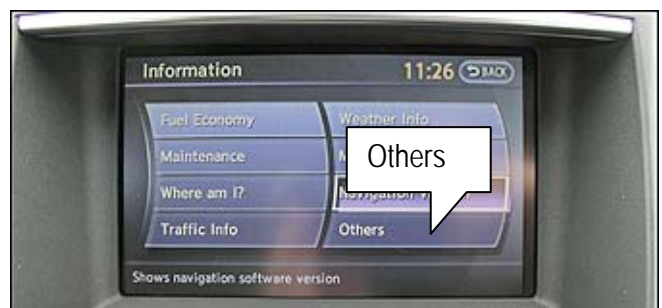
Figure 5

**NOTE:** On some vehicles you will need to select “Others” to find “Navigation Version”.

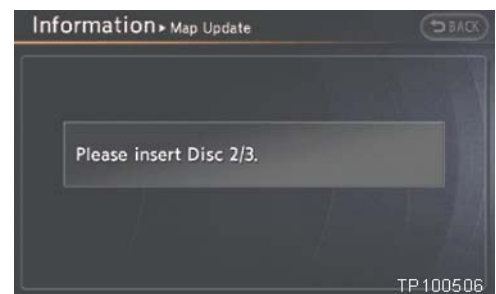
Figure 8

12. When the message "Please insert Disc 2/3" displays, insert disc ITB10-031 / NTB10-068 (Disc 2/3).

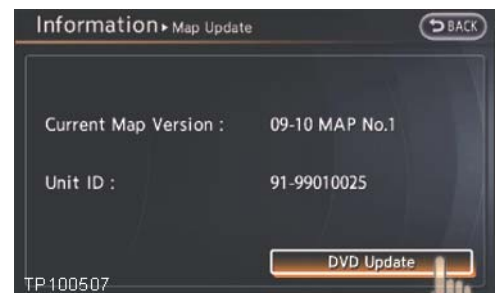
Figure 9

13. Touch "DVD update".

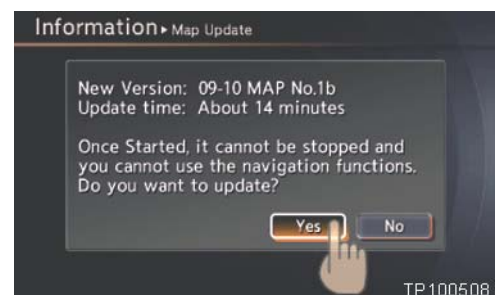
Figure 10

14. Touch "Yes" to begin the map update process.

- Map update will take about 15 minutes.

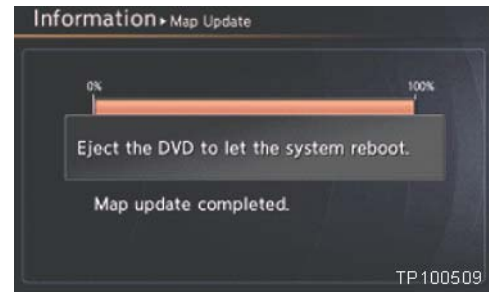
Figure 11

15. When "Eject the DVD to let the system reboot" is displayed, eject Disc 2/3.

16. The navigation system will automatically restart.

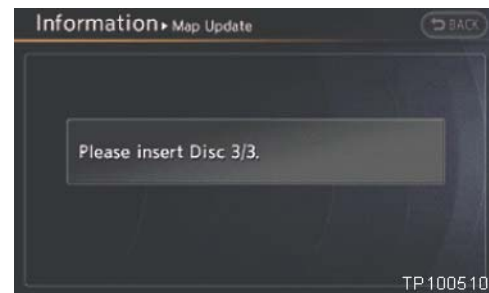
Figure 12

17. When the message "Please insert Disc 3/3" displays, insert the new disc  
NTB12-070 / ITB12-054 (Disc 1/1).

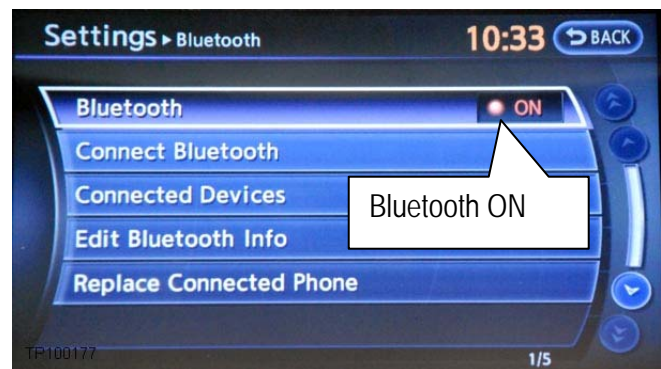
Figure 18

3. Make sure Bluetooth is set to the customer's setting (as it was before starting the procedure).

- Touching Bluetooth will change the setting ON > OFF or OFF > ON.
- Bluetooth is ON when the ON indicator displays in orange.

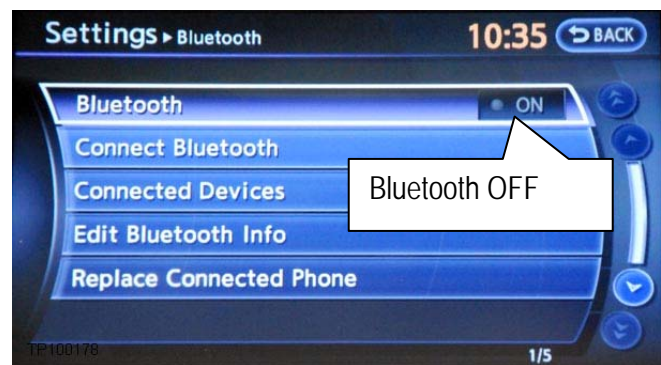
Figure 19

- Bluetooth is OFF when the ON indicator is "grayed out".

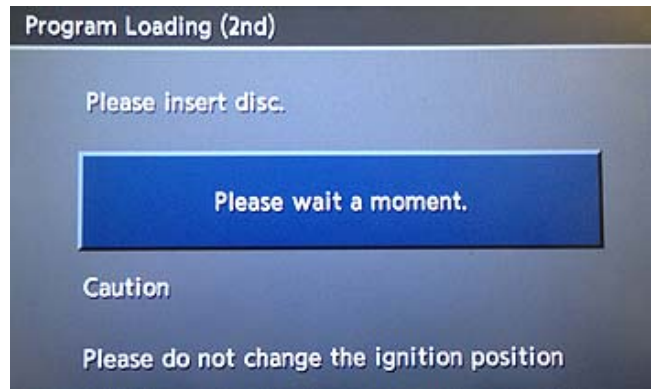
9. After the DVD is removed, the screen in Figure A7 (Please insert disc) may ask to reinstall the same Re-programming Software DVD for a second time.

- If not (Navigation System restarts), go to step 12 on the next page.
- If so, re-insert DVD disc.
  - At the top of the screen "Program Loading (2nd)" will be displayed.
