SERVICE BULLETIN

EC13-017a

NISSAN; MIL ON WITH DTC P0139 AND/OR P0159 STORED

APPLIED VEHICLES: 2012 - 2014 370Z (Z34)
2012 - 2014 370Z Roadster (Z34)
2013 - 2014 Frontier (D40) with VQ40DE (6-cyl) engine ONLY
2013 - 2014 Xterra (N50)

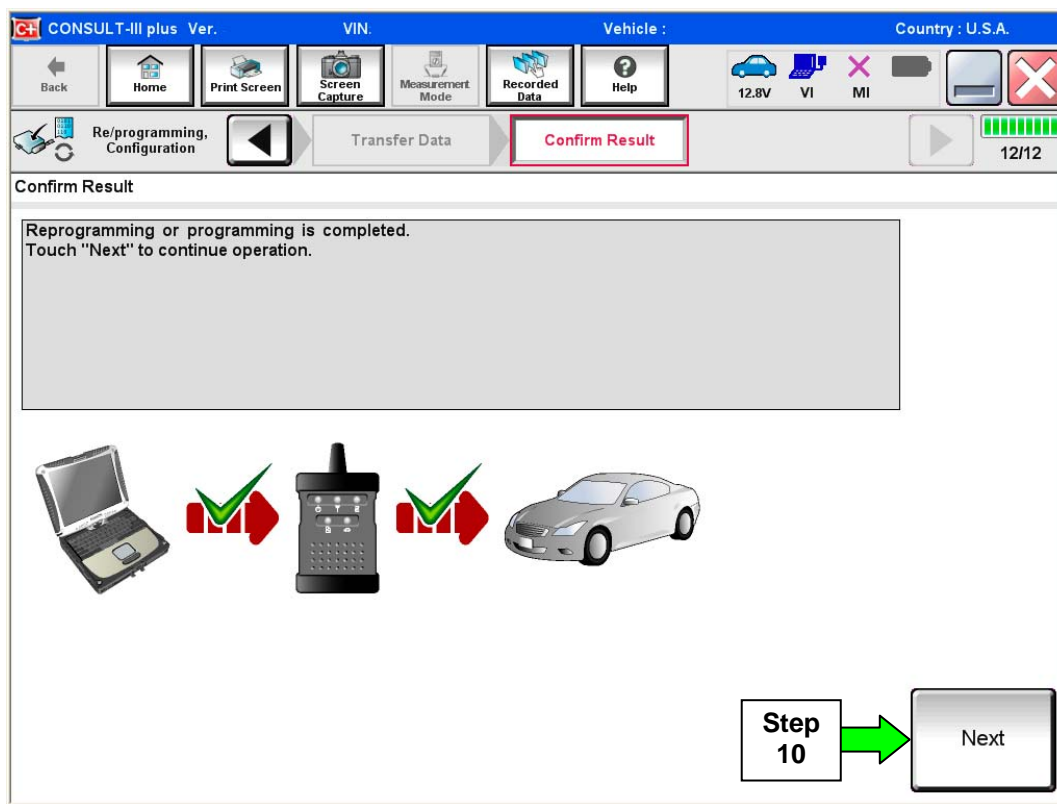
8. When the screen in Figure 4 displays, reprogramming is complete.

NOTE: If the screen in Figure 4 does not display (reprogramming does not complete), refer to the information on page 8.
