AT14-009

## 2012 – 2013 M HYBRID; HPCM AND TCM REPROGRAM

**APPLIED VEHICLE:** 2012-2013 M Hybrid (HY51)  
**APPLIED VIN AND DATE:** Built before JN1EY1AP(\*)DM 650167 and Feb 2, 2013  
**APPLIED TRANSMISSION:** Hybrid only

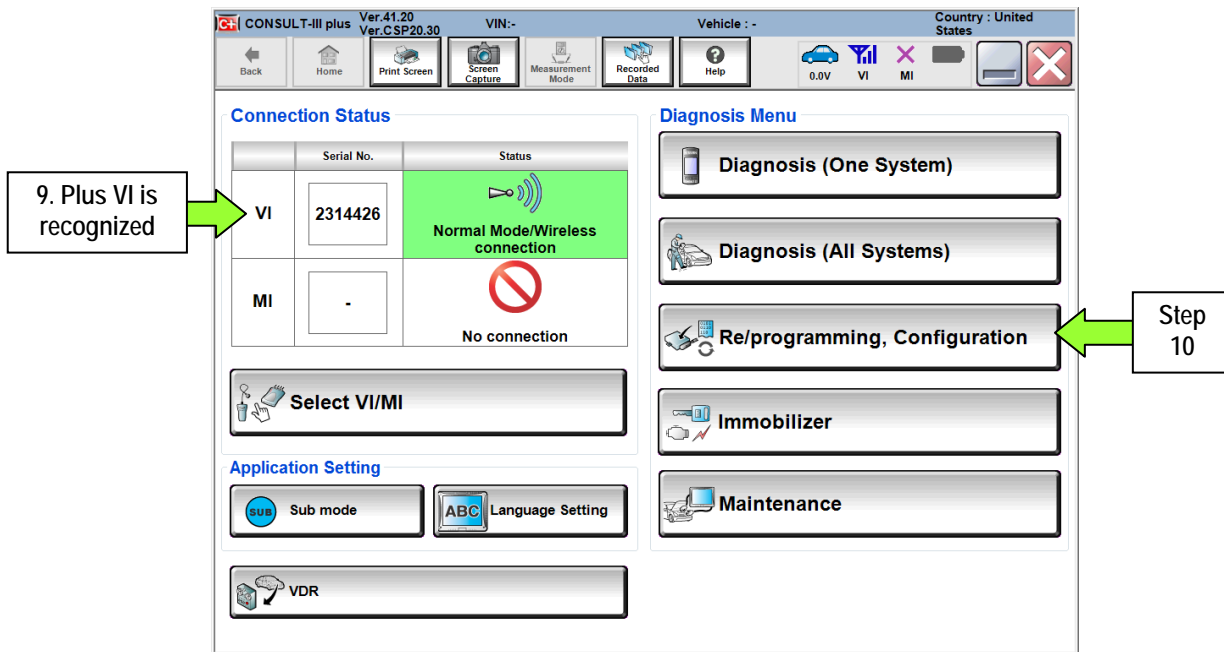
Figure 1

9. Wait for the plus VI to be recognized.
10. Select Re/programming, Configuration.

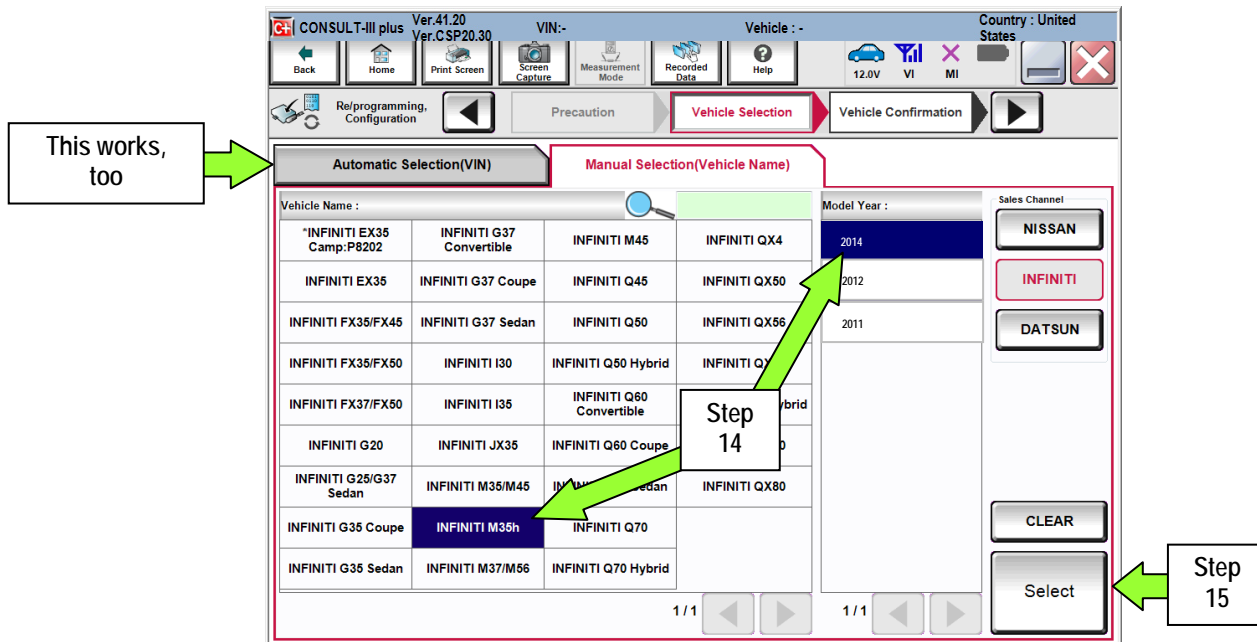
14. Select M35h and 2012 - 2013, or Automatic Selection (VIN).

- If Automatic Selection (VIN) is selected, wait for the Reading VIN screen to complete.
- If the screen in Figure 3 does not display, skip to step 16.

15. Select Select.

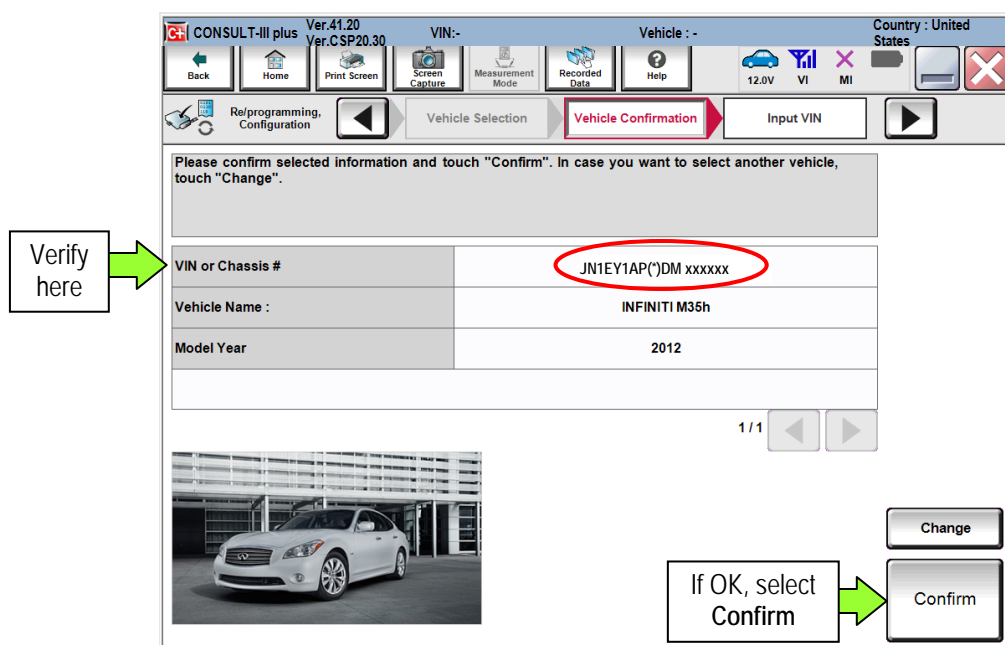
Figure 4

16. Verify the VIN in VIN or Chassis # matches the vehicle being reprogrammed.

- If the correct VIN is displayed, select Confirm.

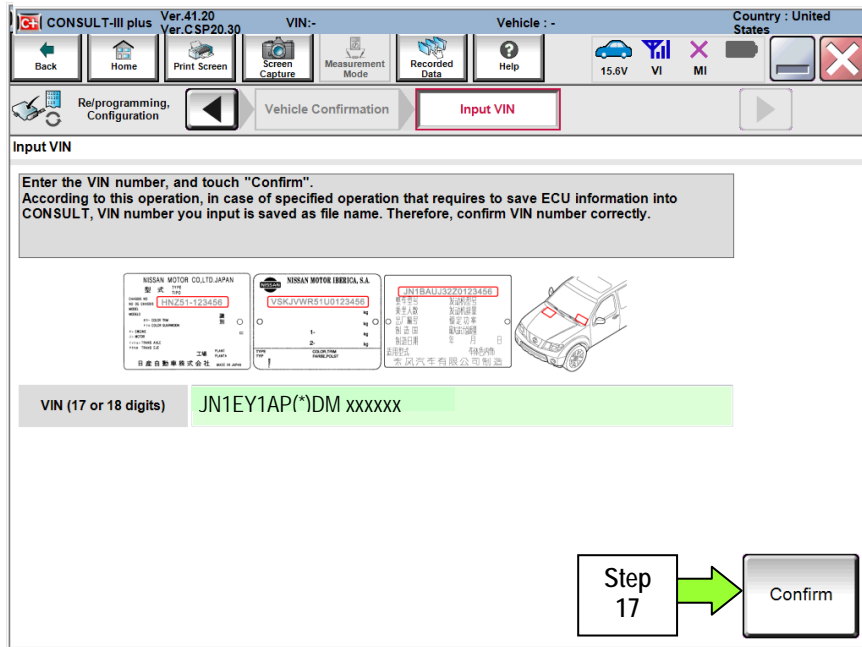
Figure 5

17. Wait for system call to complete, and then select **Confirm** again.

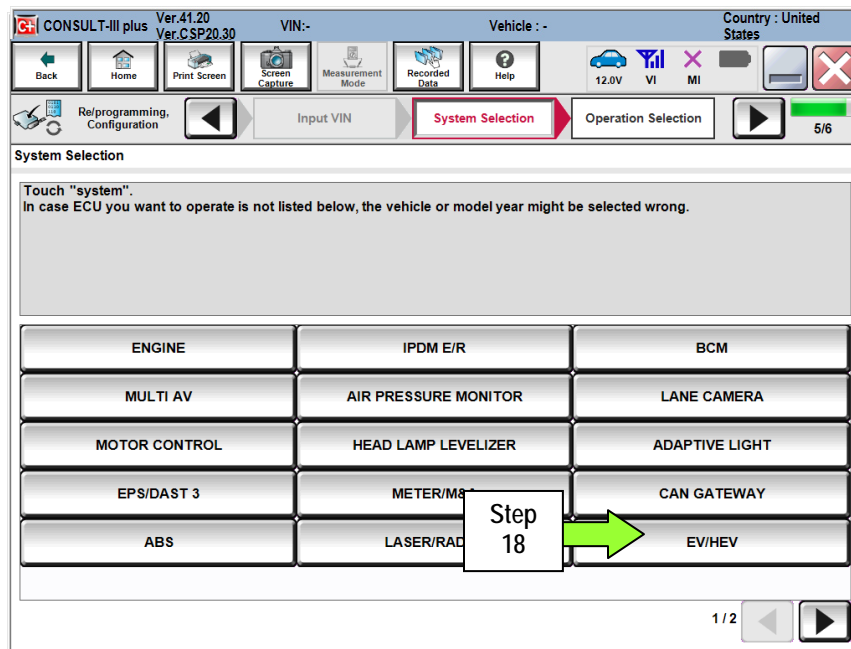
Figure 6

18. Select **EV/HEV**.

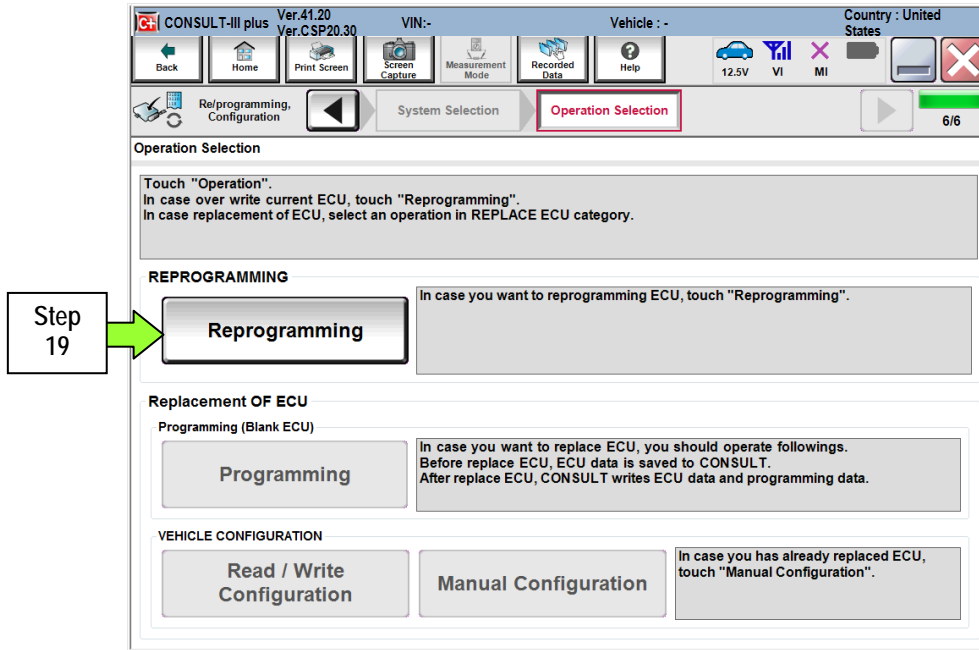
Figure 7

## 19. Select Reprogramming.

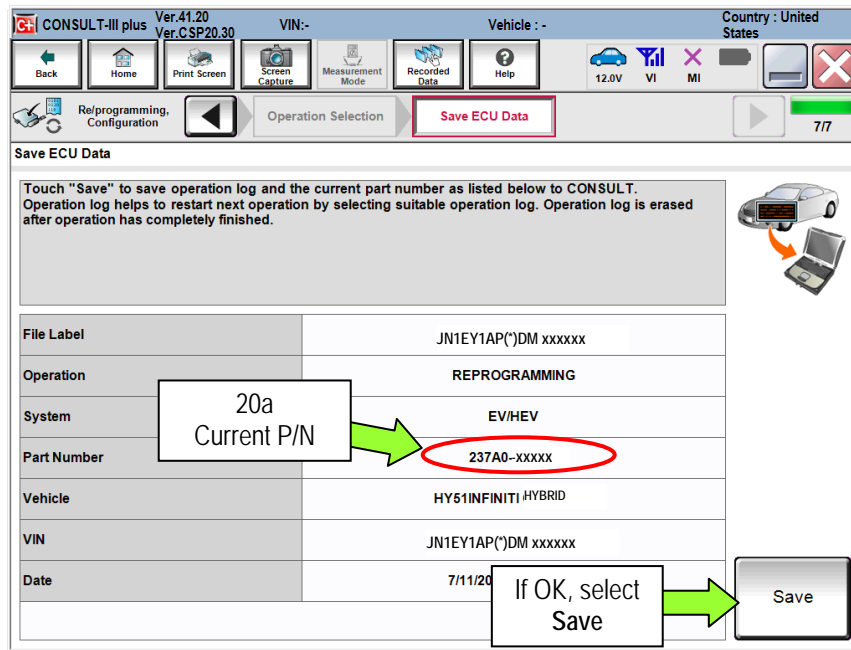
Figure 8

20. When you get to the screen shown in Figure 8, confirm this bulletin applies as follows.

- a. Find the **EV/HEV Part Number** and write it on the repair order.

**NOTE:** This is the current **EV/HEV Part Number (P/N)** and will also be needed for claims information.

- b. Compare the P/N you wrote down to the numbers in the **CURRENT EV/HEV PART NUMBER** column in **Table A** below.

- If the **EV/HEV** part number is one of the part numbers listed in the **Table A**, continue with reprogramming.
  - Select **Save**, and then go to the next step.
- If the **EV/HEV** part number is not listed in **Table A**, this bulletin does not apply.
  - Disconnect the GR8 and CONSUTLT PC.

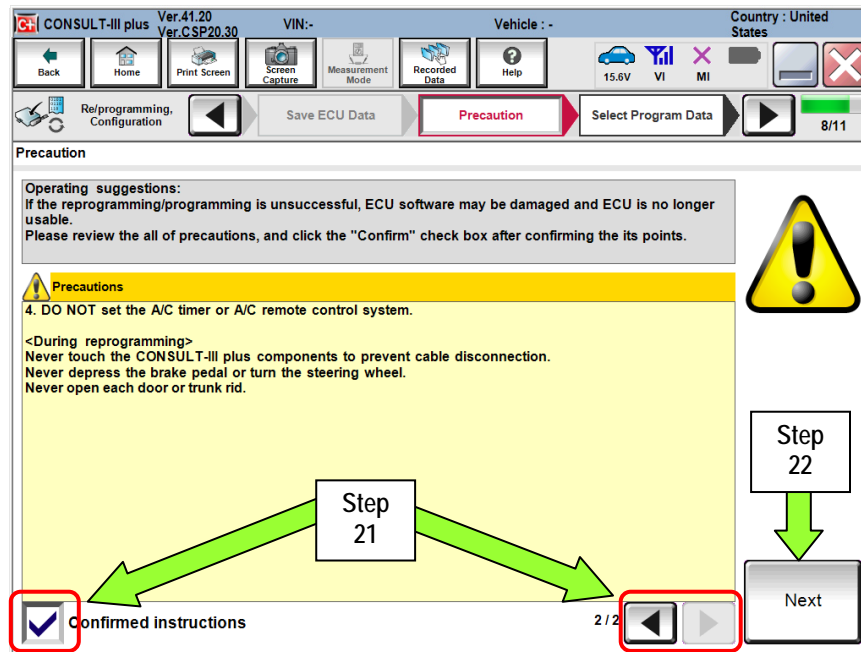
Figure 9

21. Use arrows (if needed) to view and read all precautions, then check the box confirming the precautions have been read.
22. Select **Next**.

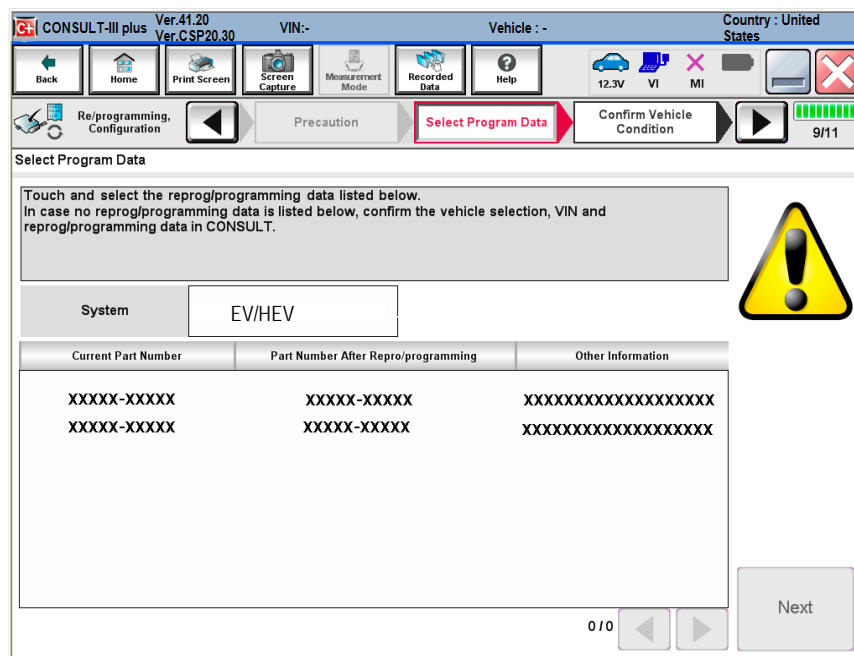
- In some cases, more than one new P/N for reprogramming is available.
  - If more than one P/N is available, the screen in Figure 10 will display. Select and use the reprogramming option that **does not** have the message “Caution! Use ONLY with NTBXX-XXX”.
- If you get this screen and it is blank (no reprogramming listed), it means there is no reprogramming available for this vehicle.

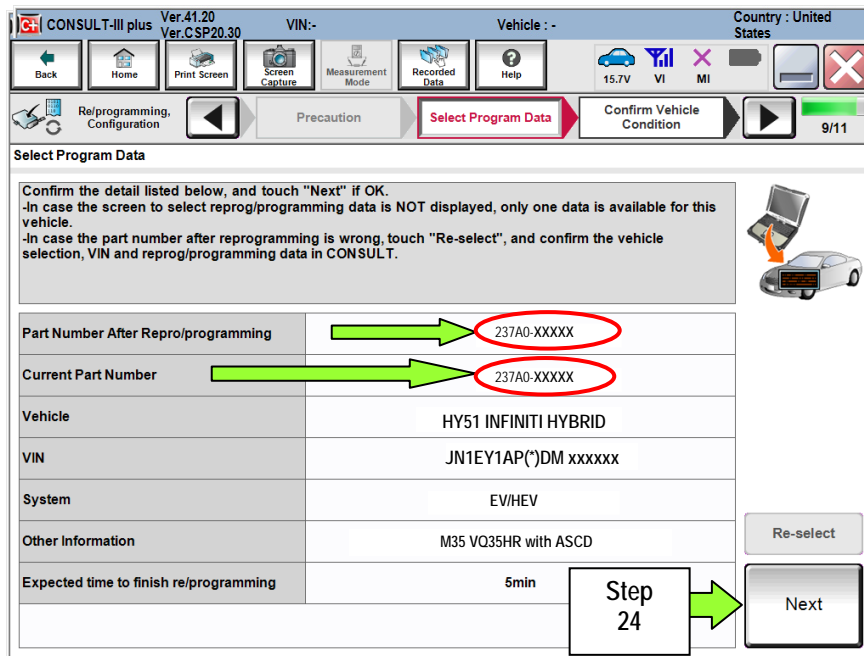
Figure 11

23. Read the Current Part Number and Part Number After Reprogramming. They should be different.

24. Select Next.

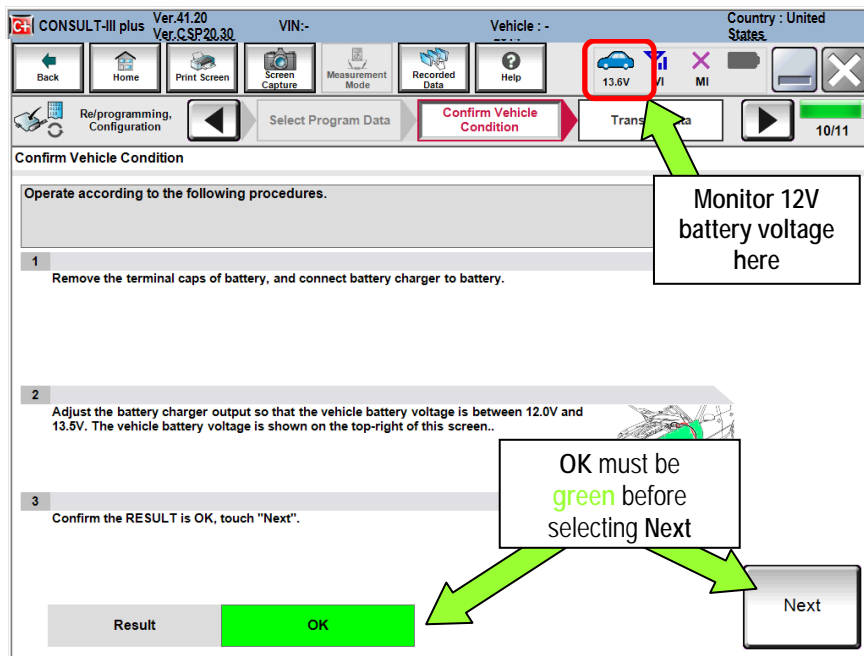
Figure 12

25. Confirm battery voltage is correct, and then select Next.

NOTE: Battery voltage must stay within specified range to make the indicator turn green.

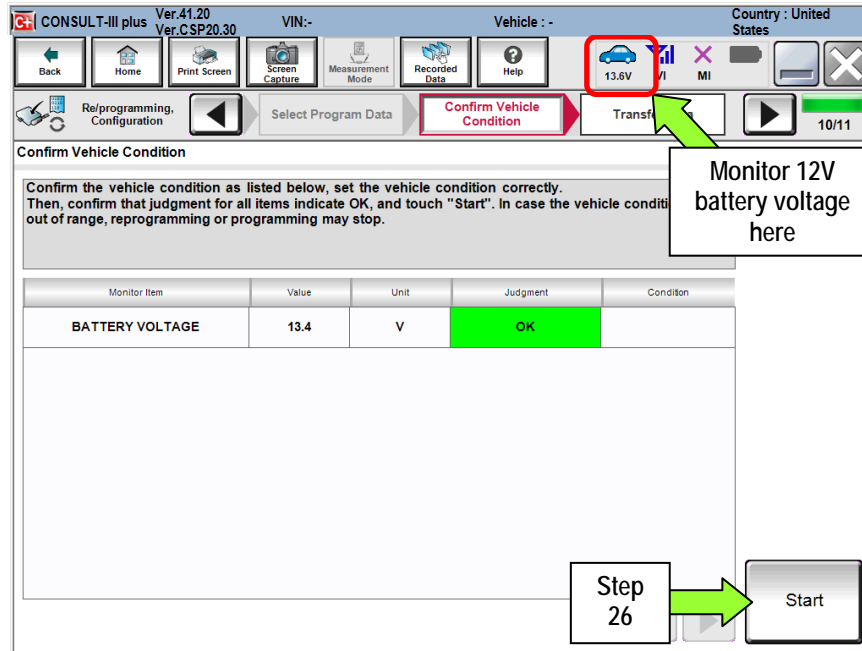
Figure 13

26. With battery voltage in the green, select **Start**.

- The reprogramming process begins when **Start** has been selected.

**NOTE:** For reprogramming to continue, vehicle 12V battery voltage must stay within 12 volts and 15.5 volts. Make sure the voltage level is sufficient.

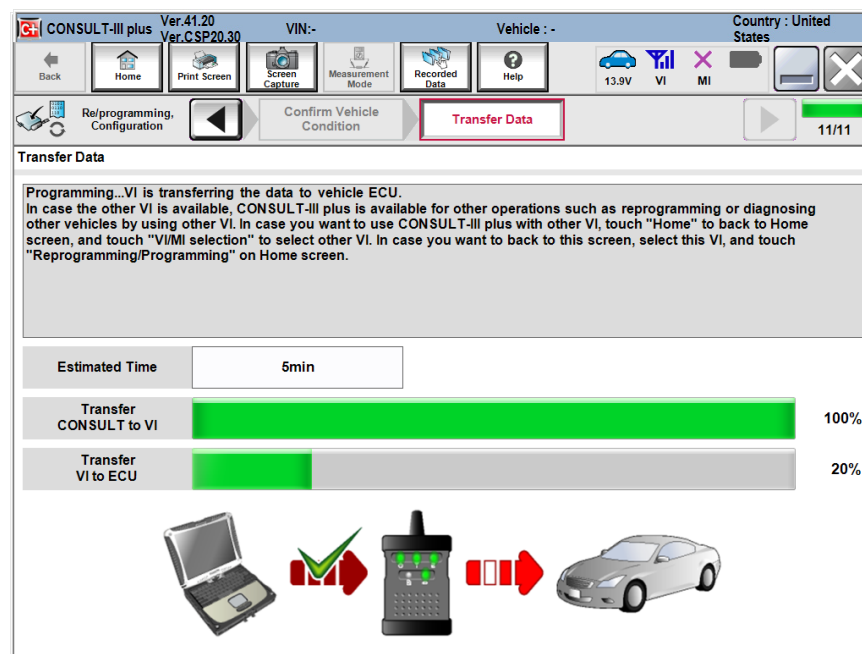
Figure 14

27. Wait for both bar graphs to complete.

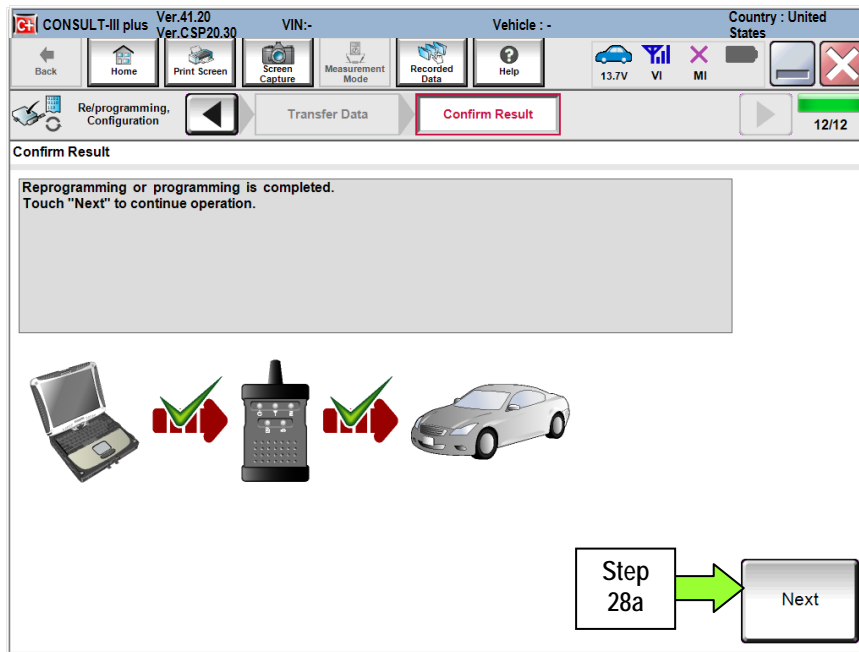
28. When the screen in Figure 15 displays, reprogramming is complete.
- a. Select **Next**, and then wait for System Call to complete.
  - b. Proceed to step 29 on page 14.

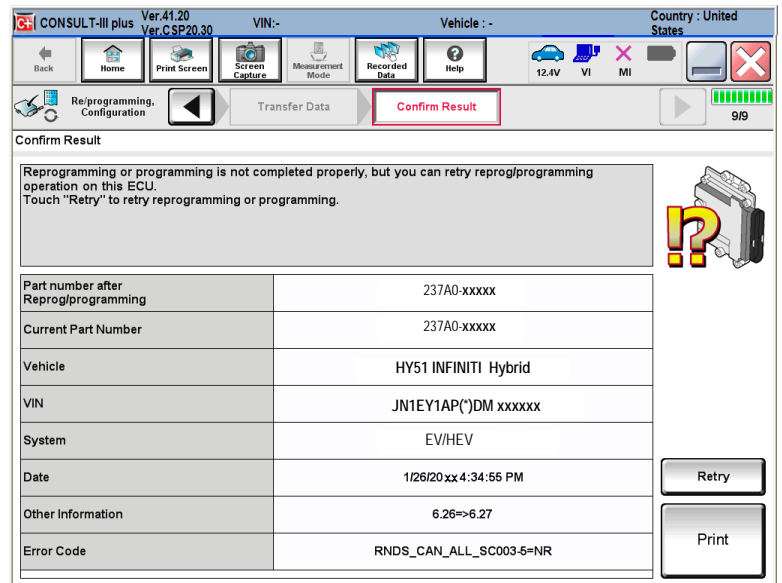
Figure 16

NOTE: If reprogramming does not complete and the **!?** displays as shown in Figure 16:

- Check battery voltage (12.0 - 15.5V).
- Ignition is ON, Ready Mode is OFF.
- External Bluetooth® devices are OFF.
- All electrical loads are OFF.
- Select **Retry** and follow the on screen instructions.
- Retry may not go through on the first attempt and can be selected more than once.

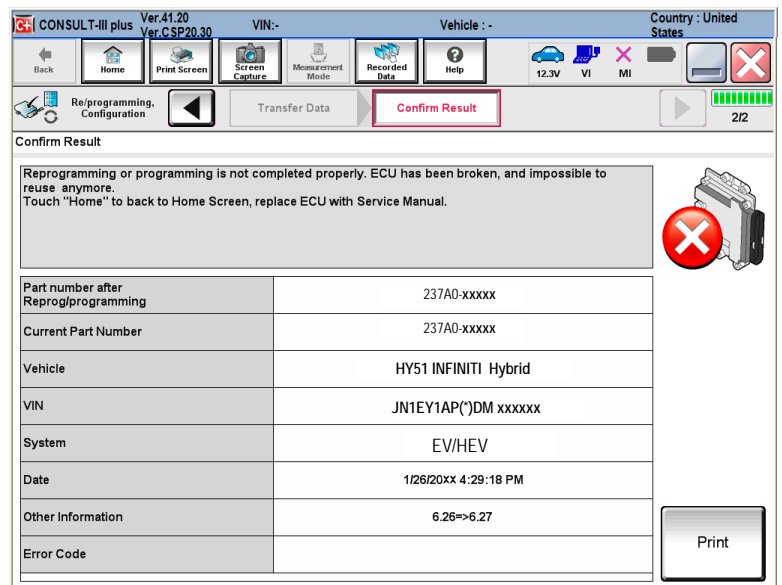
Figure 17

OR: If reprogramming does not complete and the **X** displays as shown in Figure 17:

**Do not disconnect plus VI or shut down Consult III plus if reprogramming does not complete.**

- Check battery voltage (12.0 - 15.5V).
- CONSULT A/C adapter is plugged in.
- Ignition is ON, Ready Mode is OFF.
- Transmission in Park.
- All C-III plus / plus VI cables are securely connected.
- All C-III plus updates are installed.
- Select **Home**, and then restart the reprogram procedure from the beginning.

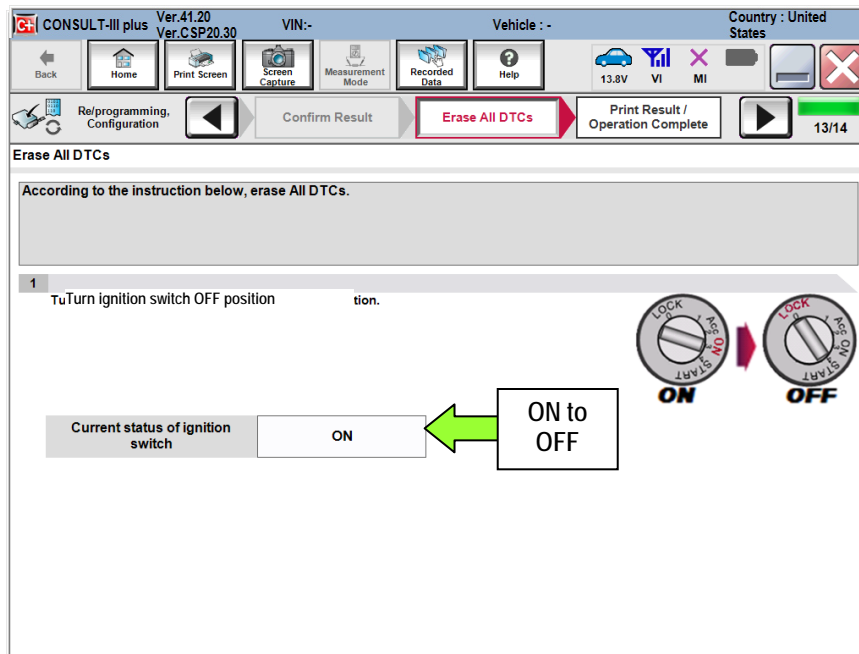
- a. Turn the "ignition" off by depressing the power switch once.
  - The screen in Figure 18 will read **OFF** after pressing the power switch once.

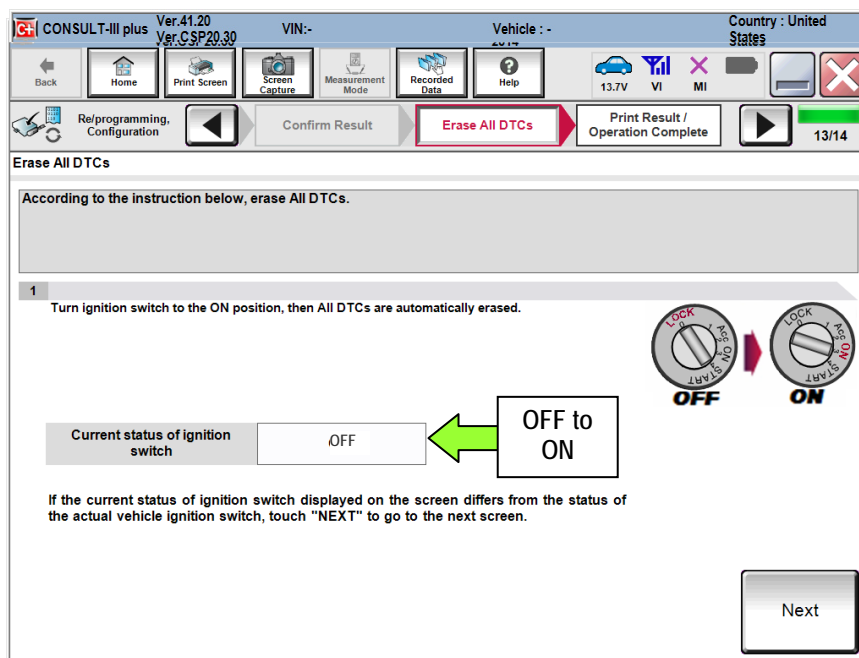
- b. Wait 1 minute with the ignition OFF.
- c. Turn the "ignition" ON by depressing the power switch twice (not Ready mode).
  - Do not step on the brake pedal when depressing the power switch.
  - The screen in Figure 19 will read **ON** after pressing the power switch twice.

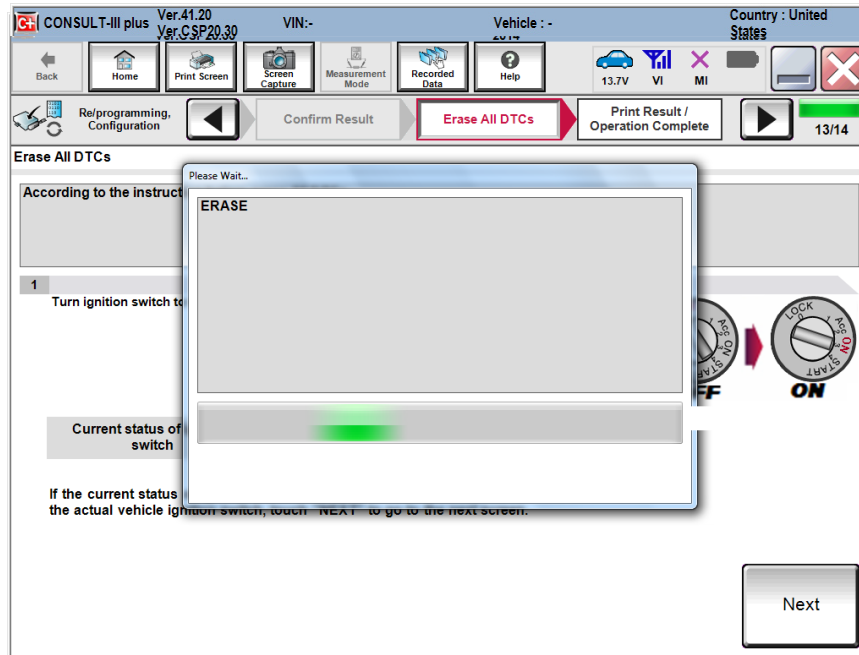
Figure 20

d. Wait for the ERASE function to complete.

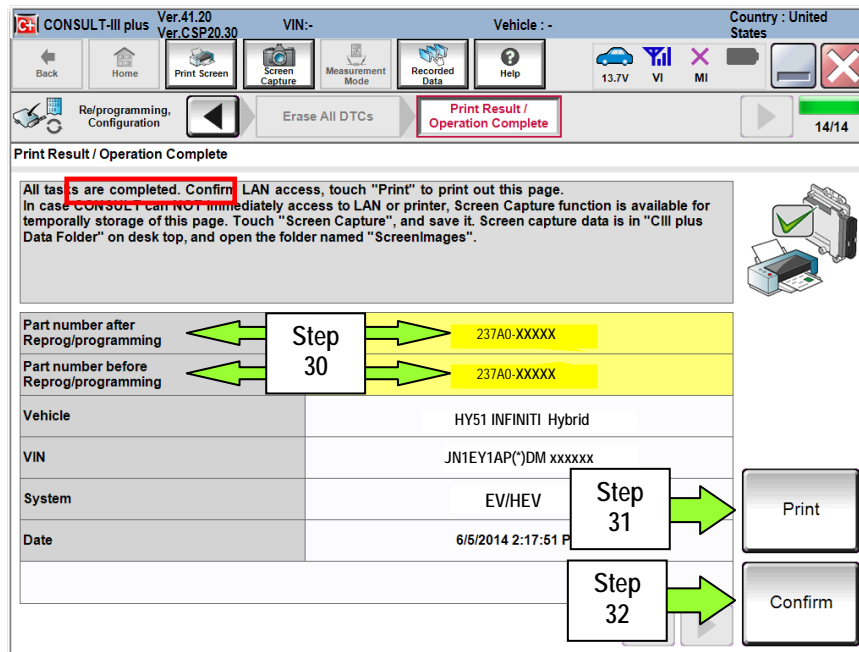
Figure 21

30. Verify the before and after part numbers are different.

31. Print a copy of this screen (Figure 21) and attach it to the repair order.

32. Select Confirm.

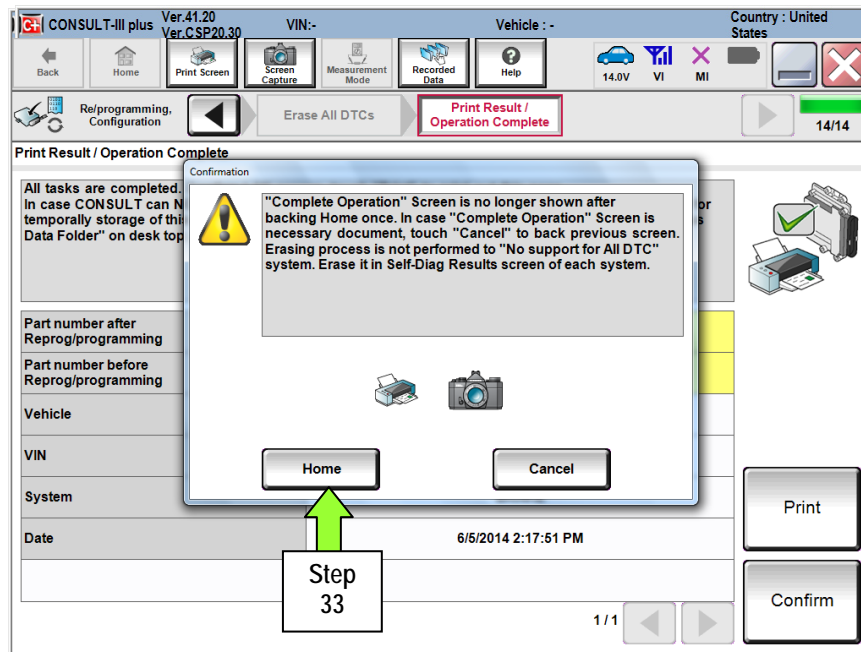
Figure 22

33. Select Home.

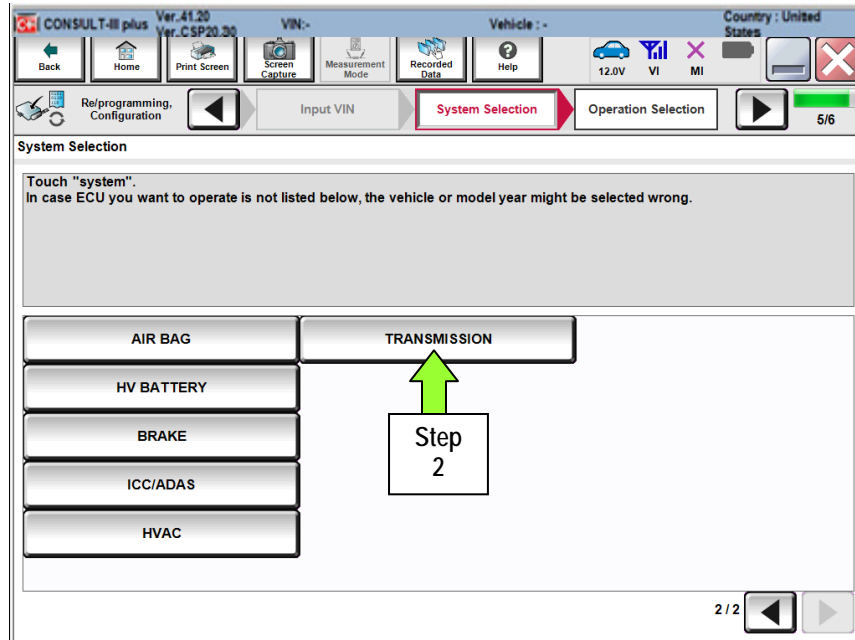
Figure 23

1. Perform steps 10 – 17 starting on page 4 and then proceed to step 2 below.
2. Select **Transmission**.

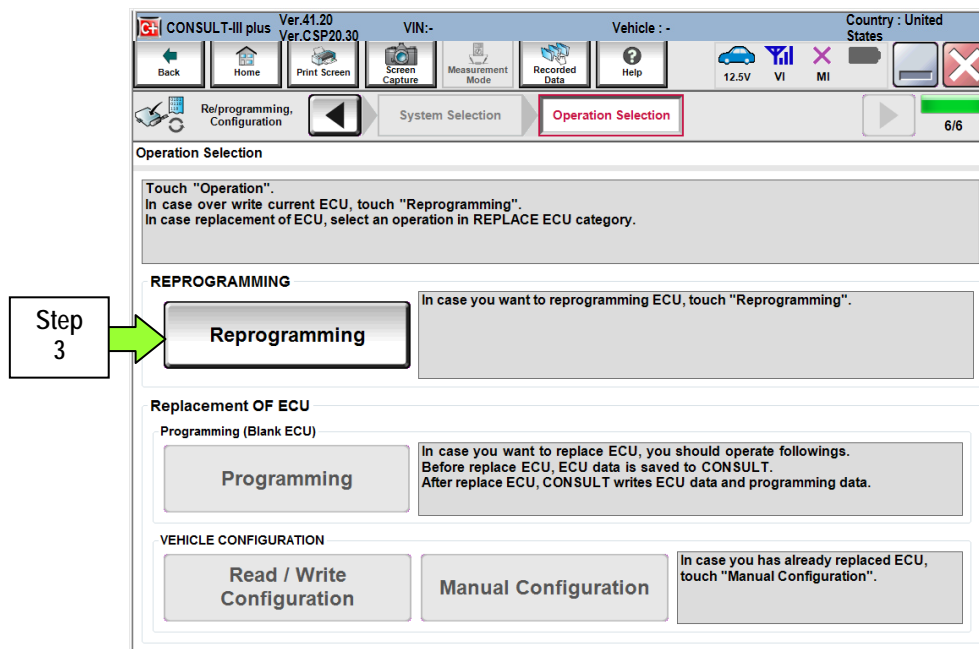
Figure 24

3. Select **Reprogramming**.

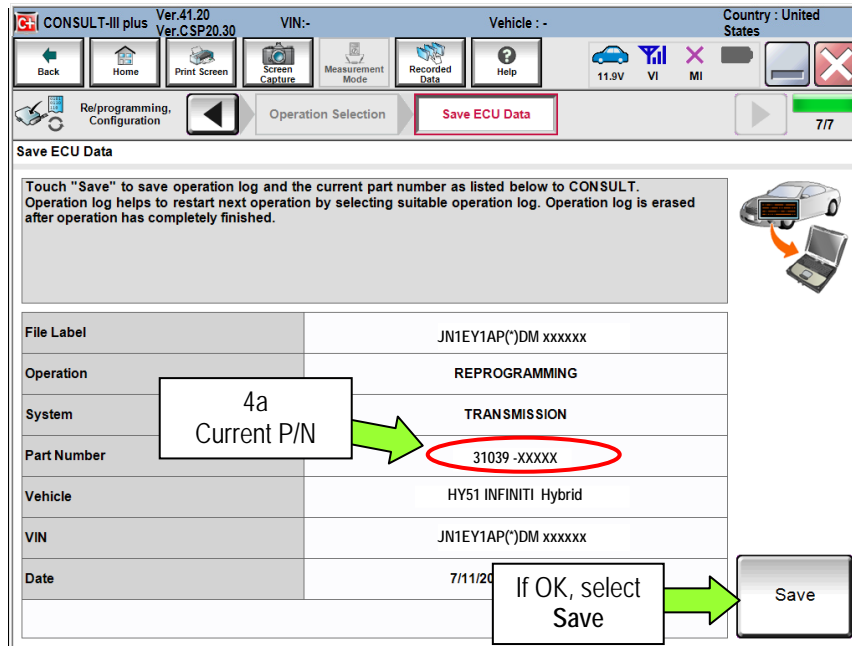
Figure 25

4. When you get to the screen shown in Figure 25, confirm if this TRANSMISSION (TCM) update has already been applied as follows.
  - a. Find the TCM Part Number and write it on the repair order.

**NOTE:** This is the current TCM Part Number (P/N) and will also be needed for claims information.

- b. Compare the P/N you wrote down to the numbers in the **CURRENT TCM PART NUMBER** column in **Table B** below.
  - If the TCM part number is one of the part numbers listed in the **Table B**, continue with reprogramming.
    - Select **Save**, and then go to the next step.
  - If the TCM part number is not listed in **Table B**, this part of the reprogram has already been performed.
    - Proceed to Step 18 on page 26.

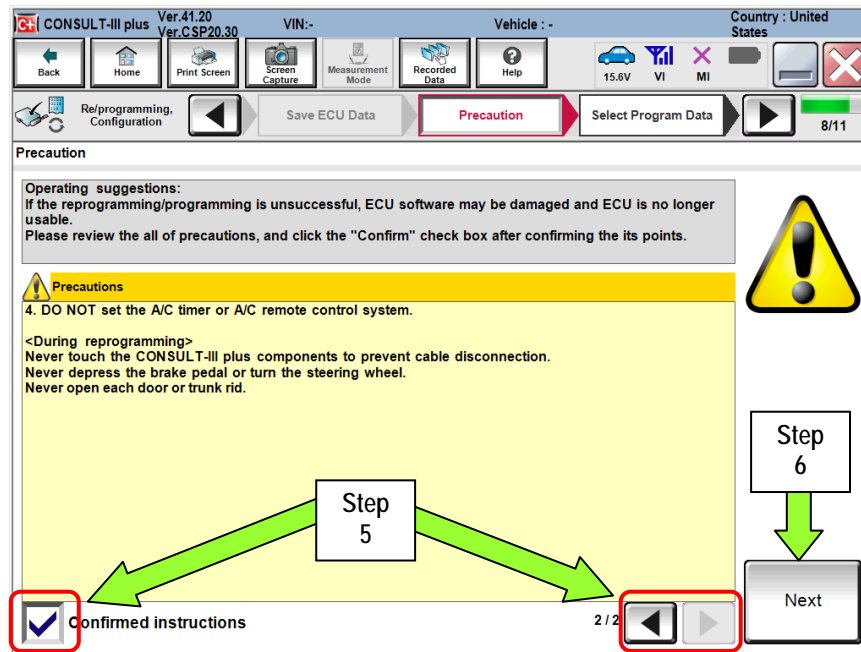
Figure 26

5. Use arrows (if needed) to view and read all precautions, then check the box confirming the precautions have been read.
6. Select **Next**.

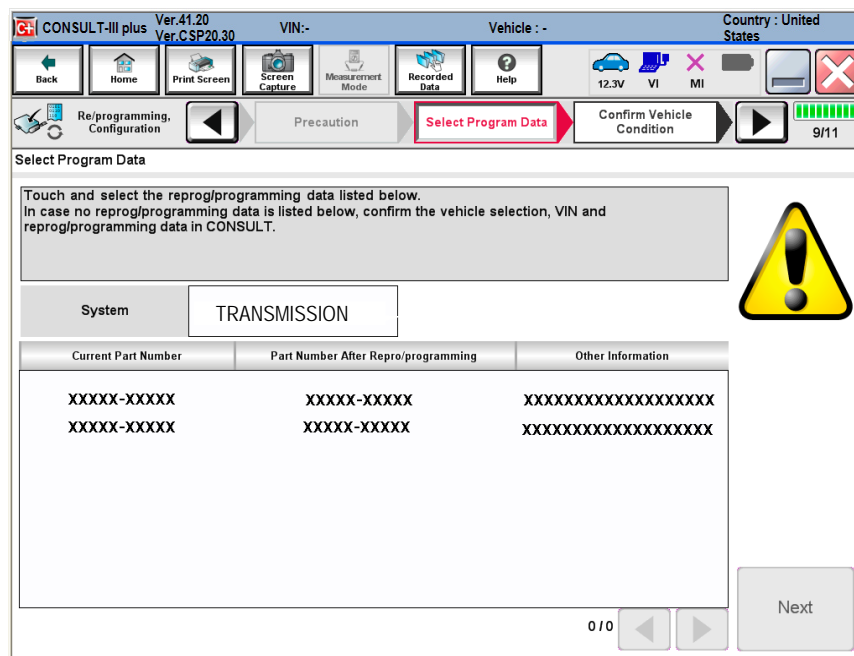
- In some cases, more than one new P/N for reprogramming is available.
  - If more than one P/N is available, the screen in Figure 27 will display. Select and use the reprogramming option that **does not** have the message “Caution! Use ONLY with NTBXX-XXX”.
- If you get this screen and it is blank (no reprogramming listed), it means there is no reprogramming available for this vehicle.

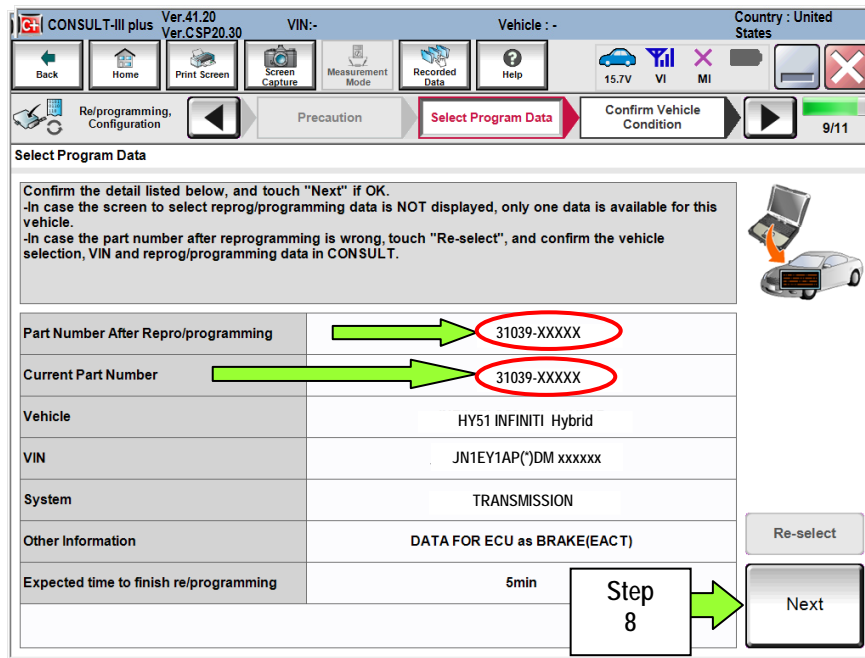
Figure 28

7. Read the **Current Part Number** and **Part Number After Reprogramming**. They should be different.
8. Select **Next**.

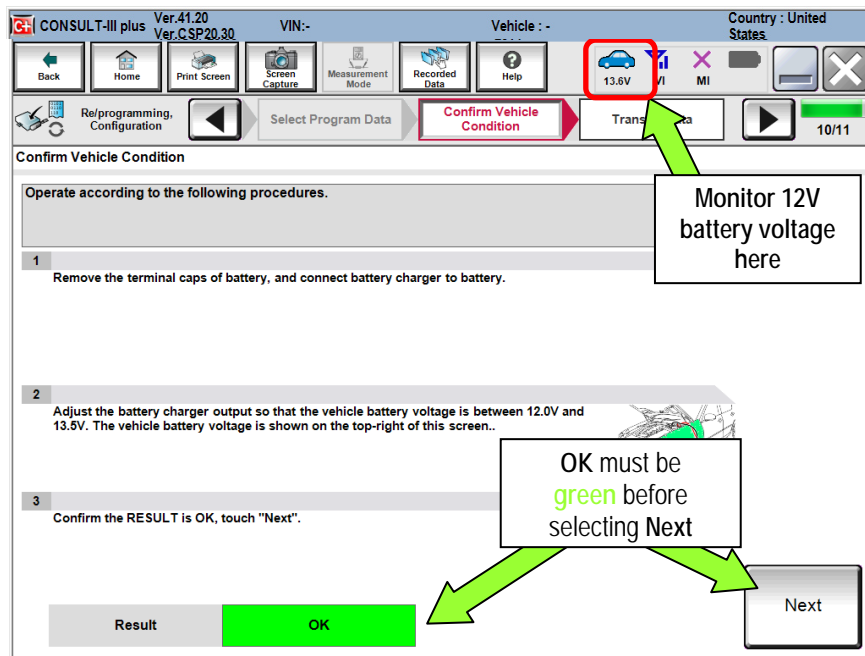
Figure 29

9. Confirm battery voltage is correct, and then select **Next**.

**NOTE:** Battery voltage must stay within specified range to make the indicator turn **green**.

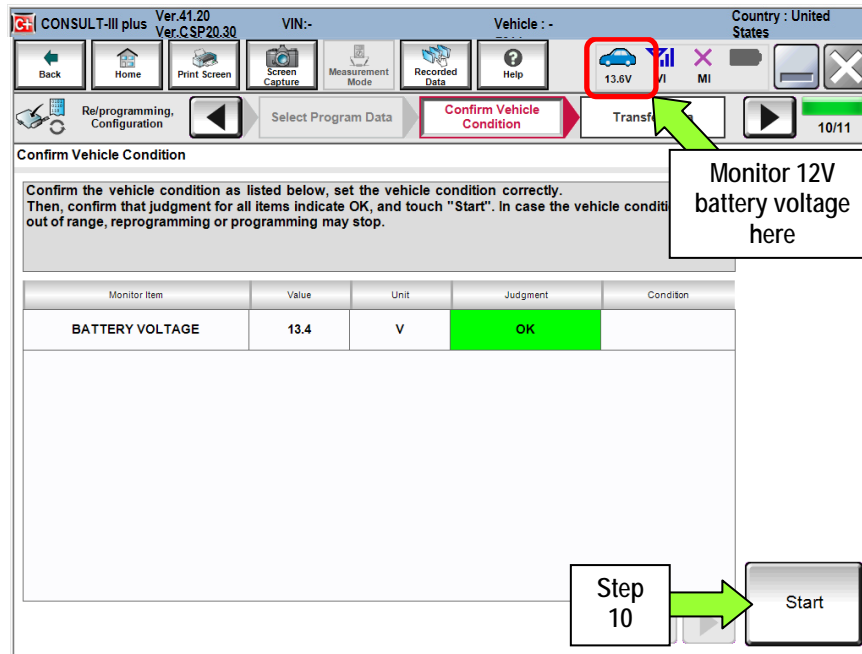
Figure 30

10. With battery voltage in the green, select **Start**.

- The reprogramming process begins when **Start** has been selected.

**NOTE:** For reprogramming to continue, vehicle 12V battery voltage must stay within 12 volts and 15.5 volts. Make sure the voltage level is sufficient.

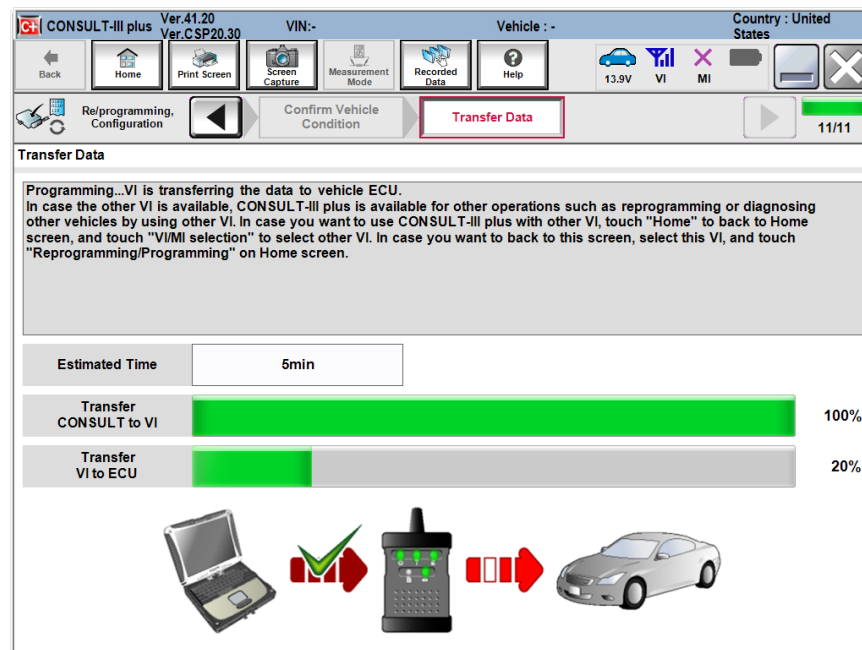
Figure 31

11. Wait for both bar graphs to complete.

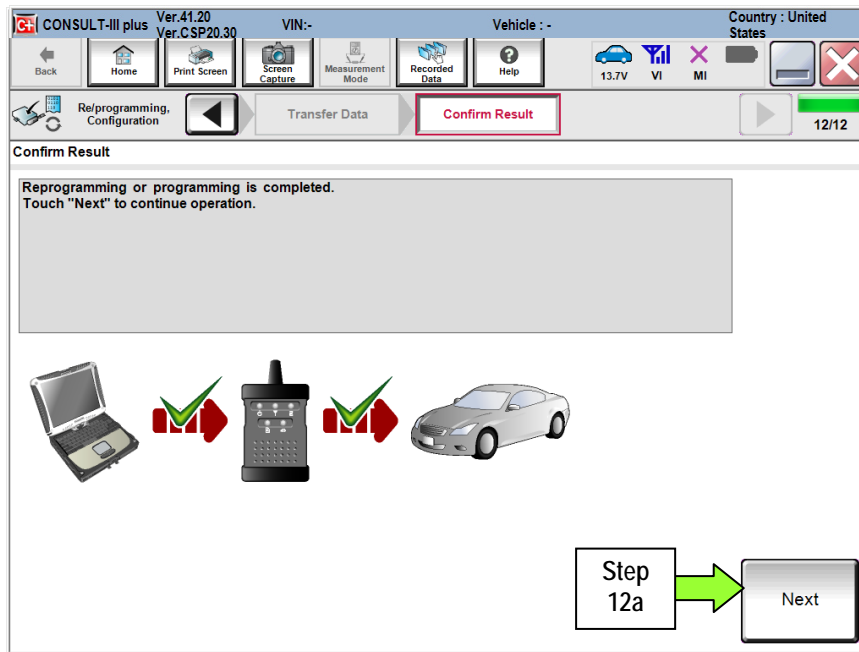
12. When the screen in Figure 32 displays, reprogramming is complete.
- a. Select **Next**, and then wait for System Call to complete.
  - b. Proceed to step 13 on page 24.

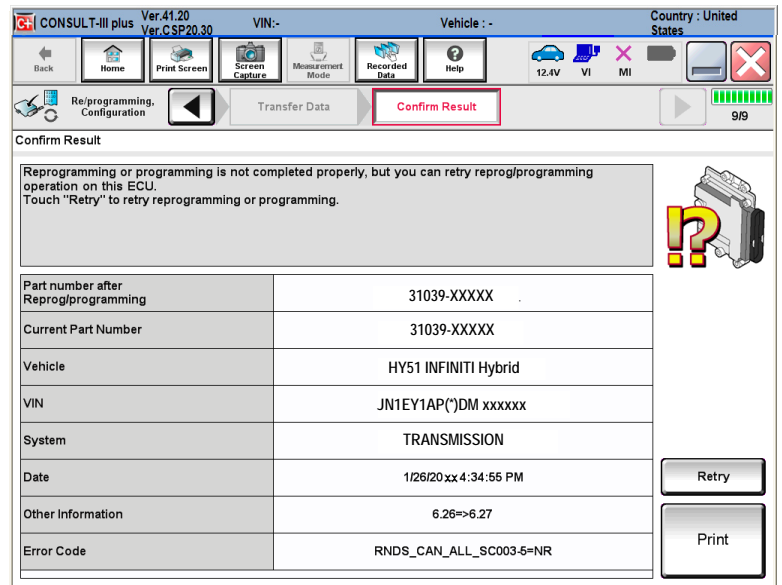
Figure 33

NOTE: If reprogramming does not complete and the **!?** displays as shown in Figure 33:

- Check battery voltage (12.0 - 15.5V).
- Ignition is ON, Ready Mode is OFF.
- External Bluetooth® devices are OFF.
- All electrical loads are OFF.
- Select **Retry** and follow the on screen instructions.
- Retry may not go through on the first attempt and can be selected more than once.

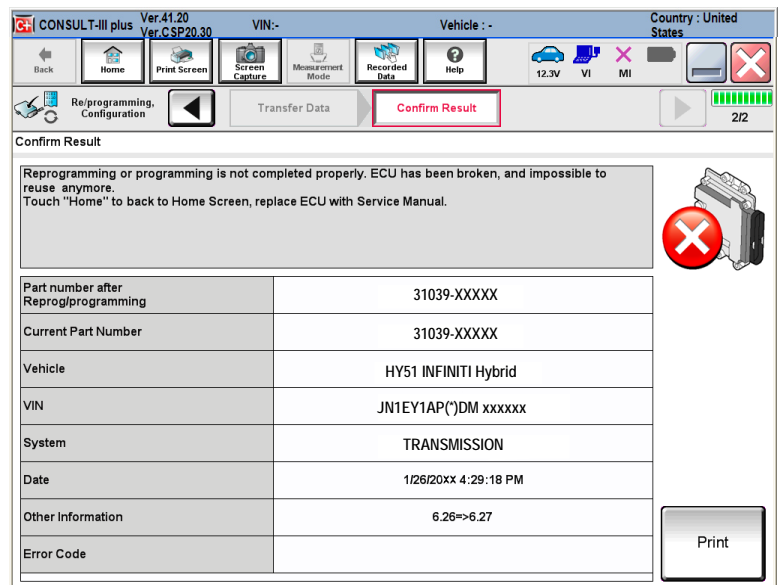
Figure 34

OR: If reprogramming does not complete and the **X** displays as shown in Figure 34:

**Do not disconnect plus VI or shut down Consult III plus if reprogramming does not complete.**

- Check battery voltage (12.0 - 15.5V).
- CONSULT A/C adapter is plugged in.
- Ignition is ON, Ready Mode is OFF.
- Transmission in Park.
- All C-III plus / plus VI cables are securely connected.
- All C-III plus updates are installed.
- Select **Home**, and then restart the reprogram procedure from the beginning.

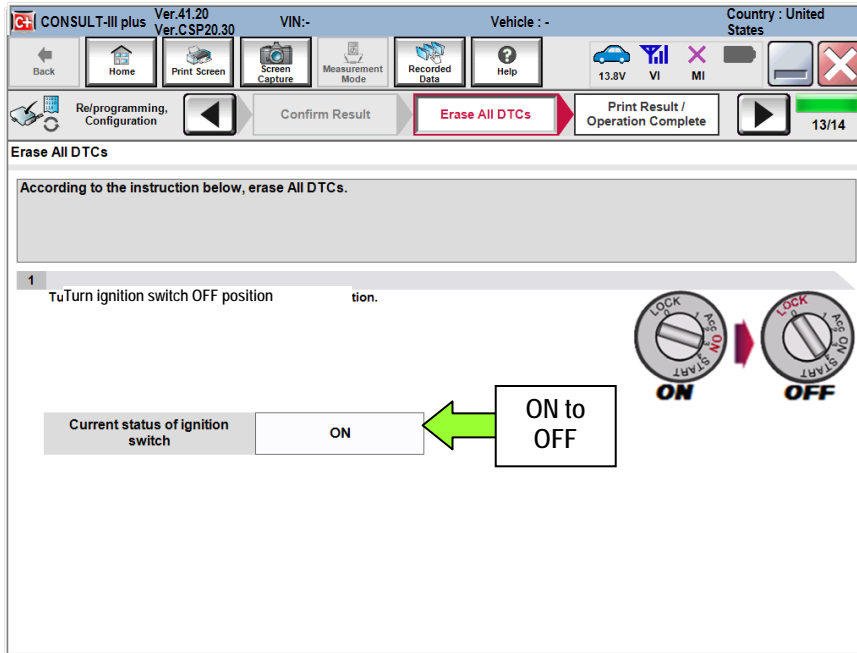
- a. Turn the "ignition" off by depressing the power switch once.
  - The screen in Figure 35 will read **OFF** after pressing the power switch once.

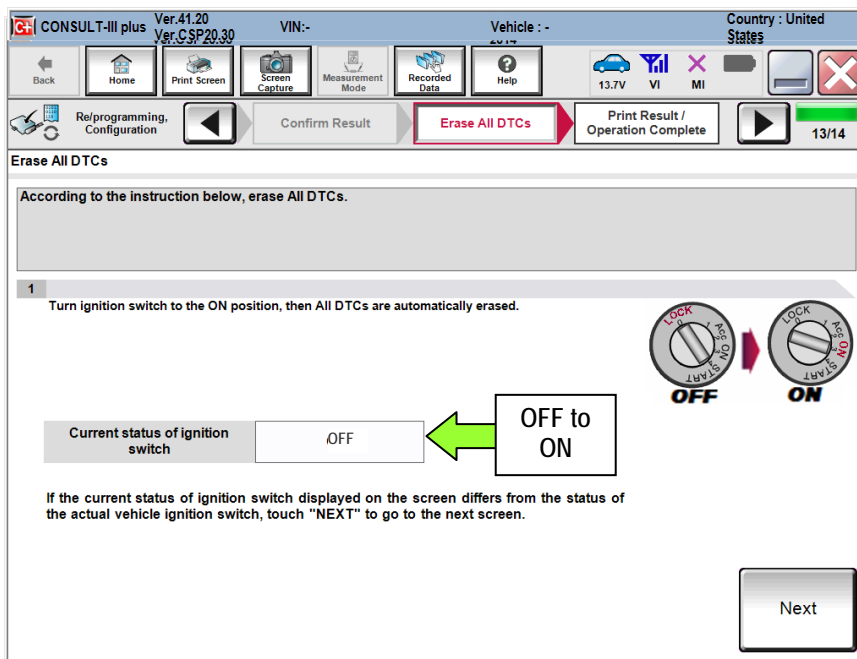
- b. Wait 1 minute with the ignition OFF.
- c. Turn the "ignition" ON by depressing the power switch twice (not "Ready" mode).
  - Do not step on the brake pedal when depressing the power switch.
  - The screen in Figure 36 will read **ON** after pressing the power switch twice.

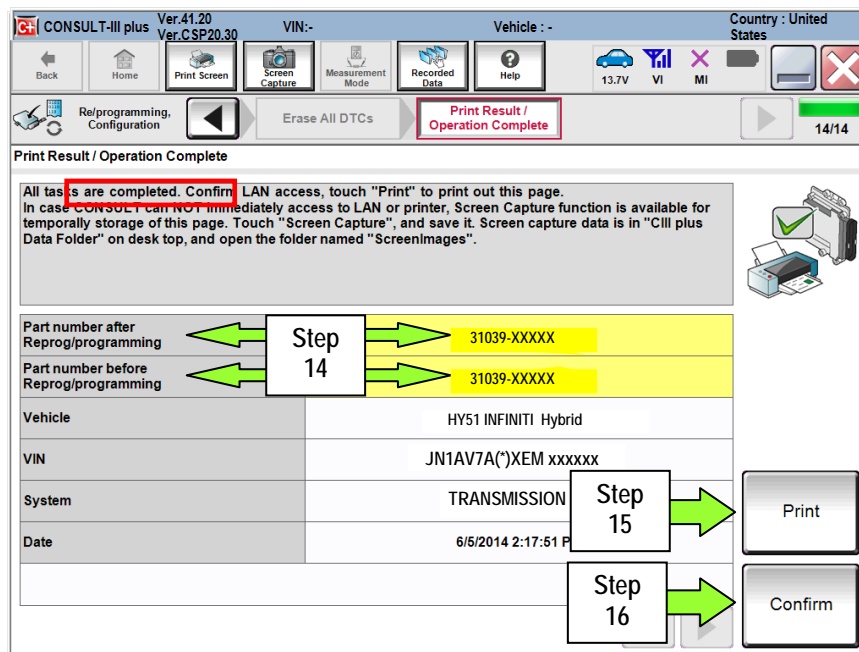
Figure 38

14. Verify the before and after part numbers are different.

15. Print a copy of this screen (Figure 38) and attach it to the repair order.

16. Select **Confirm**.
