AT14-009

## 2012 – 2013 M HYBRID; HPCM AND TCM REPROGRAM

**APPLIED VEHICLE:** 2012-2013 M Hybrid (HY51)  
**APPLIED VIN AND DATE:** Built before JN1EY1AP(\*)DM 650167 and Feb 2, 2013  
**APPLIED TRANSMISSION:** Hybrid only

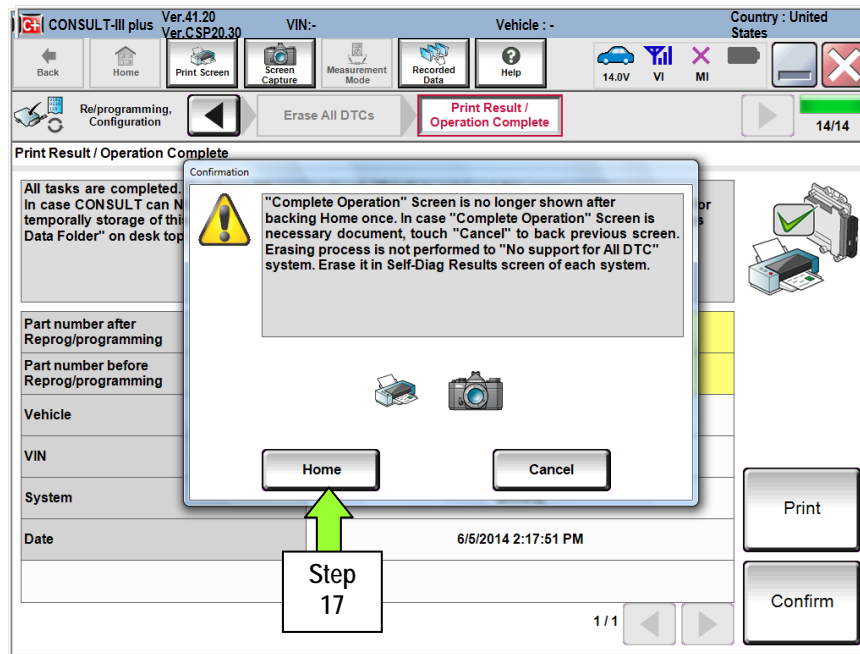
Figure 39

17. Select **Home**.
