SERVICE BULLETIN

Classification: EL13-053a Reference:

2013 JX35, 2014-2015 Q50 & QX60; ONE OR BOTH INTELLIGENT KEYS LOST PRIOR TO CUSTOMER DELIVERY

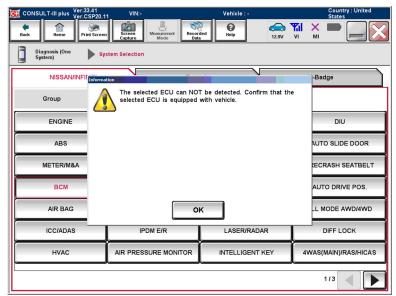
Figure 6

- 8. If the screen in Figure 5 displays, the BCM is not in Transit Mode.
 - a) Select Home.
 - b) Replace the lost Intelligent Keys.
 - c) Register both replacement Intelligent Keys using CONSULT-III (C-III) plus.
 - d) Once successfully registered, this procedure is complete.
- If an error message indicates the ECU cannot be detected (see Figure 6), the BCM is in Transit Mode.
 - a) Replace the BCM.
 - Replace the lost Intelligent Keys and have the new ones available before proceeding to the next step.
 - c) Contact TECH LINE for Intelligent Key registration procedure guidance.
