SERVICE BULLETIN

Classification:	Reference:	Date:
EM15-001	NTB15-020	March 17, 2015

2013-2014 SENTRA; ENGINE OVER TEMP, DTC P1217, AND / OR A/C NOT COLD

APPLIED VEHICLE: 2013-2014 Sentra (B17)

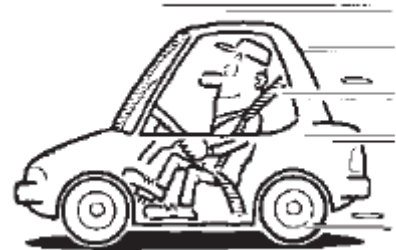
Figure A

- Most instructions for reprogramming with CONSULT-III plus (C-III plus) are displayed on the CONSULT PC screen.
- If you are not familiar with the reprogramming procedure, click here. This will link you to the "CONSULT-III plus (C-III plus) Reprogramming" general procedure.
- Take the vehicle for a 10 minute drive in order to meet the following Idle Air Volume Learn (IAVL) conditions:
 - Engine coolant temperature: 70 -100°C (158 -212°F)
 - Battery voltage: More than 12.9V (At idle)
 - Transmission: Warmed up

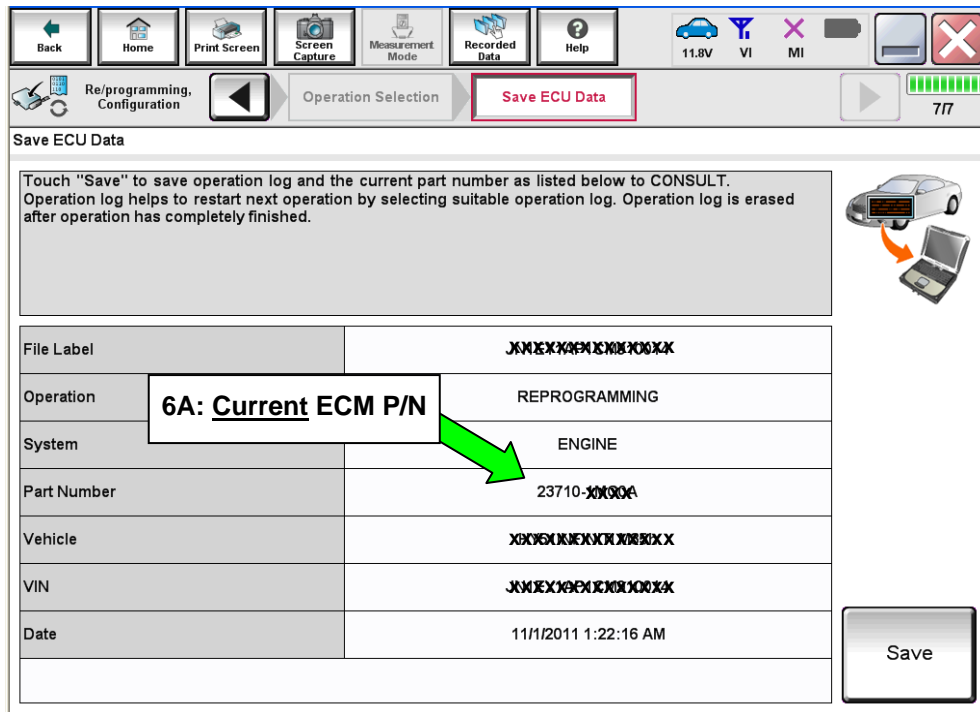
6. When you get to the screen shown in Figure 2, confirm this bulletin applies as follows.
- A. Find the ECM **Part Number** and write it on the repair order.

NOTE: This is the current ECM Part Number (P/N).

5. Follow the on-screen instructions and navigate the C-III plus to the screen shown in Figure 2 on the next page.

- B. Compare the P/N you wrote down to the numbers in the **Current ECM Part Number** column in **Table A** on the next page.
- If there is a match, the ECM needs to be reprogrammed. Continue with the reprogramming procedure.
 - If there is not a match, ECM reprogramming does not apply. Repairs are complete.

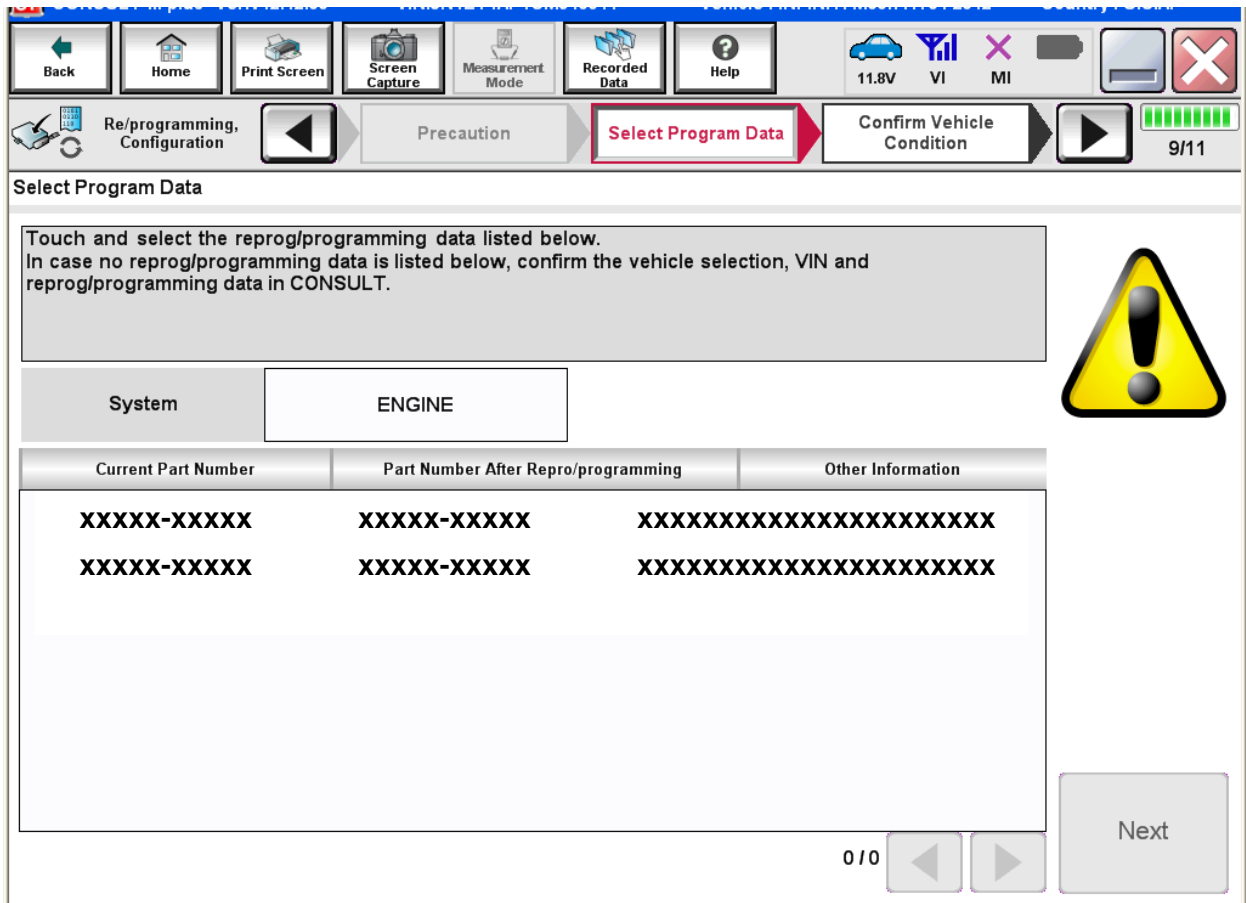
- In some cases, more than one new P/N for reprogramming is available.
 - In this case, the screen in Figure 3 displays.
 - Select and use the reprogramming option that **does not** have the message “Caution! Use ONLY with NTBXX-XXX”.
- If you get this screen and it is blank (no reprogramming listed), it means there is no reprogramming available for this vehicle.

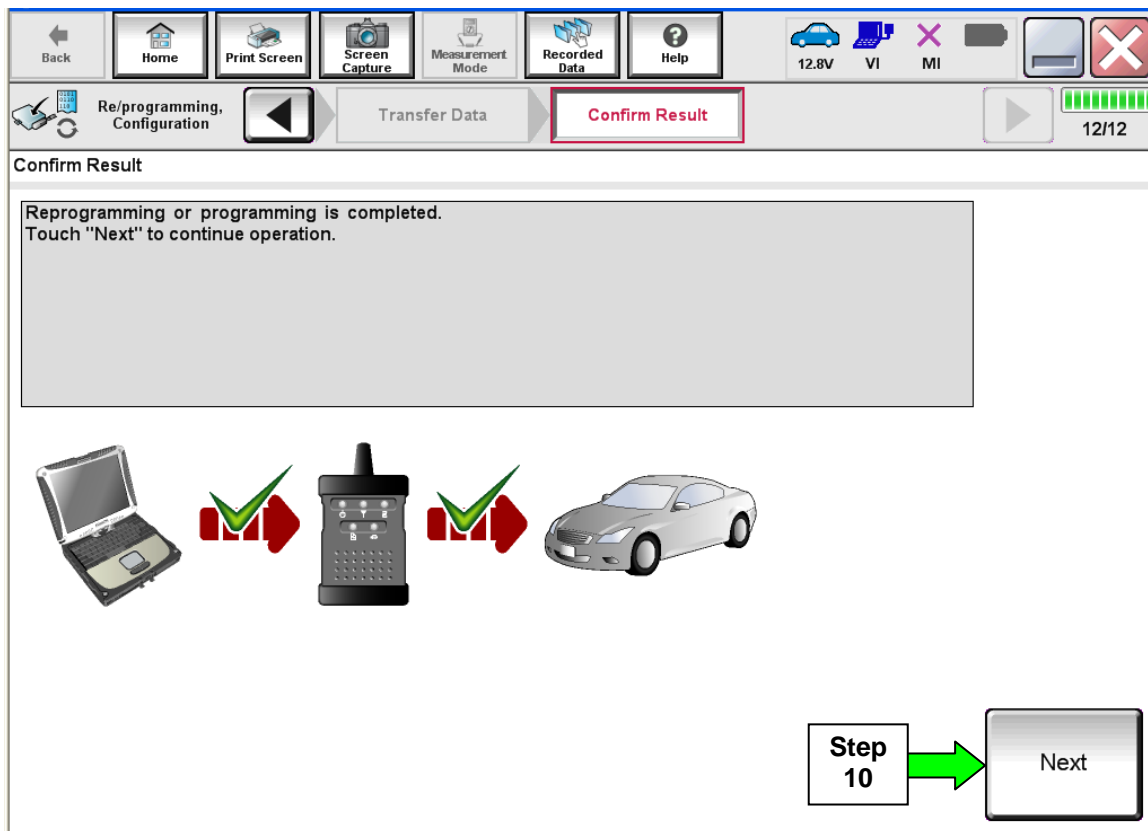
8. When the screen in Figure 4 displays, reprogramming is complete.

NOTE: If the screen in Figure 4 does not display (reprogramming does not complete), refer to the information on the next page.

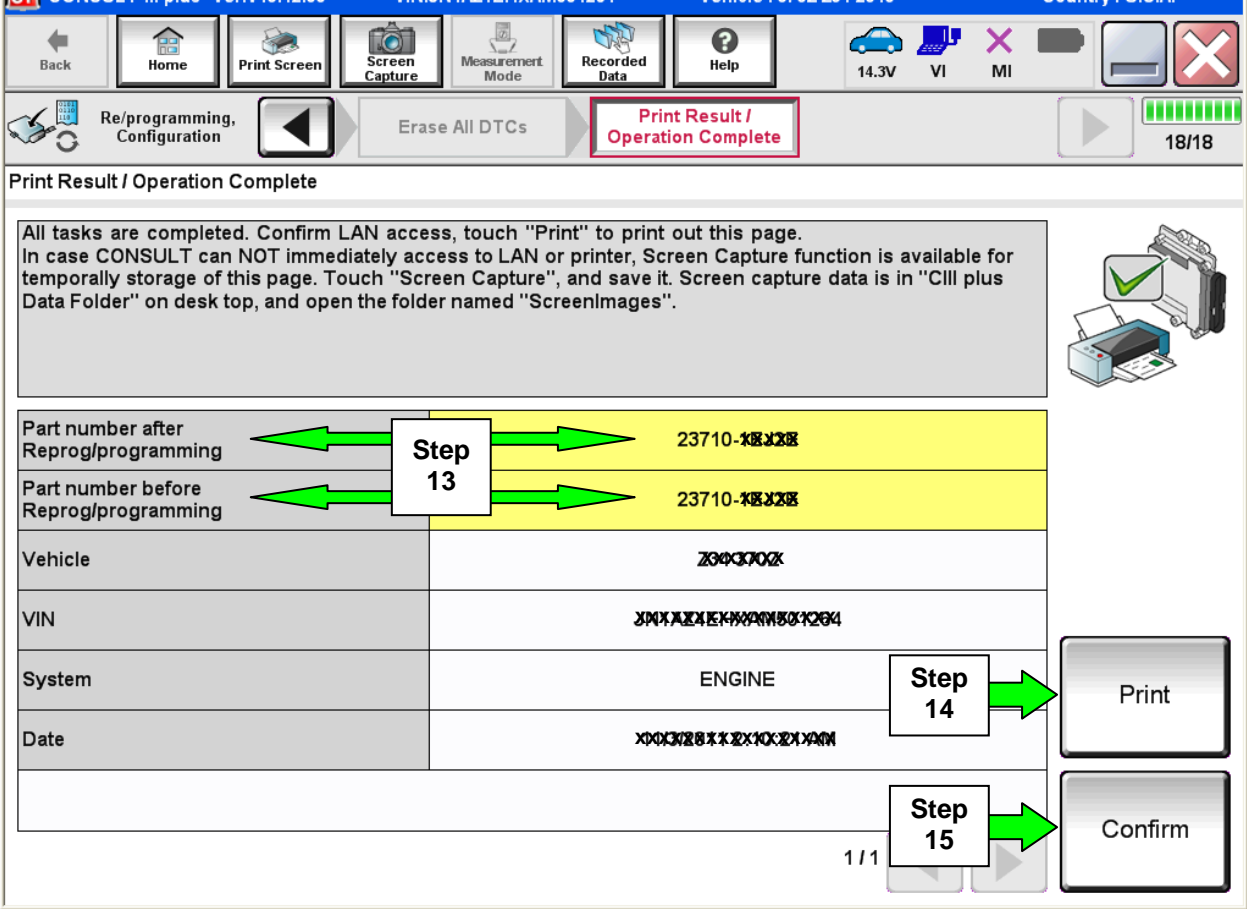
- 12. When the entire reprogramming process is complete, the screen in Figure 7 will display.
- 13. Verify the before and after part numbers are different.
- 14. Print a copy of this screen (Figure 7) and attach it to the repair order for warranty documentation.
- 15. Select **Confirm**.
