# SERVICE BULLETIN

## 2013-2014 SENTRA; INTERMITTENT ROUGH/LOW IDLE WHEN STOPPED

**APPLIED VEHICLE:** 2013-2014 Sentra (B17)

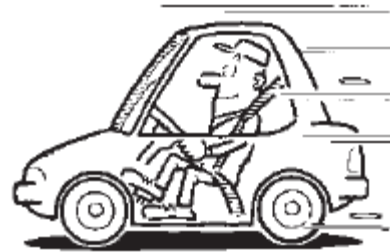
Figure A

- Most instructions for reprogramming with CONSULT-III plus (C-III plus) are displayed on the CONSULT PC screen.
- If you are not familiar with the reprogramming procedure, *click here*. This will link you to the "CONSULT-III plus (C-III plus) Reprogramming" general procedure.
- Take the vehicle for a 10 minute drive in order to meet the following Idle Air Volume Learn (IAVL) conditions:
  - Engine coolant temperature: 70 -100°C (158 -212°F)
  - Battery voltage: More than 12.9V (At idle)
  - Transmission: Warmed up

- After reprogramming is complete, you will be required to perform Throttle Valve Closed Position, Idle Air Volume Learn, Accelerator Closed Position, and DTC erase.

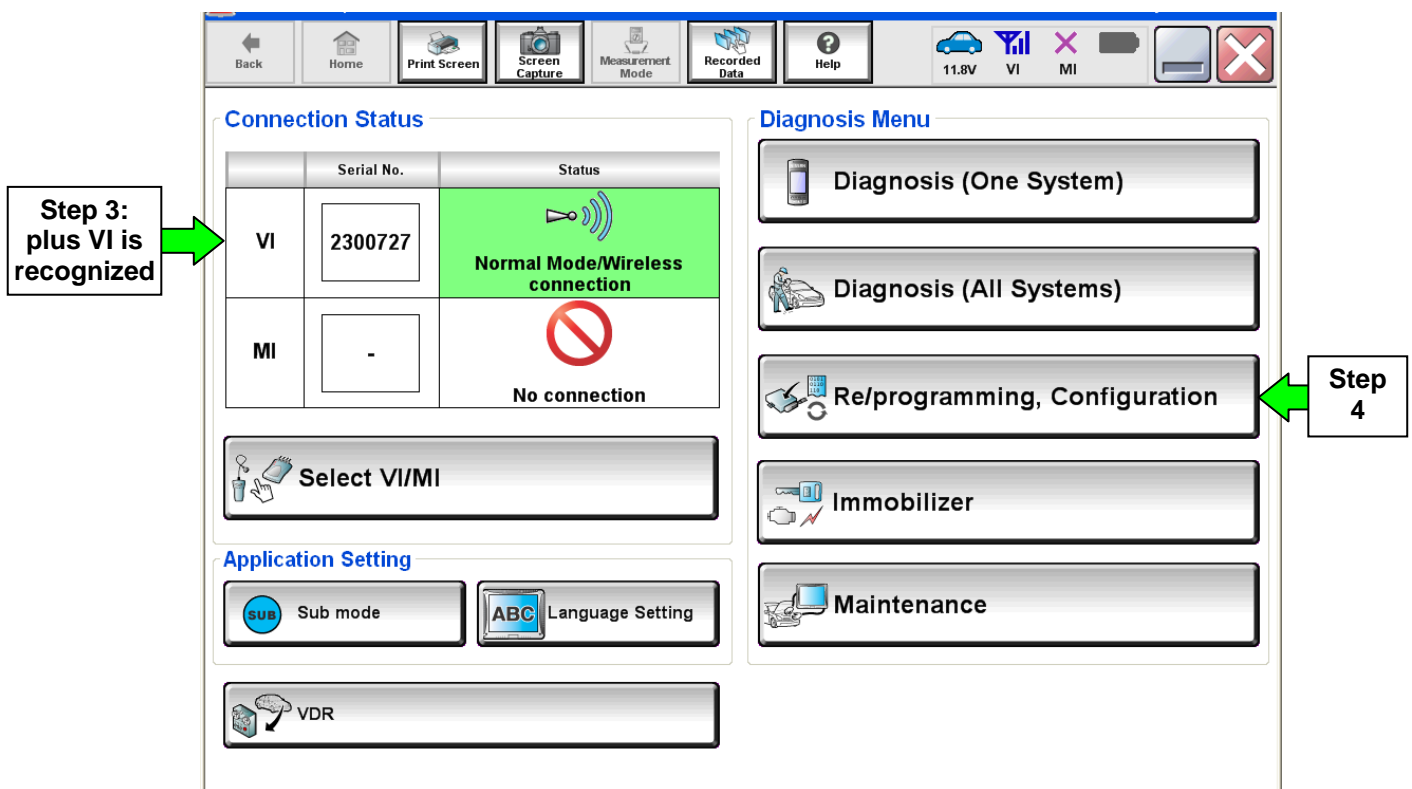
Figure 1

1. Connect the CONSULT PC to the vehicle to begin the reprogramming procedure.
2. Open C-III plus.
3. Wait for the plus VI to be recognized.
  - Serial number will display when the plus VI is recognized.
4. Select **Re/programming, Configuration**.

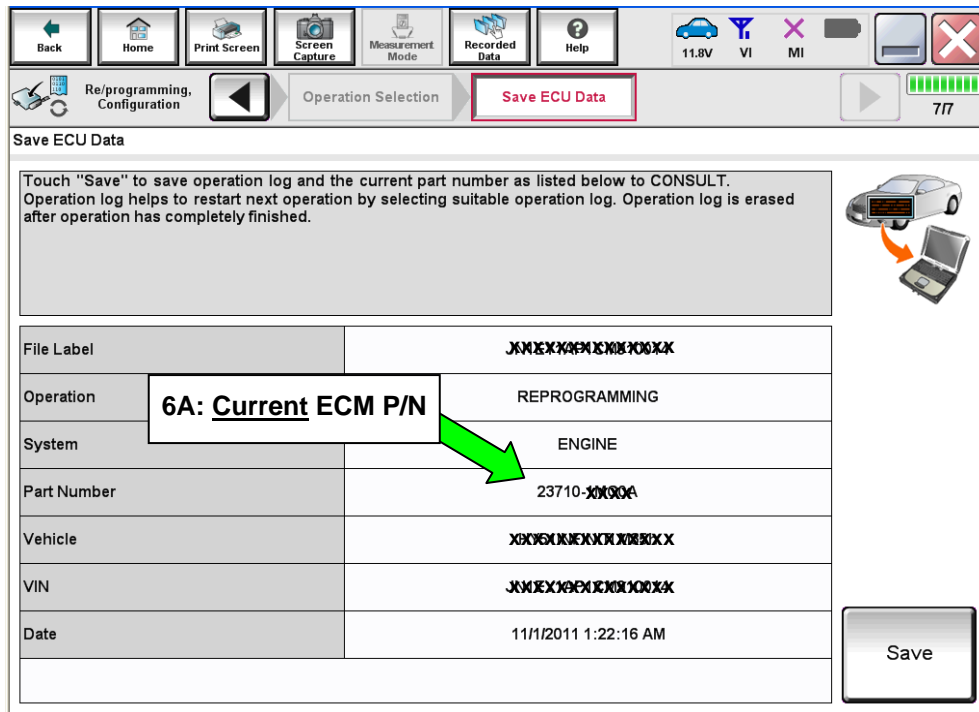
6. When you get to the screen shown in Figure 2, confirm this bulletin applies as follows.

A. Find the ECM **Part Number** and write it on the repair order.

**NOTE:** This is the current ECM Part Number (P/N).

5. Follow the on-screen instructions and navigate the C-III plus to the screen shown in Figure 2 on the next page.

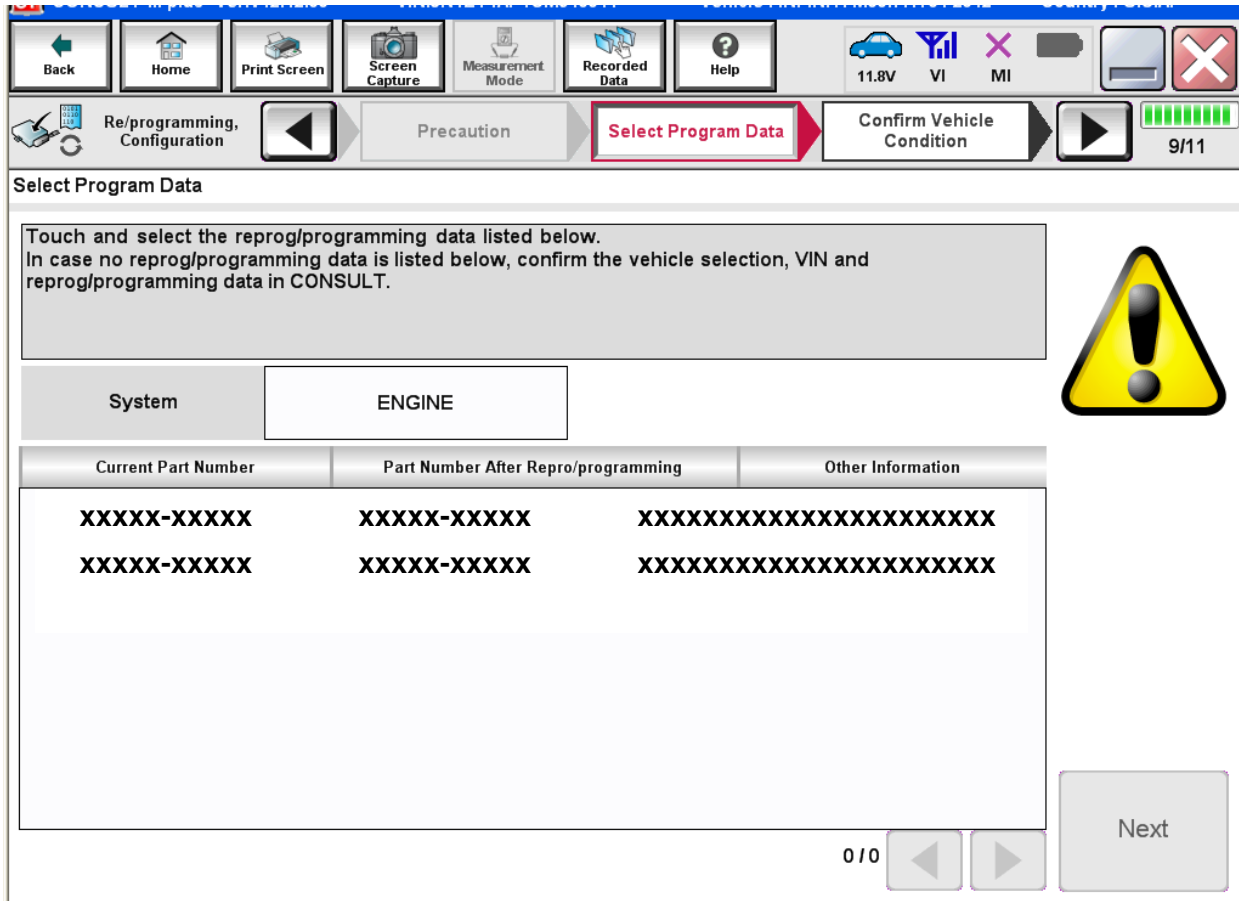
- In some cases, more than one new P/N for reprogramming is available.
  - In this case, the screen in Figure 3 displays.
  - Select and use the reprogramming option that **does not** have the message “Caution! Use ONLY with NTBXX-XXX”.
- If you get this screen and it is blank (no reprogramming listed), it means there is no reprogramming available for this vehicle. Close C-III plus and refer back to ASIST for further diagnosis.

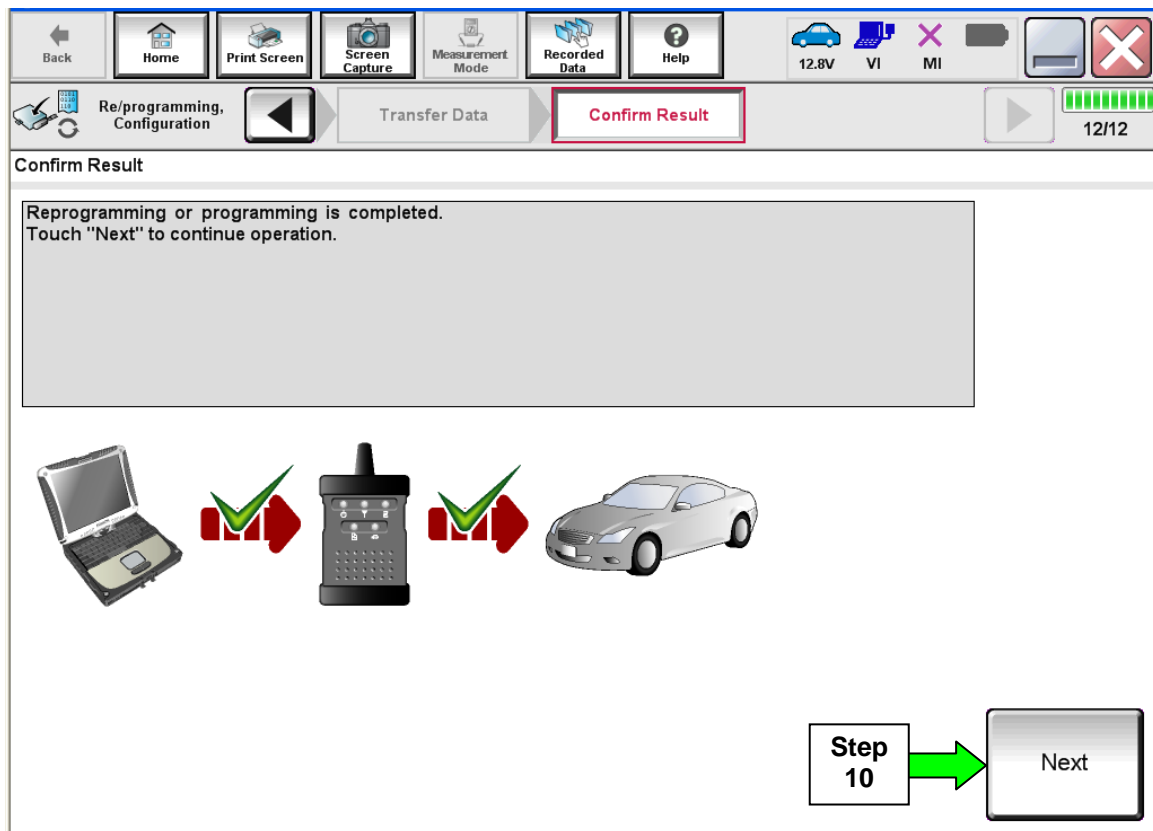
8. When the screen in Figure 4 displays, reprogramming is complete.

**NOTE:** If the screen in Figure 4 does not display (reprogramming does not complete), refer to the information on the next page.

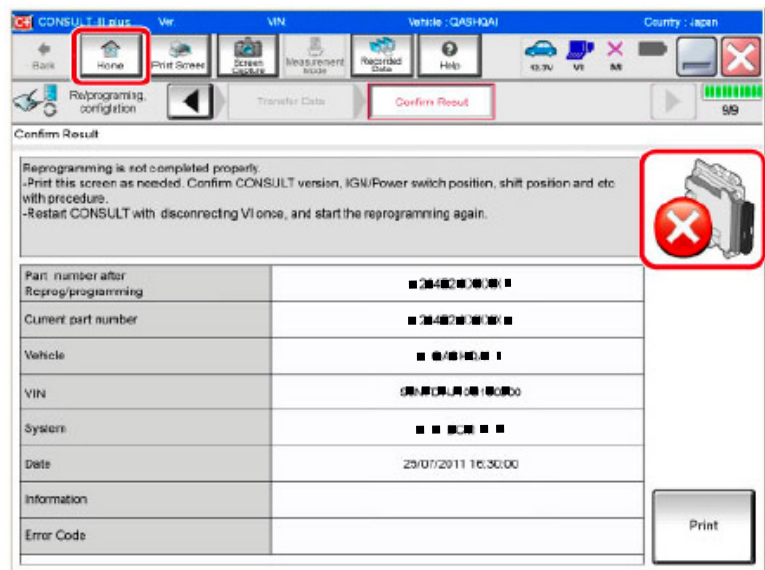
Figure 6

If reprogramming does not complete and the “X” icon displays as shown in Figure 6:

- Check battery voltage (12.0–15.5 V).
- CONSULT A/C adapter is plugged in.
- Ignition is ON, engine OFF.
- Transmission is in Park.
- All C-III plus / VI cables are securely connected.
- All C-III plus updates are installed.
- **Select Home, and restart the reprogram procedure from the beginning.**

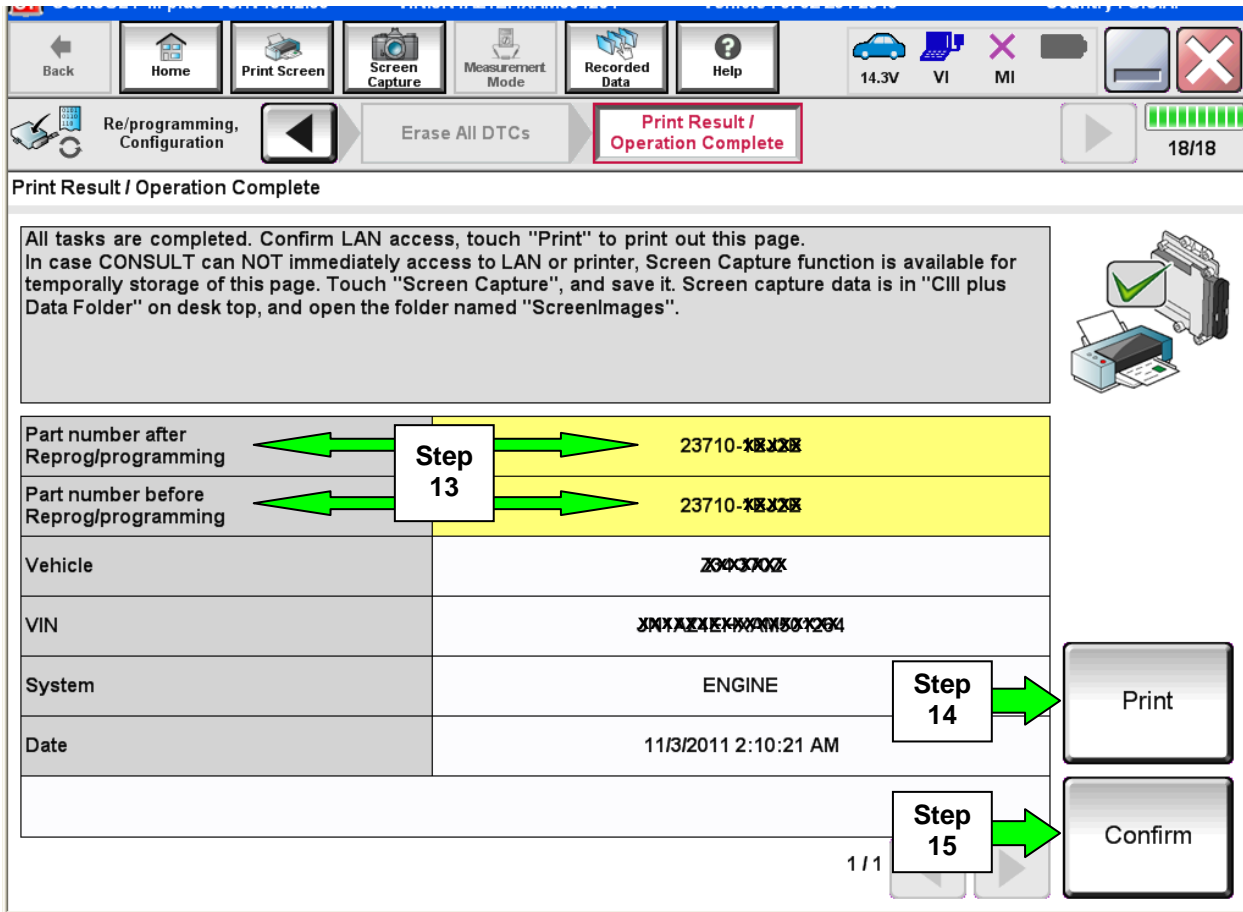
12. When the entire reprogramming process is complete, the screen in Figure 7 will display.
13. Verify the before and after part numbers are different.
14. Print a copy of this screen (Figure 7) and attach it to the repair order for warranty documentation.
15. Select **Confirm**.
