# SERVICE BULLETIN

EC16-017

## 2016 TITAN XD; MIL ON WITH HESITATION ON ACCEL IN COLD TEMPERATURE

**APPLIED VEHICLES:** 2016 Titan XD (A61)

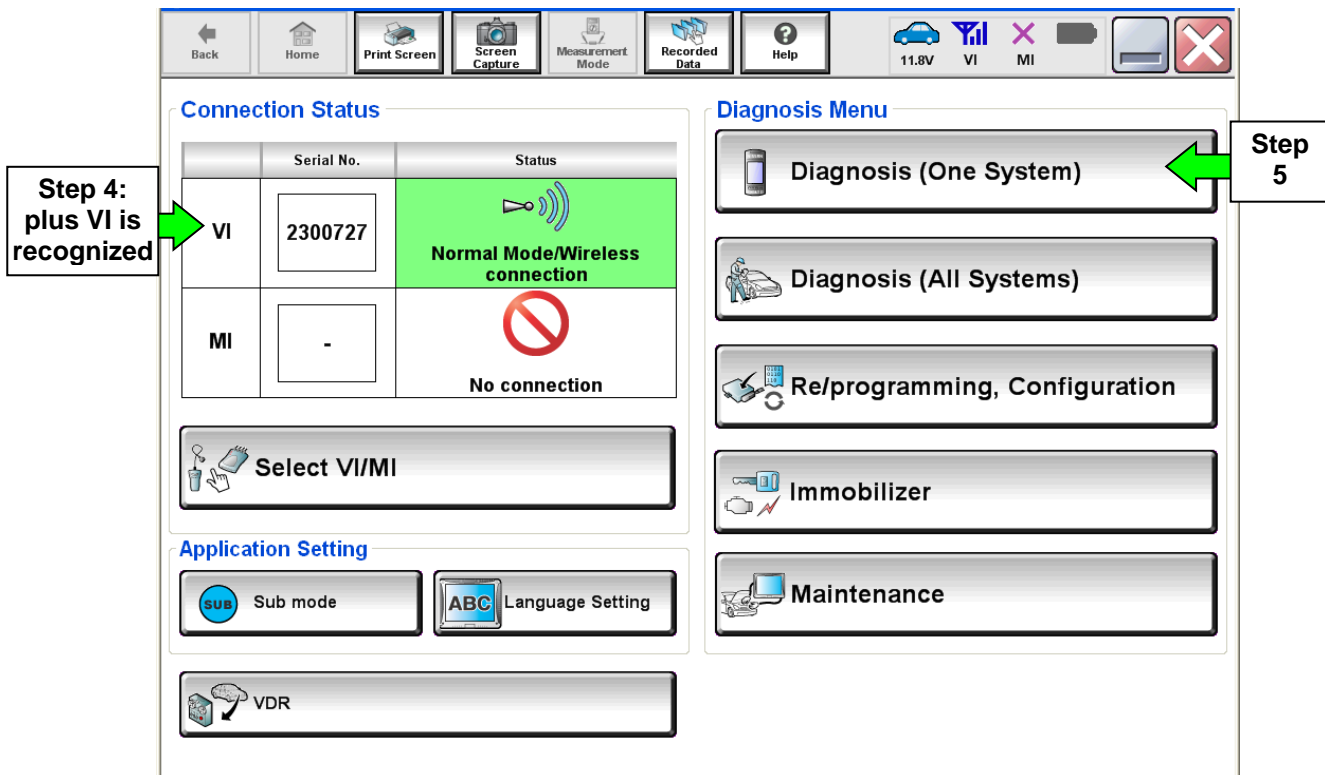
Figure A

1. Connect the CONSULT PC to the vehicle.
2. Open / start C-III plus.
3. Turn the ignition ON, with engine OFF (engine not running).
4. Wait for the plus VI to be recognized.
  - The **Serial No.** will display when the plus VI is recognized.
5. Select **Diagnosis (One System)**.

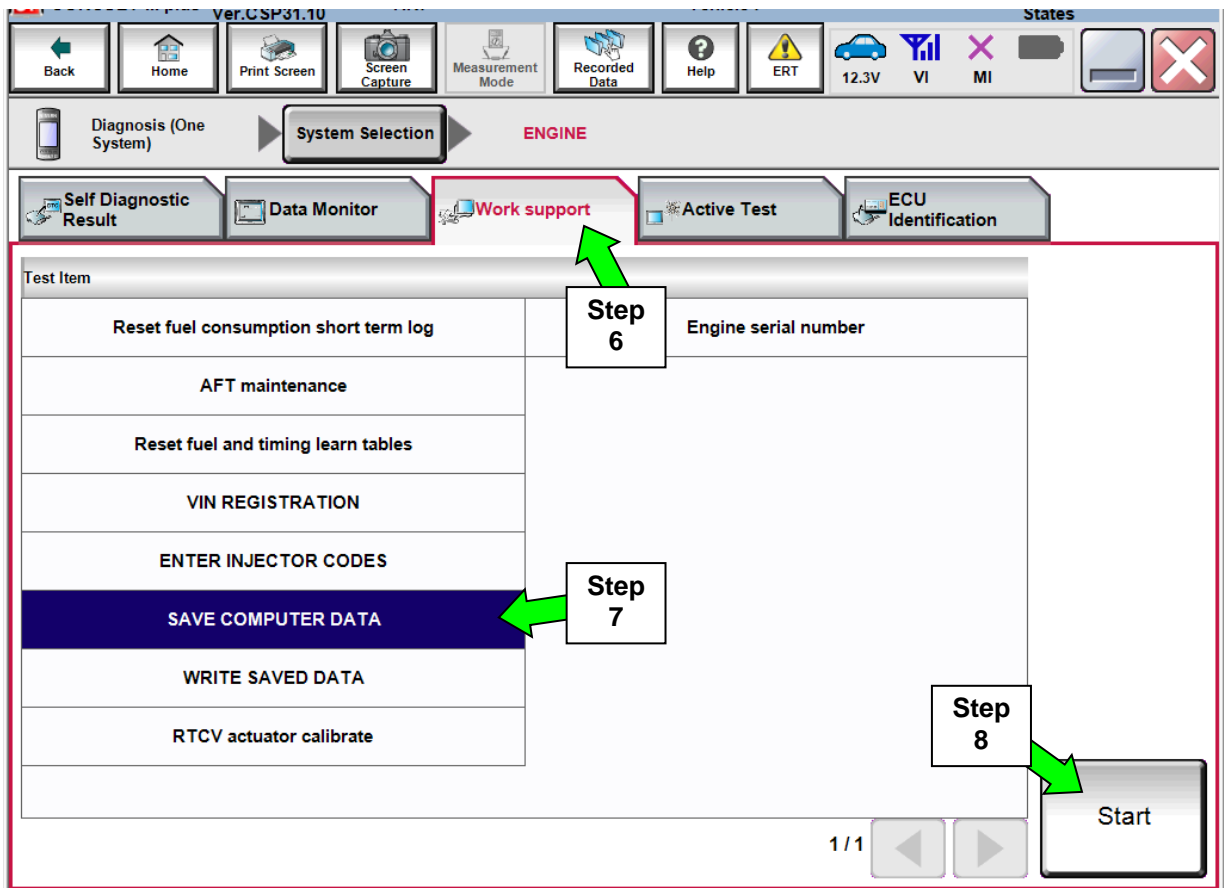
Figure B

6. Navigate C-III plus to Engine > Work Support (see Figure B).
7. Select **SAVE COMPUTER DATA**.
8. Select **Start**.

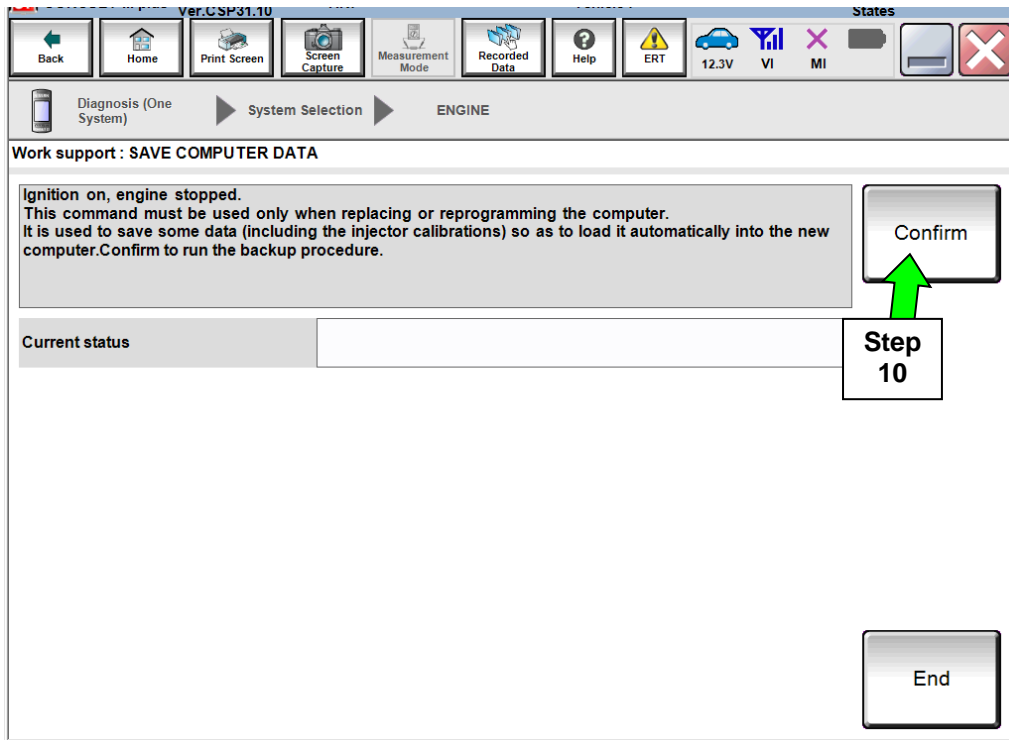
Figure C

9. Make sure the ignition is ON and the engine is OFF (engine not running).

10. Select **Confirm**.

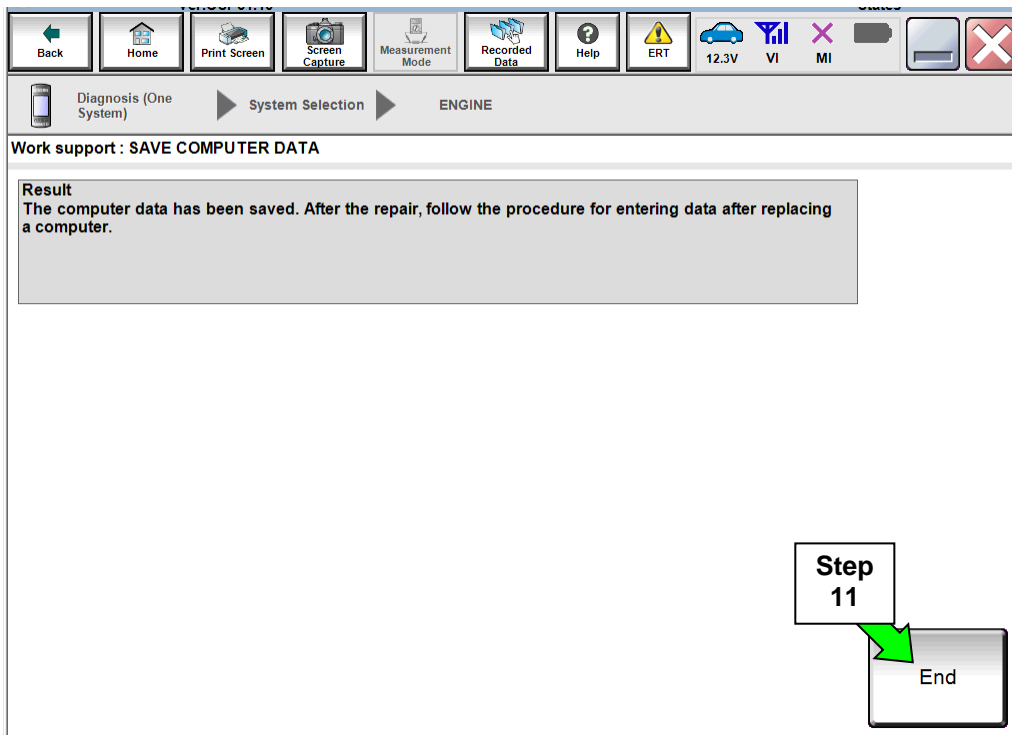
Figure D

11. Select **End**.

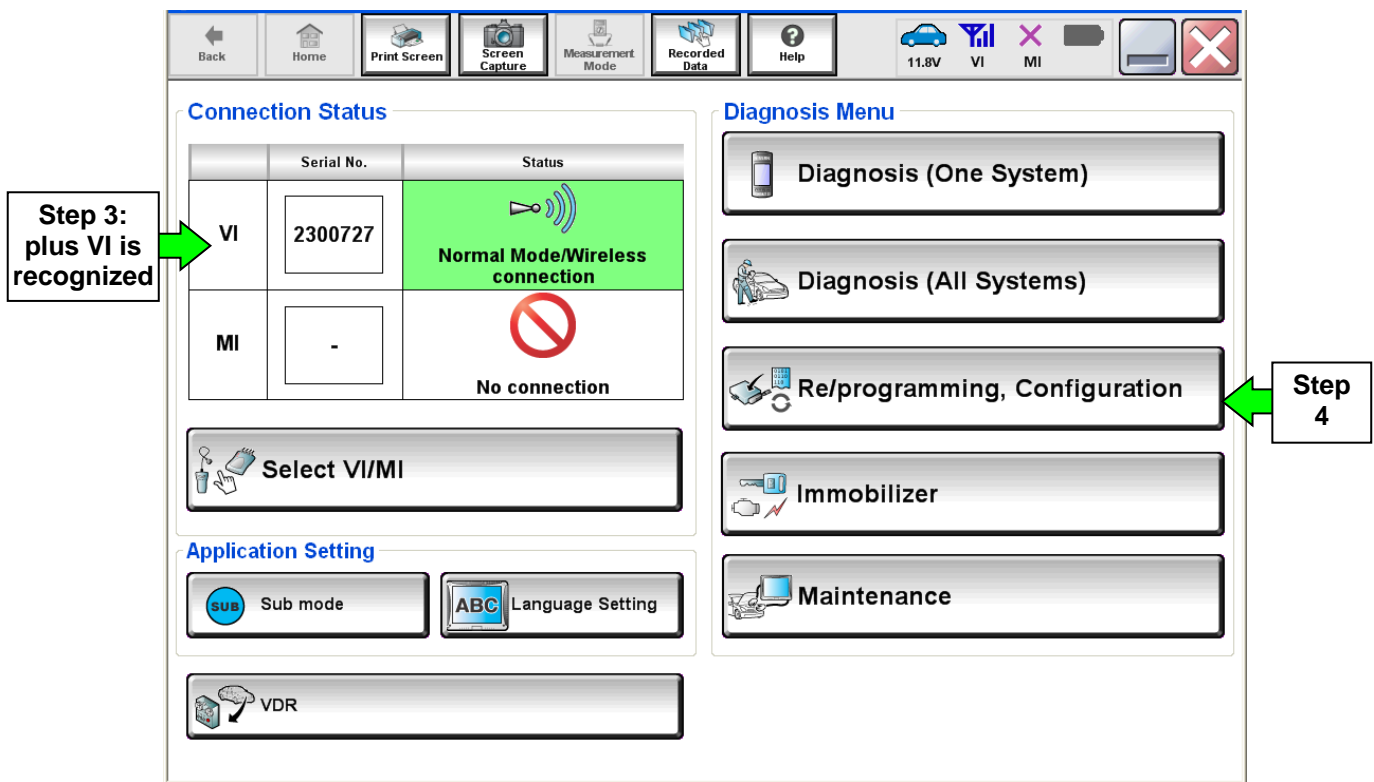
Figure 1

1. Return to the C-III- plus Home screen (see Figure 1).
2. Confirm the ignition is ON, with engine OFF.
3. Confirm the plus VI is recognized.
  - The **Serial No.** will display when the plus VI is recognized.
4. Select **Re/programming, Configuration.**

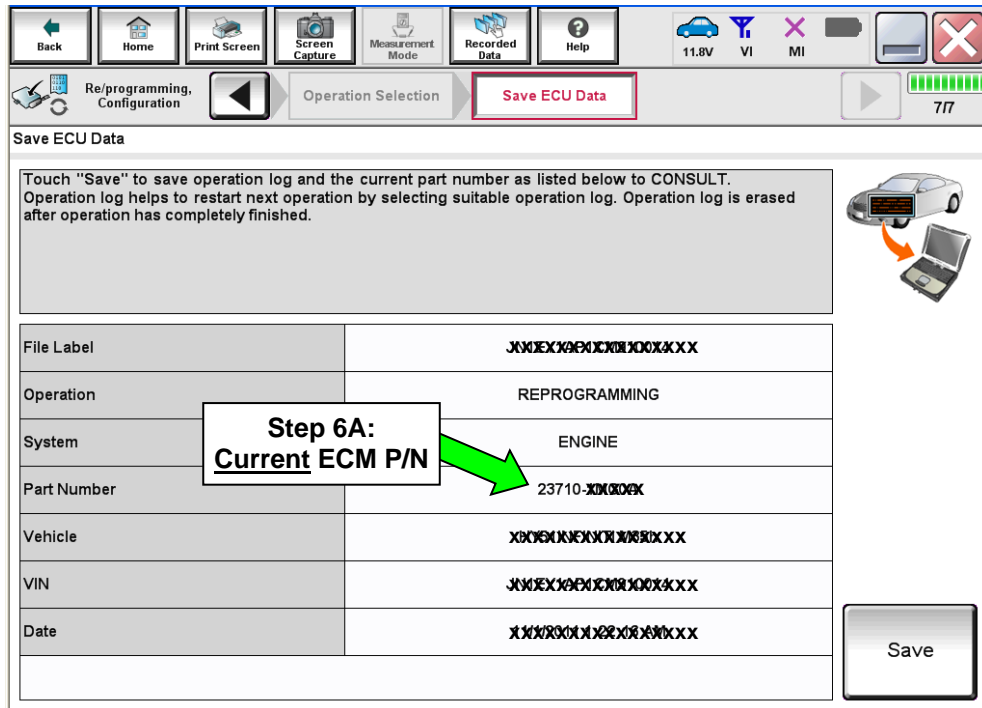
6. When you get to the screen shown in Figure 2, confirm this bulletin applies as follows.

A. Find the ECM **Part Number** and write it on the repair order.

**NOTE:** This is the current ECM Part Number (P/N).

5. Follow the on-screen instructions and navigate C-III plus to the screen shown in Figure 2 on the next page.

B. Compare the P/N you wrote down to the numbers in the **Current ECM Part Number** column in **Table A** below.

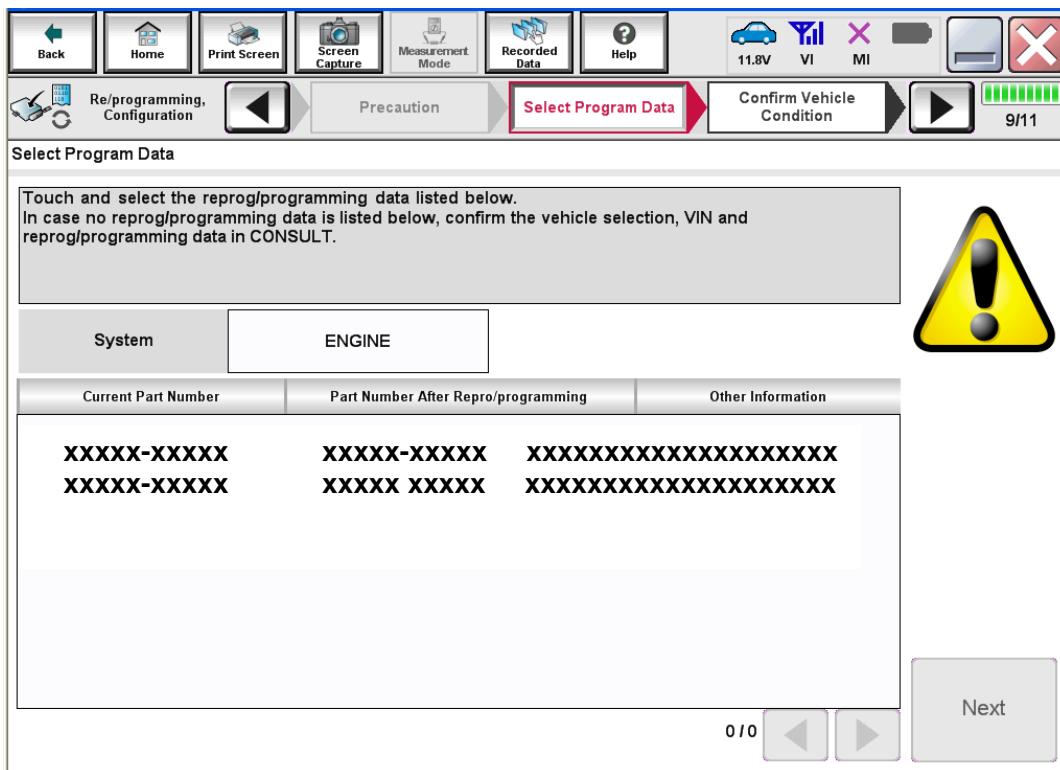
- In some cases, more than one new P/N for reprogramming is available.
  - If more than one new P/N is available, the screen in Figure 3 displays.
  - Select and use the reprogramming option that **does not** have the message “Caution! Use ONLY with NTBXX-XXX”.
- If you get this screen and it is blank (no reprogramming listed), it means there is no reprogramming available for this vehicle. Close C-III plus and refer back to ASIST for further diagnosis.

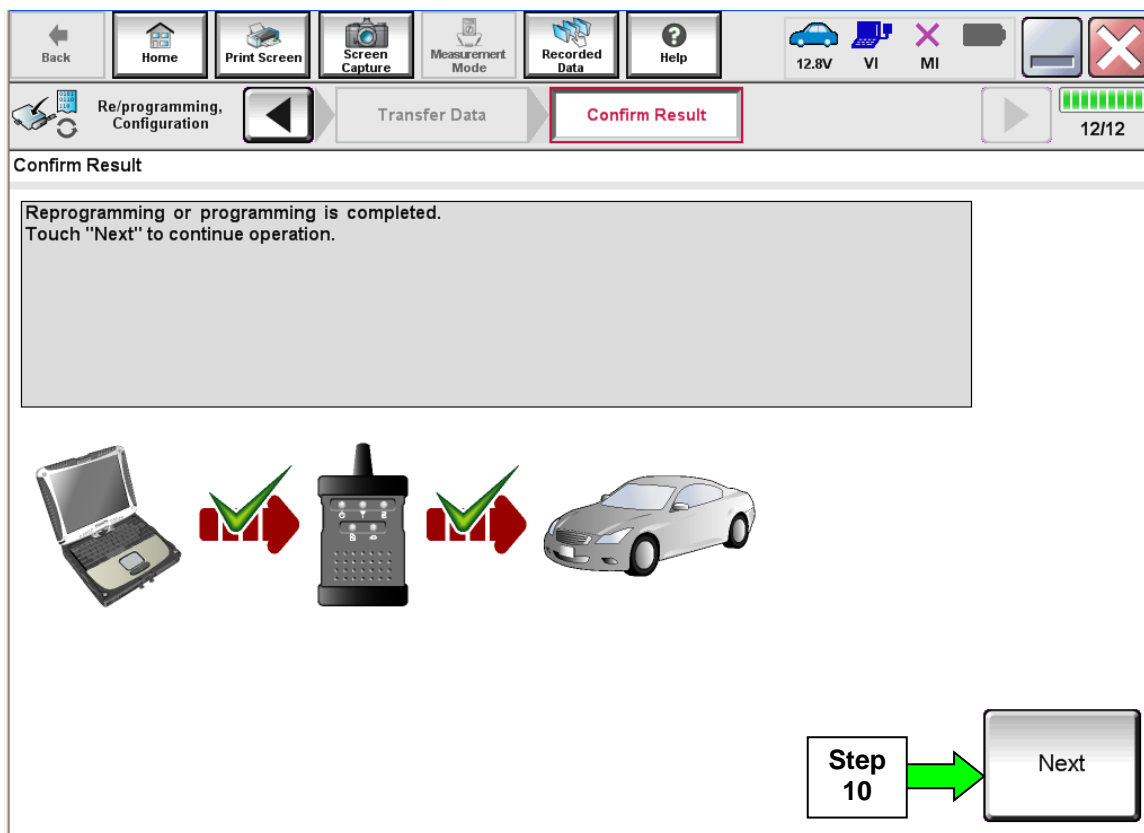
8. When the screen in Figure 4 displays, reprogramming is complete.

**NOTE:** If the screen in Figure 4 does not display (indicating that reprogramming did not complete), refer to ECM recovery on the next page.

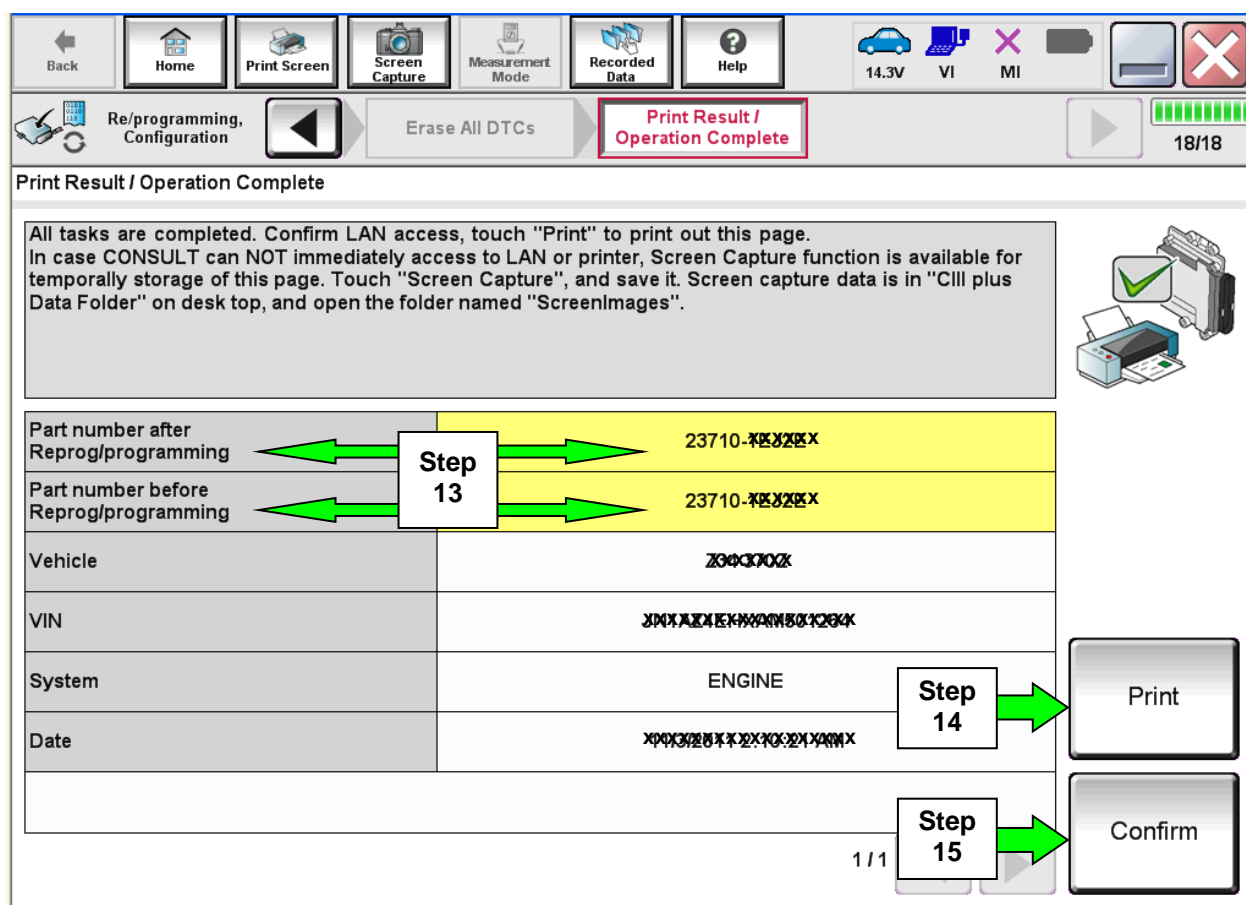
11. Follow the on-screen instructions to **Erase DTCs**.
12. When the entire reprogramming process is complete, the screen in Figure 7 will display.
13. Verify the before and after part numbers are different.
14. Print a copy of this screen (Figure 7) and attach it to the repair order for warranty documentation.
15. Select **Confirm**.

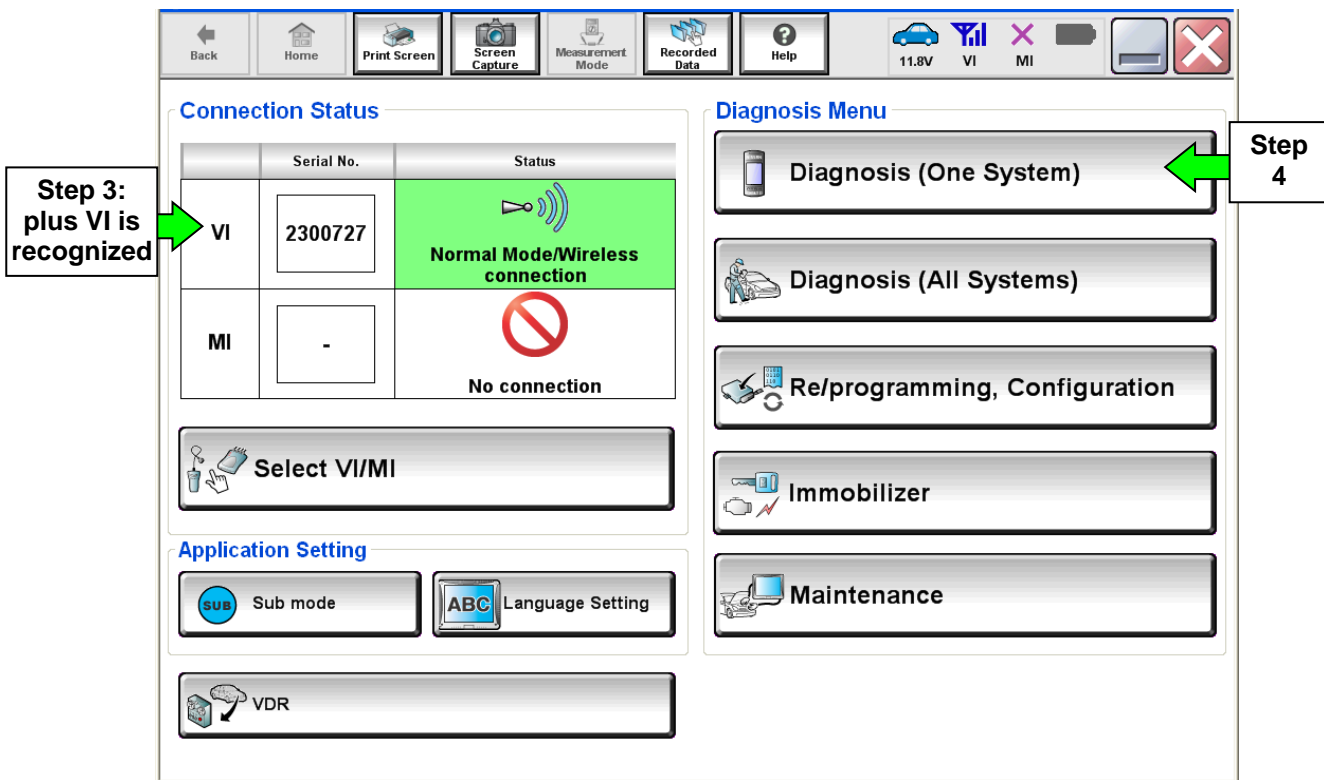
Figure 1A

1. Return to the C-III- plus Home screen (see Figure 1A).
2. Confirm the ignition is ON, with engine OFF.
3. Confirm the plus VI is recognized.
  - The **Serial No.** will display when the plus VI is recognized.
4. Select **Diagnosis (One System)**.

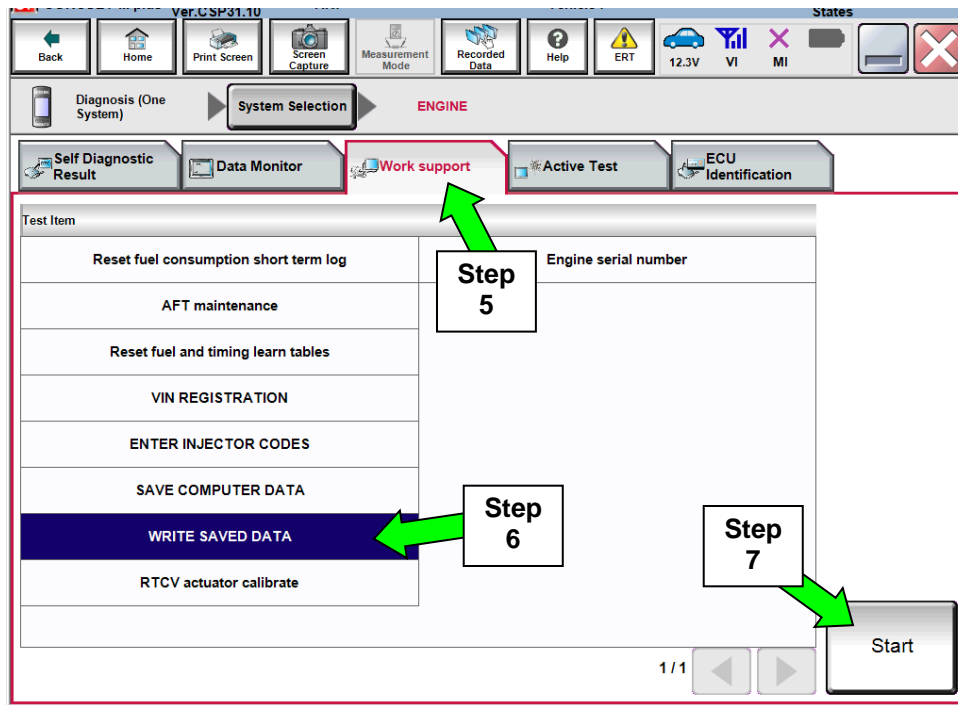
Figure 2A

5. Navigate C-III plus to ENGINE > Work support (see Figure 2A).
6. Select **WRITE SAVED DATA**.
7. Select **Start**.

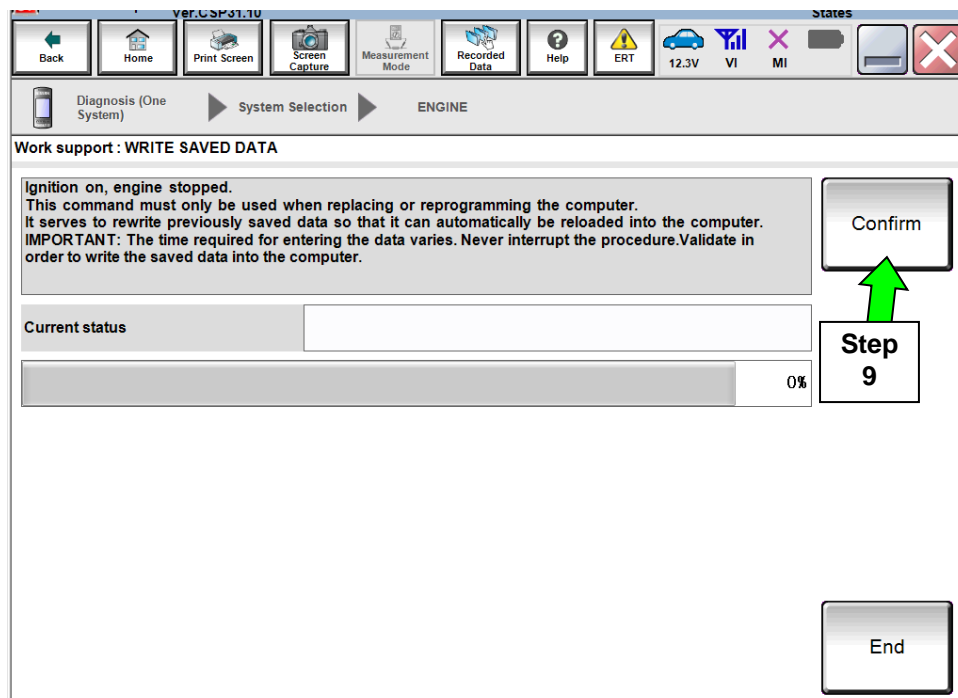
Figure 3A

8. Make sure the ignition is ON and the engine is OFF (engine not running).
9. Select **Confirm**.

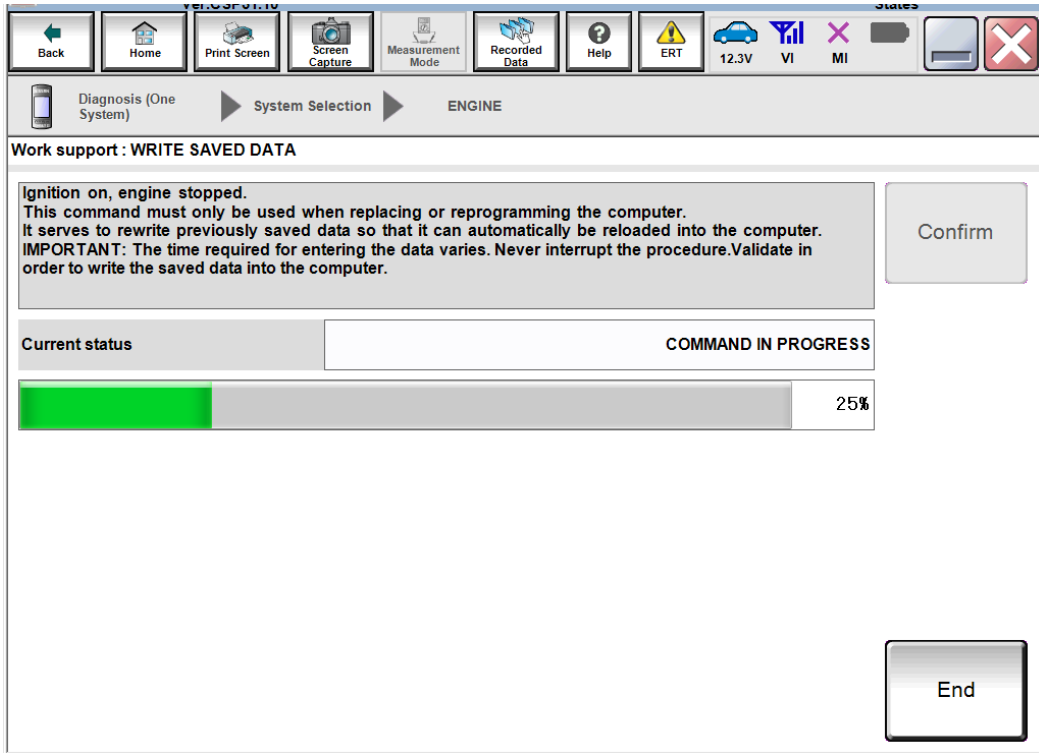
Figure 4A

10. Wait for the procedure to complete.

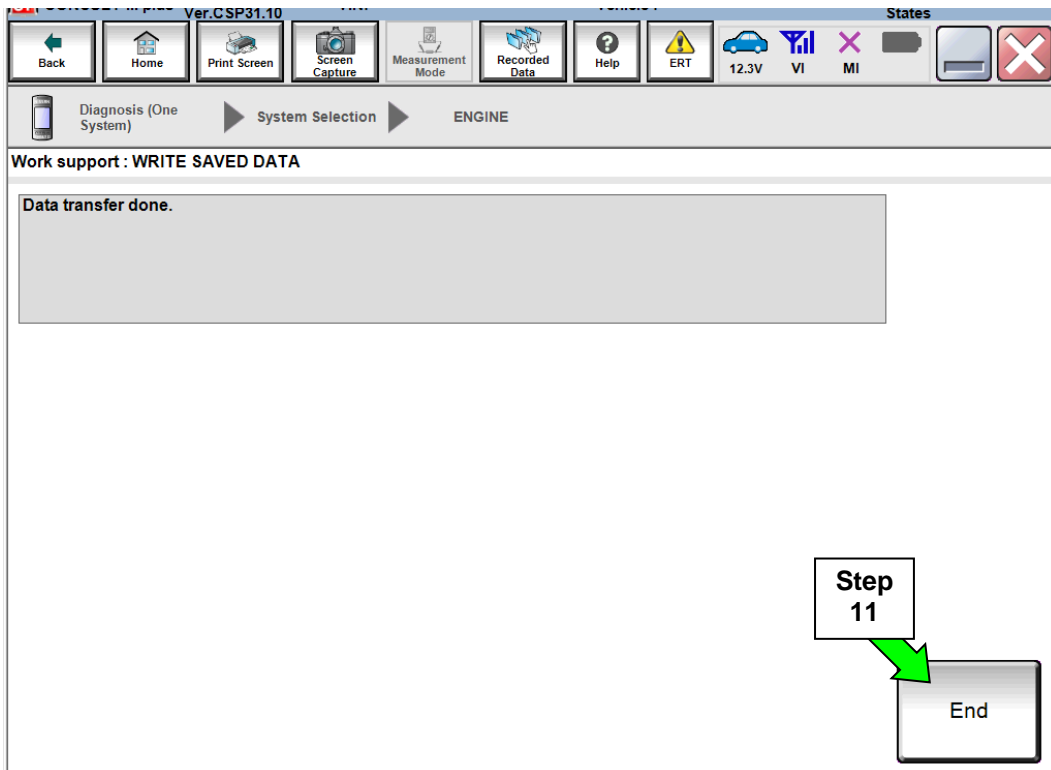
Figure 5A

11. Select **End**.
