# Technical Service Bulletin

SUBJECT:			No: <b>TSB-16-13-001REV</b>
<b>ECM REPROGRAMMING FOR HARD TO RE-START ENGINE WITH LOW COOLANT TEMPERATURE</b>			DATE: <b>March, 2016</b>
			MODEL: <b>2014-16 Outlander</b>
CIRCULATE TO:	<input type="checkbox"/> GENERAL MANAGER	<input type="checkbox"/> PARTS MANAGER	<input checked="" type="checkbox"/> TECHNICIAN
<input checked="" type="checkbox"/> SERVICE ADVISOR	<input checked="" type="checkbox"/> SERVICE MANAGER	<input checked="" type="checkbox"/> WARRANTY PROCESSOR	<input type="checkbox"/> SALES MANAGER

Affected vehicles may exhibit a condition where the engine is hard to re-start if engine coolant temperature is low. Due to inappropriate programming in the engine ECM, if the coolant temperature is between 32 – 68 °F (0 – 20 °C), a hard to re-start condition may occur.

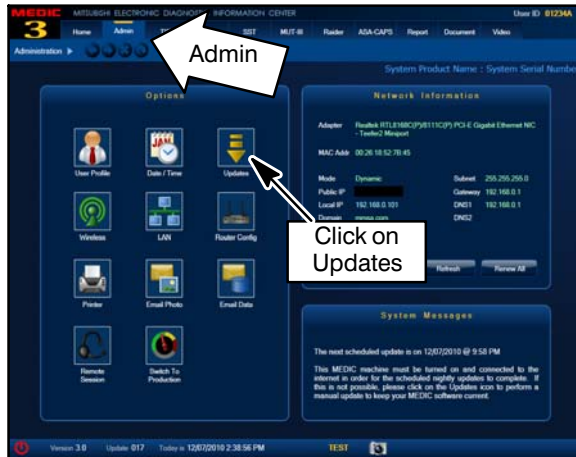
2. Verify the MEDIC 3/4 is at version 3.5 and at update **382** or higher.

If your **MEDIC 3/4 update is at least 382**, continue with the Reprogramming Procedure on page 4.

If your **MEDIC 3/4 update is below 382**, update your MEDIC as follows.

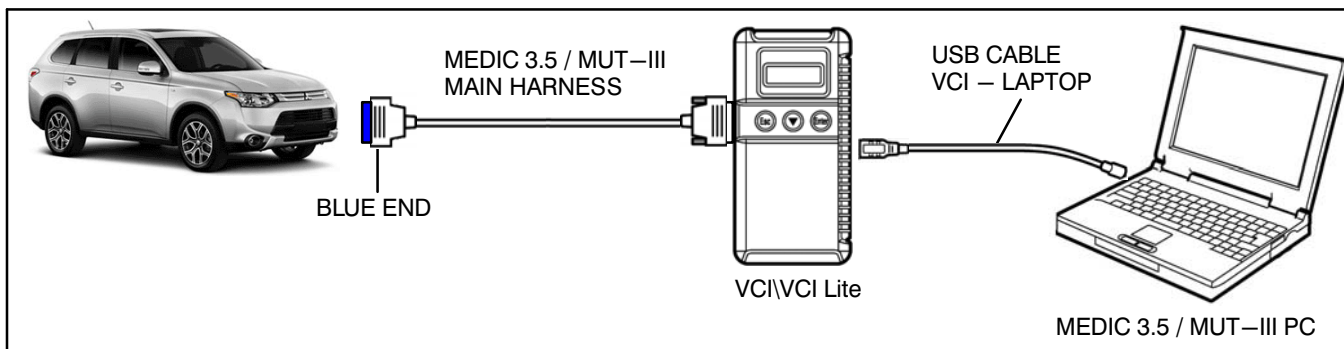
- Turn the MEDIC PC/tablet on. If the battery indicator in the lower right hand corner of the screen does not show a full charge, it is recommended that either the battery be charged prior to beginning, or be used with the A/C power adaptor connected.
- Connect the USB cable to the VCI/VCI Lite.
- When the laptop/tablet displays the MUT-III main screen, connect the USB cable to the device.
- Connect the MUT-III main harness with the blue DLC connection to the VCI/VCI Lite.
- Connect the blue connection of the MUT-III main harness to the vehicle's data link connector.
- Turn the VCI power switch ON . Verify that the indicator lamp in the upper right corner of the screen is green.

**NOTE:** VCI and MEDIC 3.5 Laptop shown for illustration purposes only.

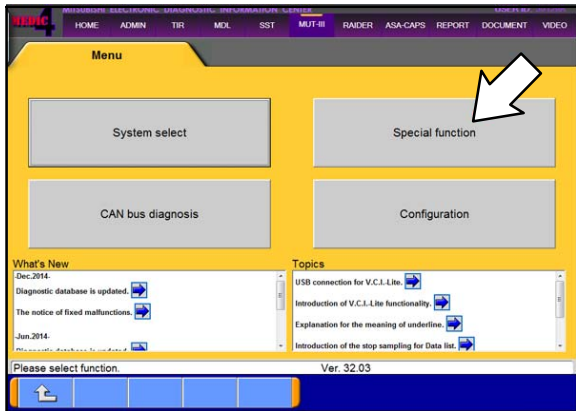
- #### 3. If using MEDIC, from the main page, click the MUT-III STV icon at the top center of the screen to open MUT-III.

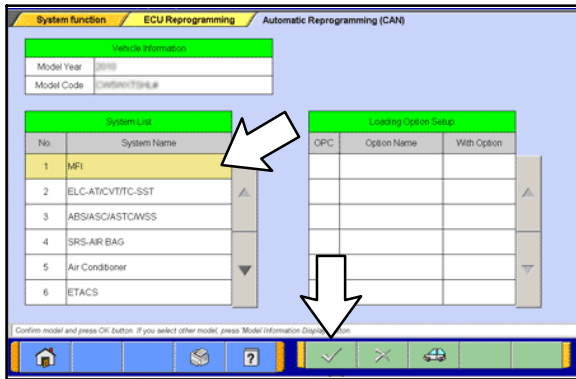
8. “MFI” should be highlighted by default. If not, click on it to highlight it. Click the **check mark** to continue.

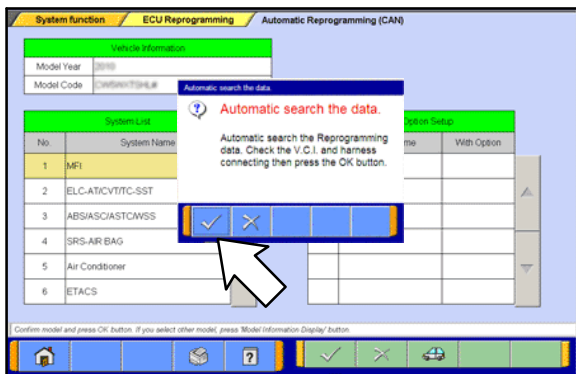
9. A message will advise the system will “Automatic search the data.”

Click the check mark to continue.

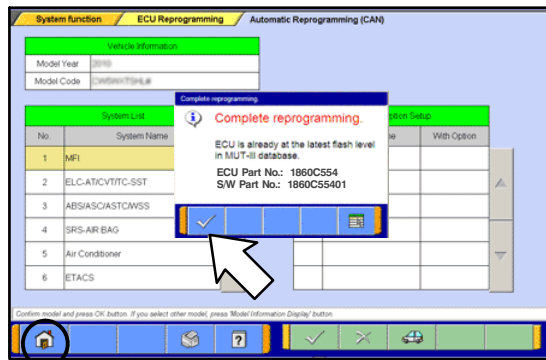
If the message seen at left is displayed, the ECU software is already at the most current level. Do not continue with the reprogramming procedure. This TSB does **not** apply.

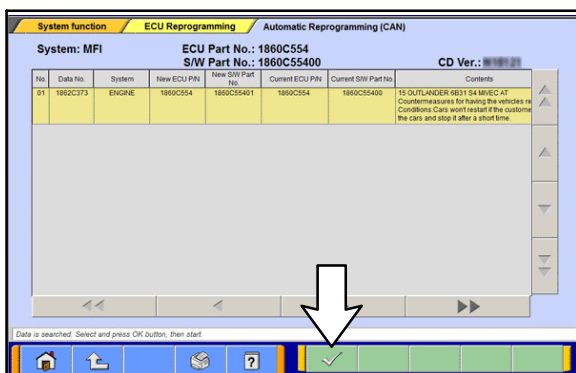
10. The Automatic Reprogramming (CAN) database screen will display.

- Verify that the new ECU and S/W part numbers are listed in the table.
- Confirm the database number at the top right of the table is *N16031* or higher.
- If more than one row is displayed in the table, refer to the ECM Reprogramming Chart on page 2 to highlight and select the correct row.
- Click the check mark to continue.

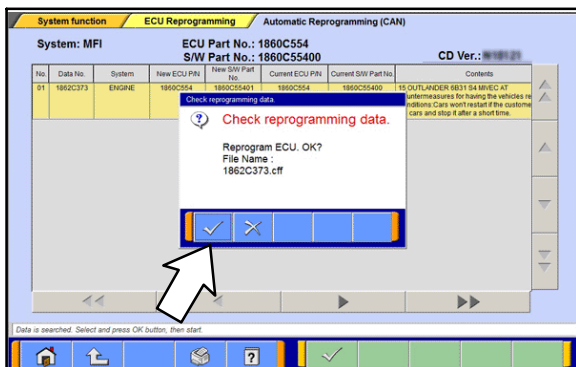
11. The “Check reprogramming data” window should appear with the new file name.

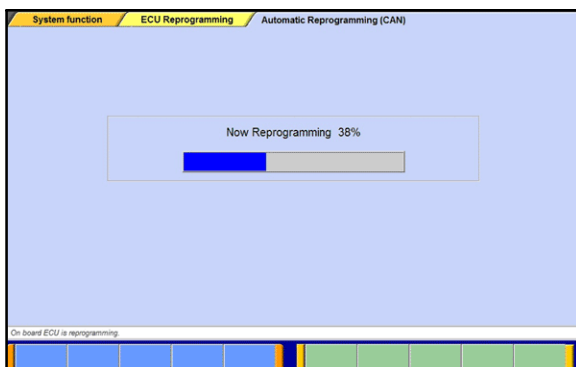
13. Once the reprogramming is initiated, the screen as shown will indicate the reprogramming progress.

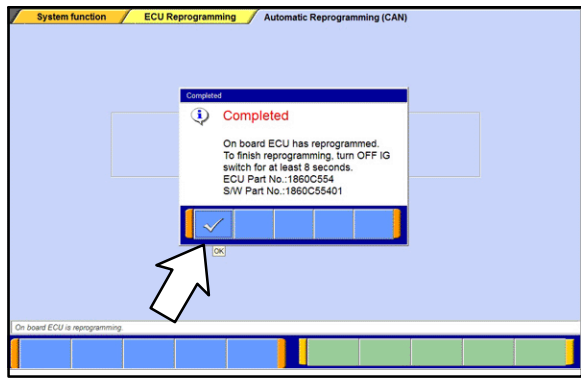
- 14. Reprogramming is completed.
  - a. Verify that the S/W Part No. Is correct.
  - b. Click on the check mark.
  - c. Turn OFF ignition switch for at least 8 seconds.
  - d. Turn ignition switch ON, then proceed to the next step.

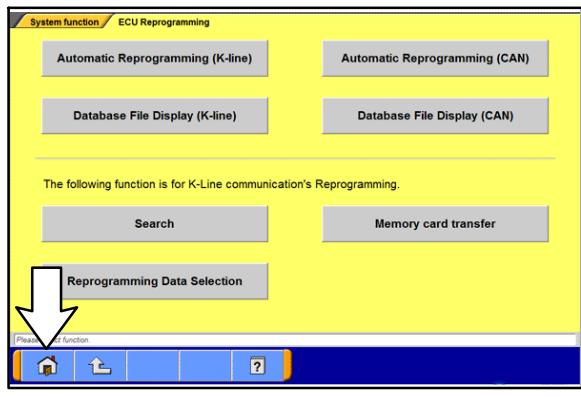
- 15. Click on the "home" button.

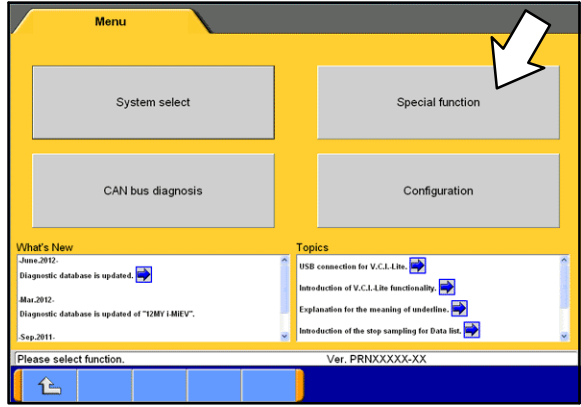
- 16. Perform an "Erase and Read all DTCs."
  - a. Select "Special function."

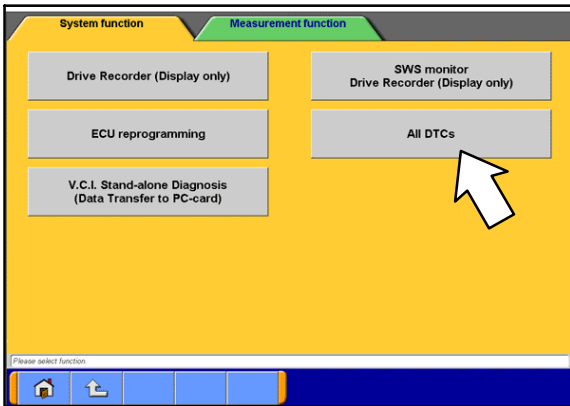
b. Select "All DTCs."

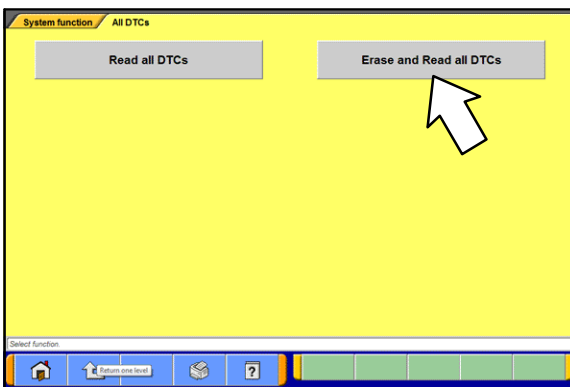
c. Select "Erase and Read All DTCs."

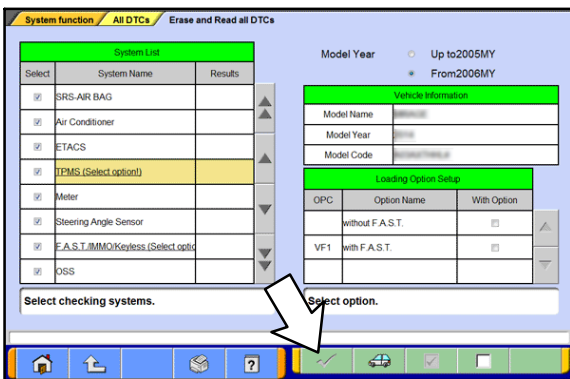
d. The "System List" on the left side of the screen will have all selections checked. Do not change these selections. DTCs may be set if the vehicle is equipped with options that are unchecked.

e. Click the check mark to continue.

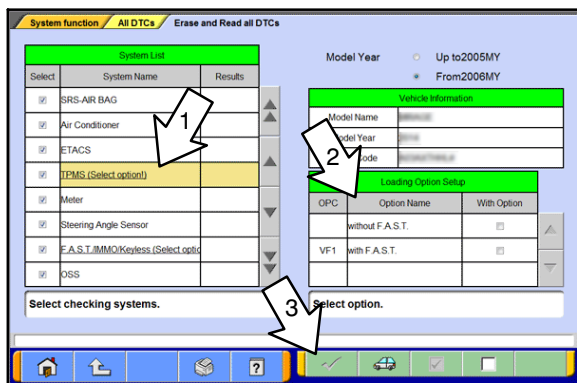
**NOTE:** If, in some cases, the check mark button at the bottom is not active, perform the following:

- 1) Select the System name that is underlined (for example, TPMS, as shown on left).
- 2) Select the appropriate option for the vehicle. Repeat steps 1 and 2 for all underlined systems.
- 3) Click on the check mark. Wait until MUT-III is finished and click the check mark again to confirm.

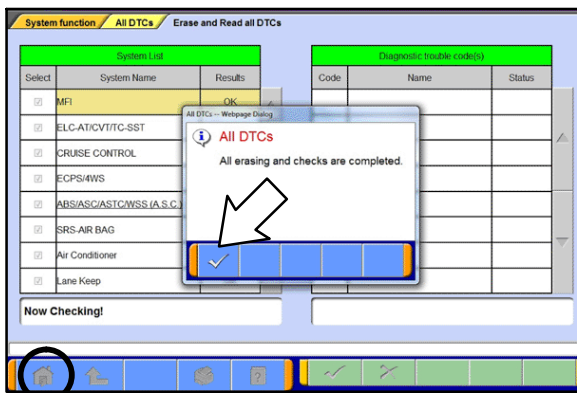
f. A window will pop up asking you to confirm DTC erasing. Click the check mark for DTC erasing and reading to begin.
