MODEL  
2012-2016MY  
Soul (AM, PS)  
w/Gamma 1.6L GDI

NUMBER  
PI2002A (Rev 2, 06/09/2021)

**1.6L GDI KNOCK SENSOR DETECTION SYSTEM  
(KSDS) LOGIC IMPROVEMENT (PI2002A)**

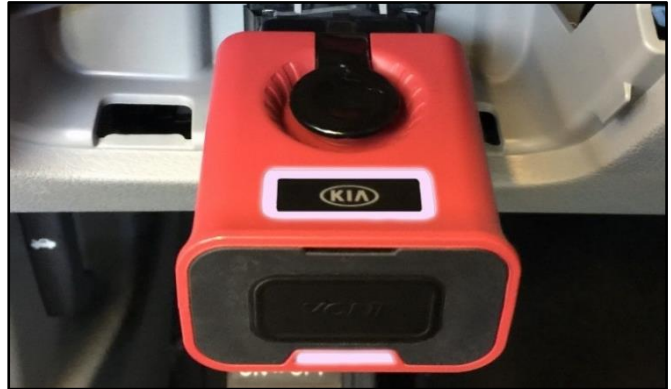
The ECU upgrade function on KDS operates wirelessly. It is not necessary to perform the upgrade via USB cable.

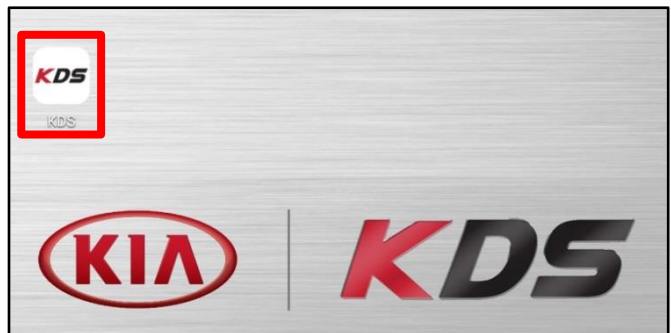
2. With the ignition ON, turn ON the KDS tablet. Select **KDS** from the home screen.

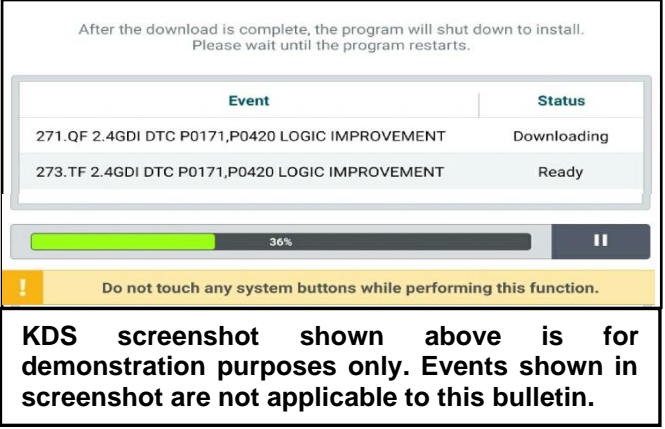
- The KDS will check the server for recently uploaded Events and then automatically download **Upgrade Event #522 (AM) or #559 (PS)**.

**\* NOTICE**  
 The vehicle must be identified in Vehicle Selection to download an Event for that vehicle.

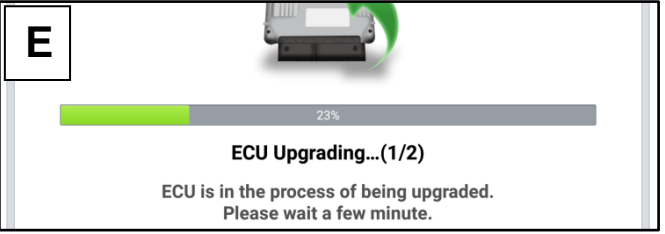
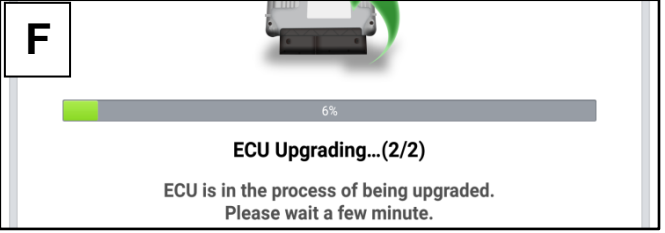
- The ECU upgrade will begin and the progress of the upgrade will appear on the bar graph. Upgrade part (1/2) (E) will download the upgrade event to the VCI-II. Upgrade part (2/2) (F) will upgrade the ECU.

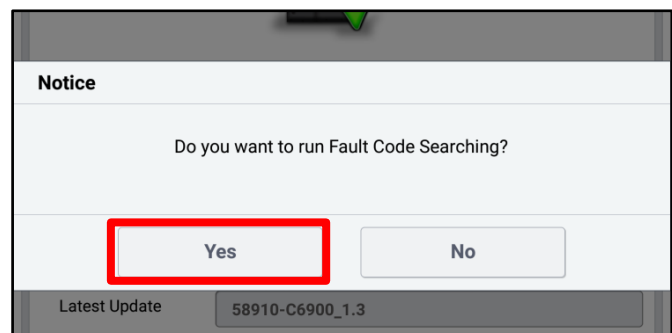
12. When prompted, select **YES** to check for Diagnostic Trouble Codes (DTC) and erase any DTCs stored such as EPS, ESC, and TPMS that may have been set during the upgrade.
