SERVICE BULLETIN

SOFTWARE UPDATE FOR INFOTAINMENT ISSUES

APPLIED VEHICLES: 2020-2021 Titan/Titan XD (A61)

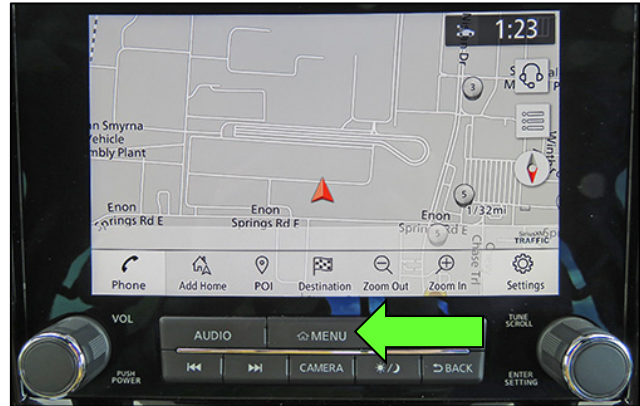
Figure 2

1. Push the **MENU** button.

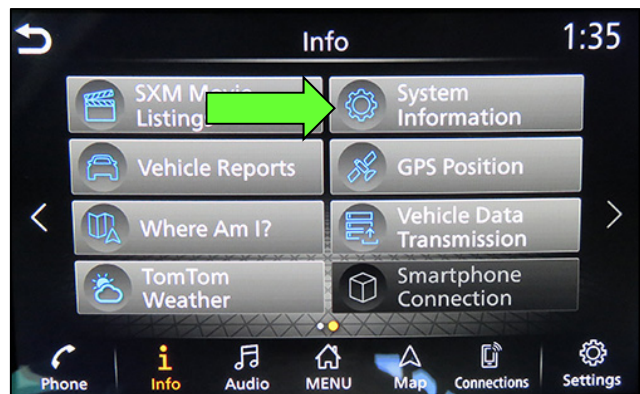
Figure 4

3. Select **System Information** to access the vehicle update menu.

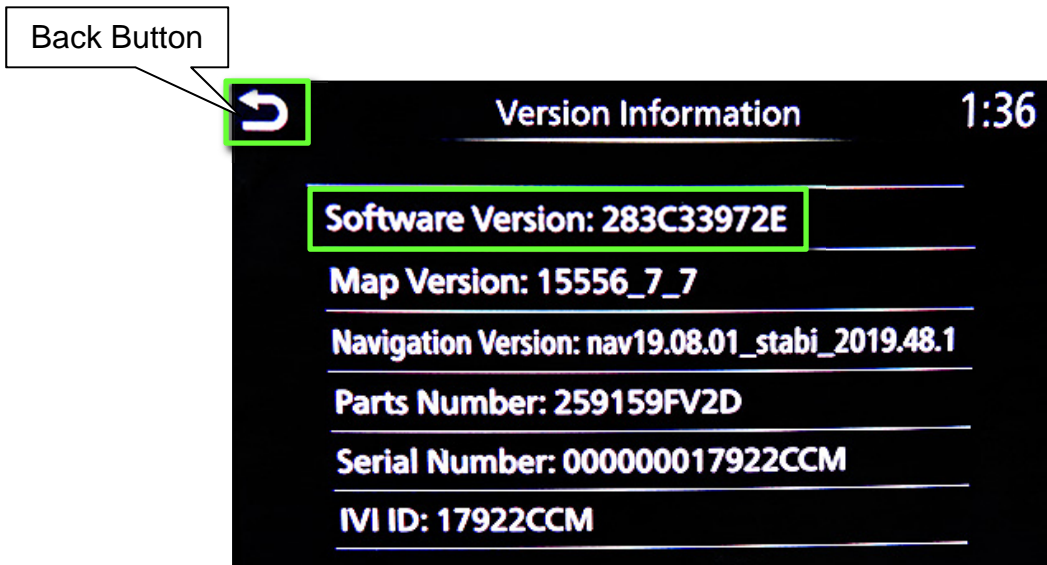
Figure 6

- If the Software Version is the version listed in **Table A**, select the back button and continue to step 5 on the next page.
- If the Software Version is NOT the version listed in **Table A**, select the back button, this bulletin **does not apply**.
