GLOBAL SAFETY FIELD INVESTIGATIONS
DCS5801
URGENT - DISTRIBUTE IMMEDIATELY

Subject: N212327470 - Service Update - Infotainment Screen Remains Black In Cold Temperatures

Models: 2021 Buick Envision, Cadillac CT4, Cadillac CT5, Chevrolet Corvette, Suburban, Tahoe, GMC Yukon and Yukon XL
Equipped with an Infotainment System (RPO IOS, IOT, or IOU)

N212327470 Infotainment Screen Remains Black In Cold Temperatures

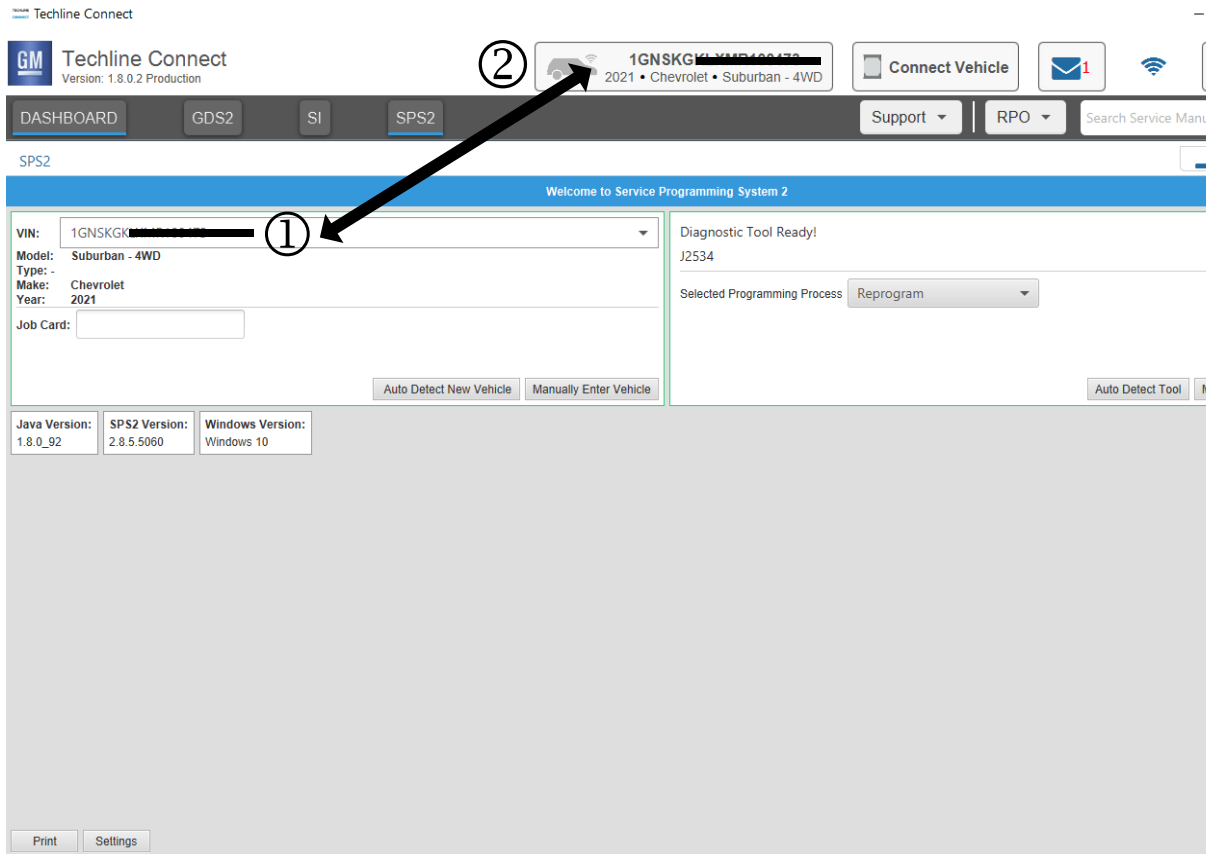
5743643

Caution: Be sure the VIN selected in the drop down menu (1) is the same as the vehicle connected (2) before beginning programming.

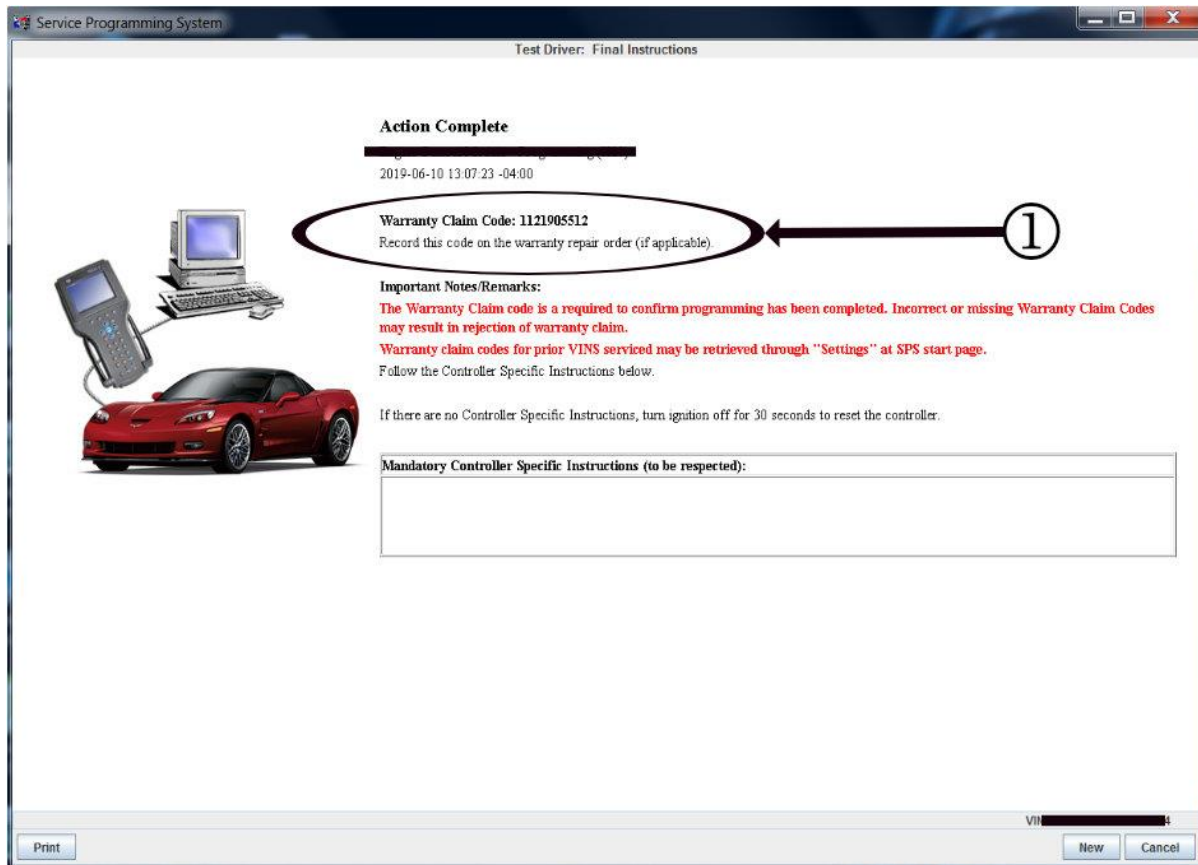
5431209

Note: The screenshots above are an example of module programming and may not be indicative of the specific module that is being programmed. Module selection and VIN information have been blacked out.
