## PRODUCT CAMPAIGN BULLETIN

**APPLICABILITY:** 2018 Model Year Legacy, Outback, and BRZ Vehicles

**SUBJECT:** Harman Kardon Head Unit FMVSS 111 Noncompliance Recall

**NUMBER:** WTZ-85R

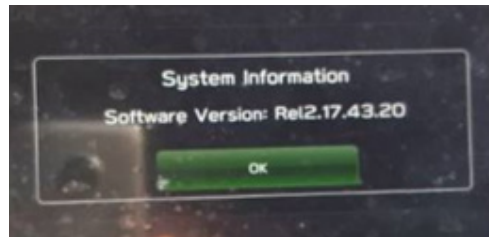
(EXAMPLE photo)

- Confirm the current Software Version ID. If the Current Version is **Rel\_UO.18.43.20 or later per TSB 15-211-17R, STOP** as this latest update has already been installed. Otherwise, proceed to **Step 2** below.

Refer to TSB 15-211-17R to see the latest software version information as well as a history of prior updates. Software versions Rel\_UO.18.43.20 (or later) are acceptable to complete and close this recall.

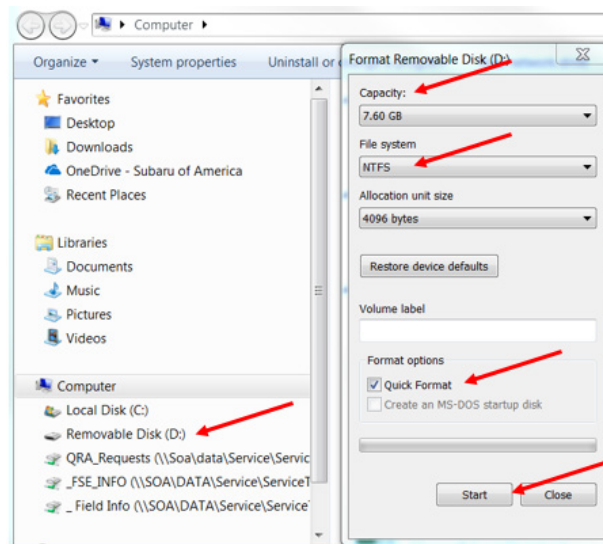
- Make sure the USB flash drive contains no other files.
- Right click on the corresponding “Removable Disk”.
- Select “Format”.
- From the File System drop-down menu, select “NTFS”
- Check the “Quick Format” box (if not already done).
- Click on “Start” to format the USB flash drive.

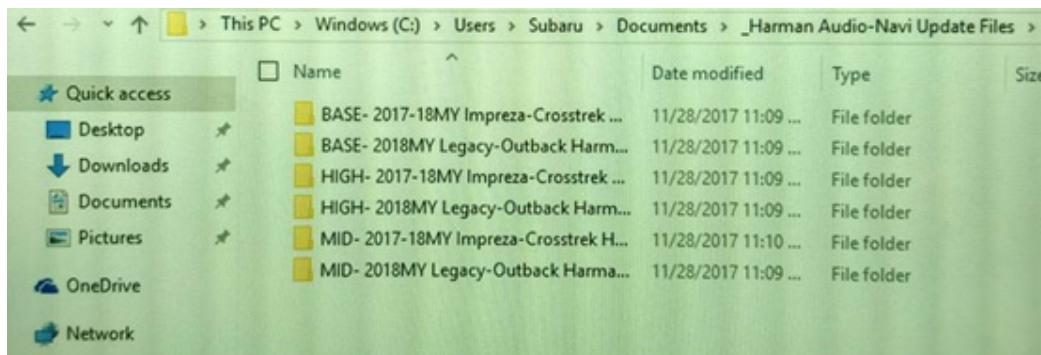
- Go to My Documents on the GUI screen to display the list of available update files shown below.
- Sort by Date Modified to bring the most recent files to the top of the list. The folder is named: \_Harman Audio-Navi Update Files. It contains the six folders shown in the EXAMPLE photos below.
