Volvo Chassis - Diagnostic Trouble Code (DTC) P0471 Illuminating The Malfunction Indicator Lamp (MIL) - Turbo Compound Generation I

It has been determined that turbo compound chassis may set P0471 at higher altitudes. This can occur if the vehicle is operated at high altitudes consistently, or only passes through a section of high altitude during travel.

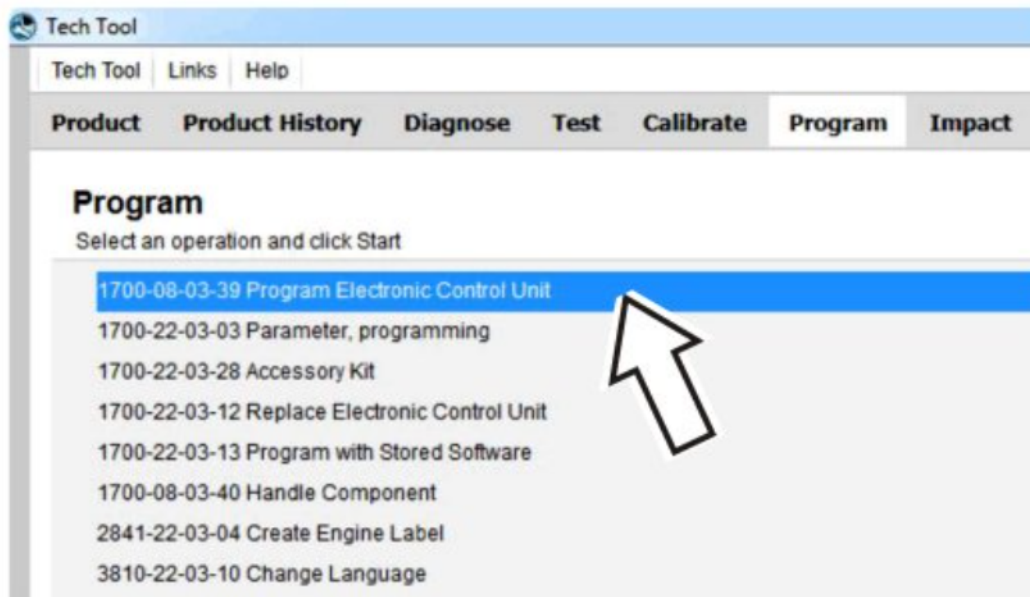
9. From the Main Menu select Program and then Program Electronic Control Unit 1700-08-03-39. Then click Start.
