Intermittent Passive Entry Operation

20-21MY L663 Defender

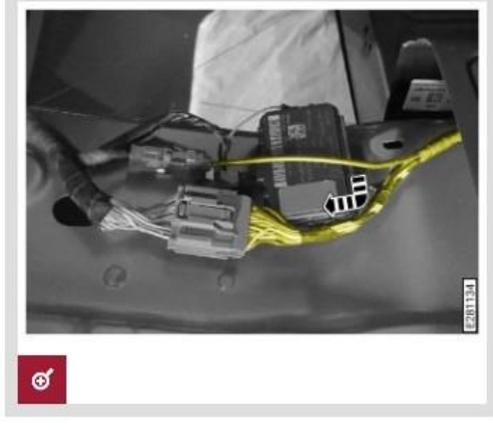
- **JLRTB02076NAS1** provides instructions to relocate a new RF Receiver behind the left D-pillar trim.
- Prior to installation a link lead will need to be assembled, please refer to TOPIX Workshop Manual section 418-02: Wiring Harnesses – Description & Operation Wiring Harness to review JLR approved wiring harness repair methods.
- Publication of JLRTB02076NAS1 was been delayed due to part availability.
