# Technical Service Bulletin

SUBJECT:			No: <b>TSB-21-54A-002</b>
<b>SOFTWARE UPDATE FOR SMARTPHONE LINK DISPLAY AUDIO</b>			DATE: <b>June 2021</b>
			MODEL: <b>See below</b>
<b>CIRCULATE TO:</b>	<input type="checkbox"/> GENERAL MANAGER	<input checked="" type="checkbox"/> PARTS MANAGER	<input checked="" type="checkbox"/> TECHNICIAN
<input checked="" type="checkbox"/> SERVICE ADVISOR	<input checked="" type="checkbox"/> SERVICE MANAGER	<input checked="" type="checkbox"/> WARRANTY PROCESSOR	<input type="checkbox"/> SALES MANAGER

A software update is now available for the Smartphone Link Display Audio (SDA). This update resolves several issues that may occur in various models equipped with SDA, as listed below.

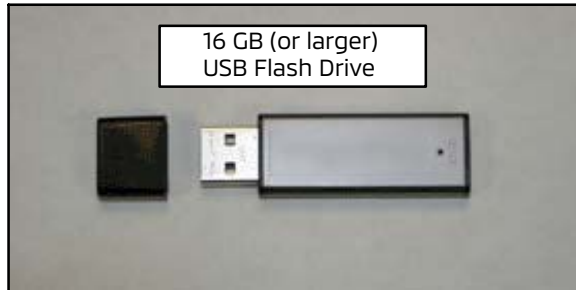
The update procedure for all audio types requires a dedicated USB flash drive (a.k.a. thumb drive) formatted to FAT 32.

A USB version 2.0 standard flash drive (thumb drive) with a **minimum capacity of 16.0 GB**, formatted to FAT32 is required for this procedure. Formatting to FAT32 will erase all data from the flash drive. The flash drive must have no other files or folders saved to it.

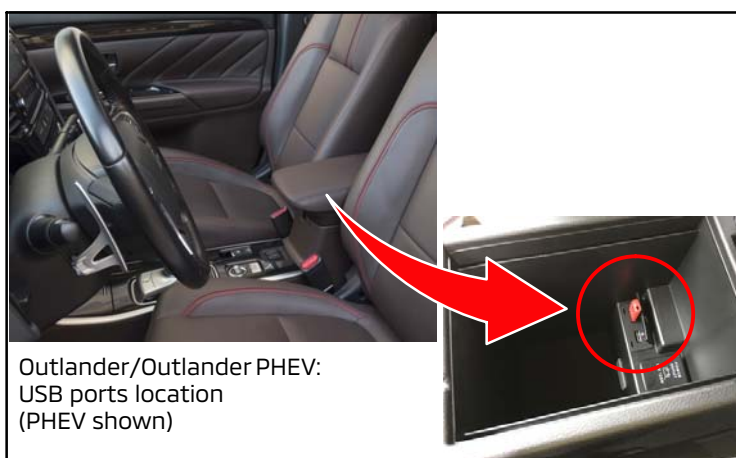
1. **For Outlander and Outlander Sport / RVR vehicles:** Turn vehicle ON, and keep the engine idling for the entire update procedure.  
**For Outlander PHEV:** Put vehicle in READY mode for the entire update procedure.
2. Plug in the USB flash drive containing the **CORRECT software update file\* for that vehicle** into the vehicle's USB port (either port may be used for the update).  
**\*Refer to step 4 of "B. Transfer Files to USB Flash Drive" in this TSB for correct file identification.**
  - For Outlander and Outlander PHEV, two USB ports are located inside the center console.
  - For Outlander Sport / RVR, two USB ports are located in the front lower dash.

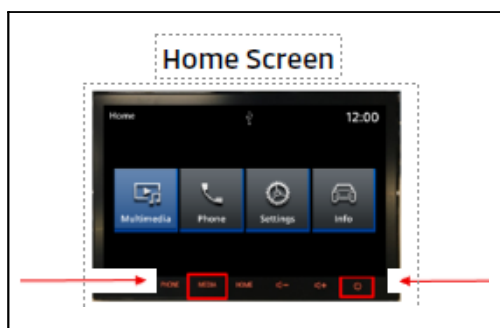
3. Before starting the update process, confirm the current software version.
  - a. Push both [MEDIA] + [⏻] at the same time and hold for 3 seconds.

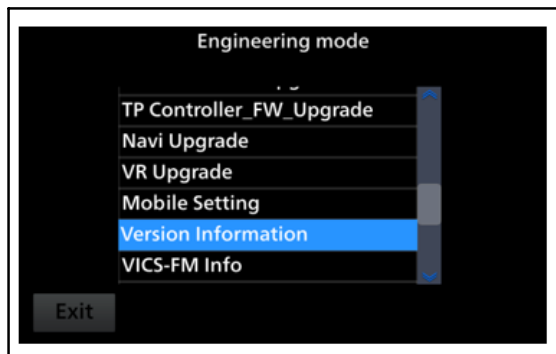
d. Scroll down to "Version Information" and push "next page".

e. Confirm the version is old by referring to the **"Display Audio Software Version Chart"** found on page 2 of this TSB. Proceed to the following page to update the software.

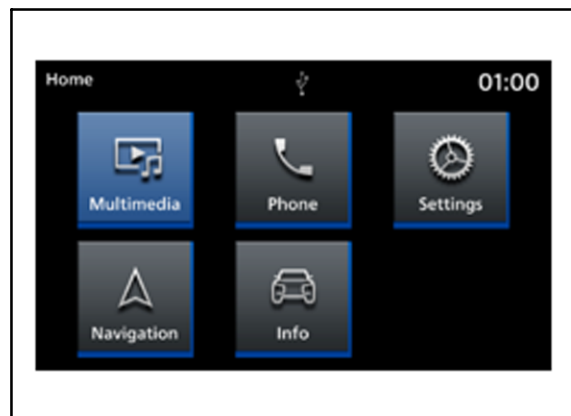
- c. Insert USB flash drive into the vehicle USB port.
- d. The software auto update will begin.

If the software update doesn't start automatically, please push "OK" on the disclaimer screen.

**Note:** The update will take approximately 13 minutes to complete.

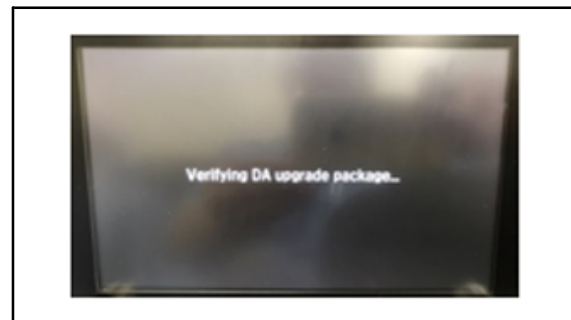
- e. This screen will be displayed for approximately 1 minute.

**NOTE:** Do NOT turn the power OFF, remove the flash drive or add another flash drive during the update.

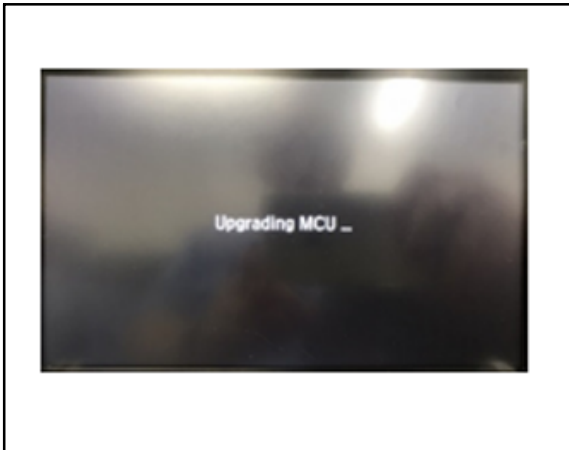
f. This screen will be displayed for about 4 minutes.

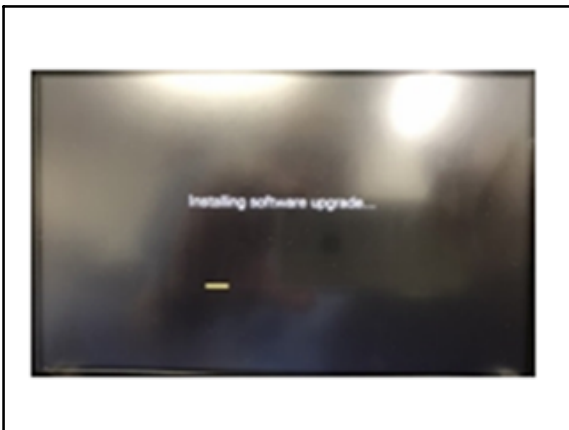
g. This screen will be displayed for about 4 minutes.

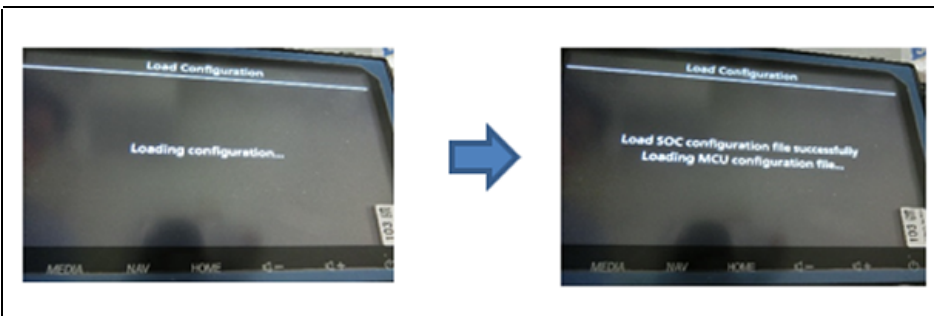
h. These screens may or may not appear. If they appear, it will be for approximately 3 minutes, total.

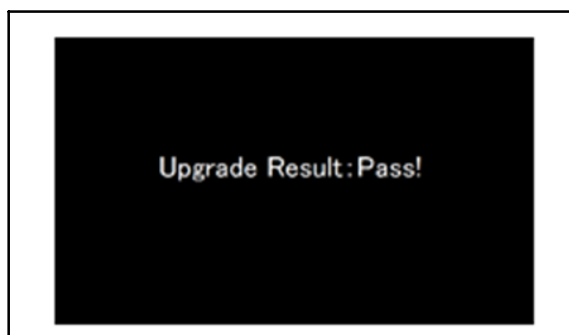
i. When "Update result: Pass!" appears, the update is complete and the USB flash drive may be removed. The home screen will then return.

**Note:** The Head Unit will be rebooted automatically when the update is completed.

\*If "Update result: Exception!" is displayed, execute ACC off and retry beginning at step 1.
