Service Bulletin

21-047

Warranty Extension: 2016-20 HR-V CVT Premature Belt Deterioration

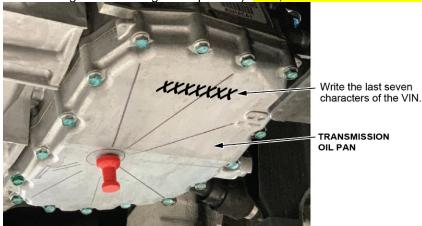
• Provide a clear picture of the magnet sticking on the CVT oil pan at the inspection area (this picture should have been taken during the CVT magnet inspection). Also, write the last seven characters of the VIN on the transmission oil pan.

- Provide a clear picture of the magnet sticking on the CVT oil pan at the inspection area (this picture should have been taken during the CVT magnet inspection).
- Drain the CVT fluid through a paint strainer as shown below. Provide a clear picture of the inside of the strainer showing any contamination.
- Provide a clear picture of the magnet on the end of the oil pan drain plug.
- If you encounter a situation where the magnet sticks but you do not find any metal on the drain plug or inside the strainer, you may be instructed to perform additional confirmation steps by Tech Line.

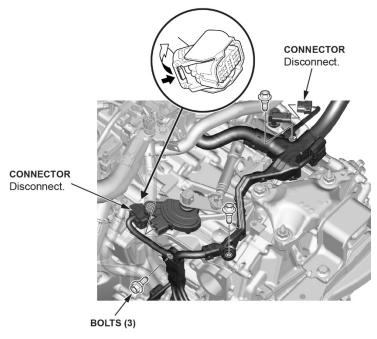
- 10. Disconnect and remove the 12-volt battery. Refer to the service information.
- 11. Remove the bolts and disconnect the connectors.

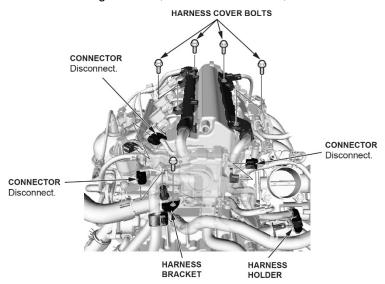
13. Remove the engine cover, harness cover bolts, harness bracket, harness holder, disconnect the connectors.

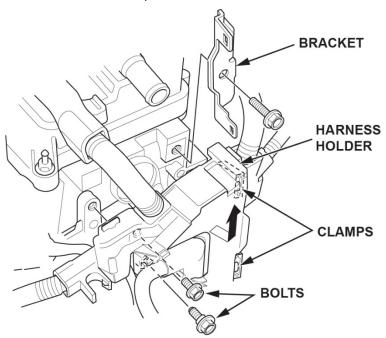
14. Remove the bolts, clamps, and move the harness holder, then remove the bracket.

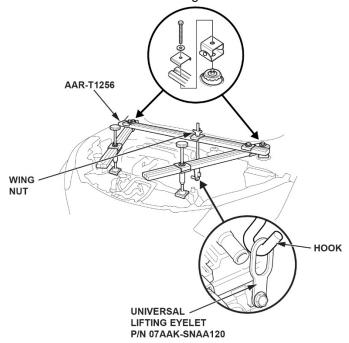
16. Install the engine support hanger, then attach the hook to the slotted hole in the universal lifting eyelet. Tighten the wing nut by hand and support the engine/transmission.

NOTE: Be careful when working around the windshield.

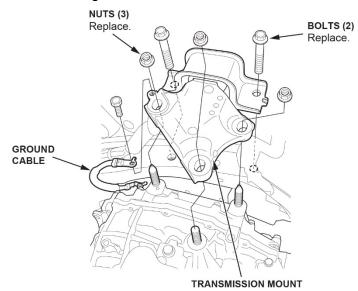
17. Remove the ground cable and the transmission mount.

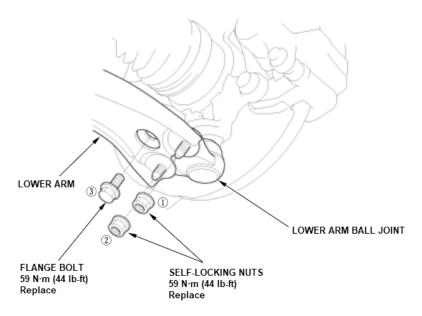
26. Remove the flange bolt and self-locking nuts, then disconnect the lower arm from the lower arm ball joint.

- Use new self-locking nuts and the flange bolt during reassembly.
- Tighten the self-locking nuts and the flange bolt in the sequence shown.

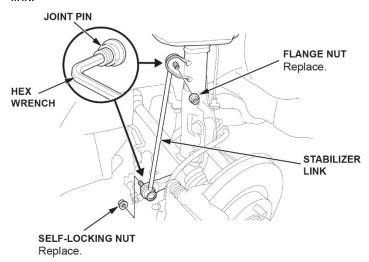
27. Remove the self-locking nut and the flange nut while holding the joint pin with a hex wrench and remove the stabilizer link.

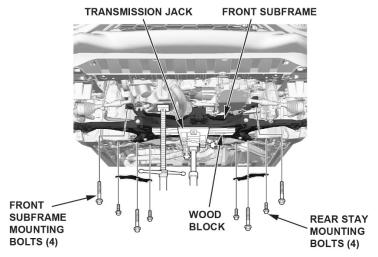
32. Attach a wood block (A) to the lower center of the front subframe, attach a transmission jack (C) to the center of the wood block. Support the front subframe securely by raising the transmission jack, remove the front subframe mounting bolts (D) and the subframe rear stay mounting bolts (E).

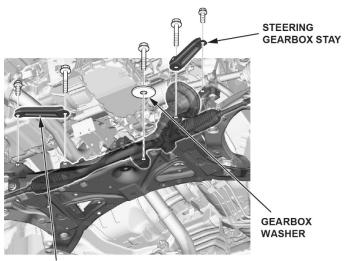
34. Remove the steering gearbox stays and remove the gearbox washer.

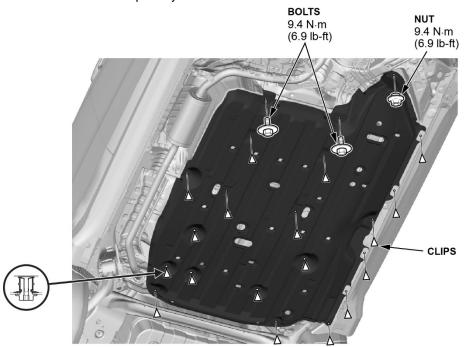
38. Remove the front floor undercover.

NOTE: The retainer clips stay in the front floor under cover.

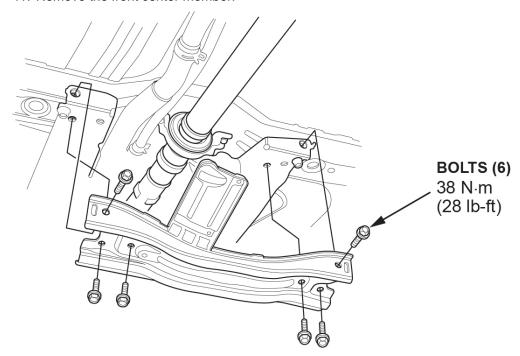
41. Remove the front center member.

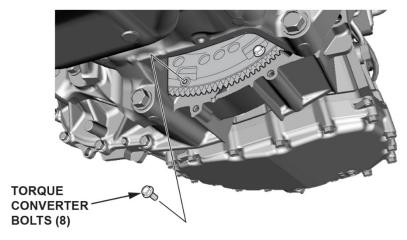
47. Remove the 8 torque converter bolts.

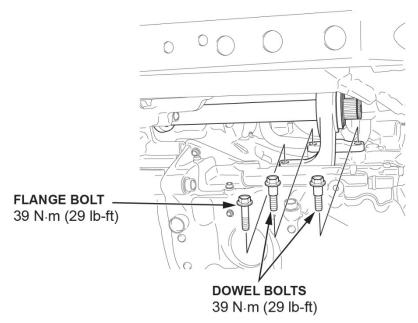
50. Remove the intermediate shaft bolts.

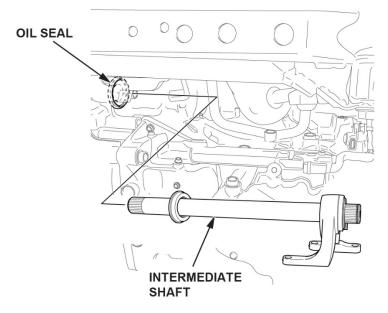
51. Remove the intermediate shaft.

NOTE: Hold the intermediate shaft horizontal until it is clear of the differential to prevent damaging the oil seal.
