GROUP	MODEL
ELE	2019-2022MY Applicable Models Listed
NUMBER	DATE
246	August 2021

## TECHNICAL SERVICE BULLETIN

# FRONT VIEW CAMERA REPLACEMENT AND SOFTWARE UPGRADE INSTALLATION

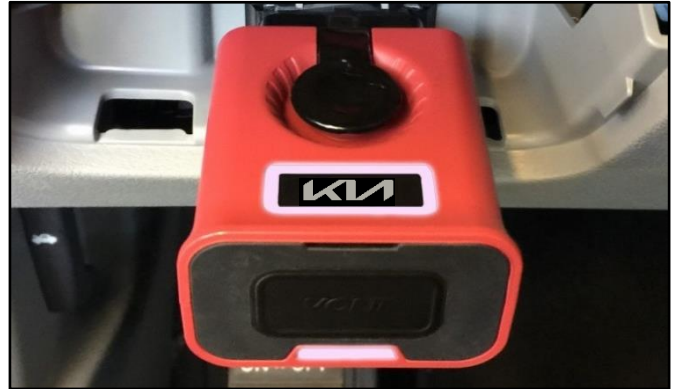
1. Connect the VCI-II to the OBD-II connector, located under the driver's side of the instrument panel.

The ECU upgrade function on KDS operates wirelessly. It is not necessary to perform the upgrade via USB cable.

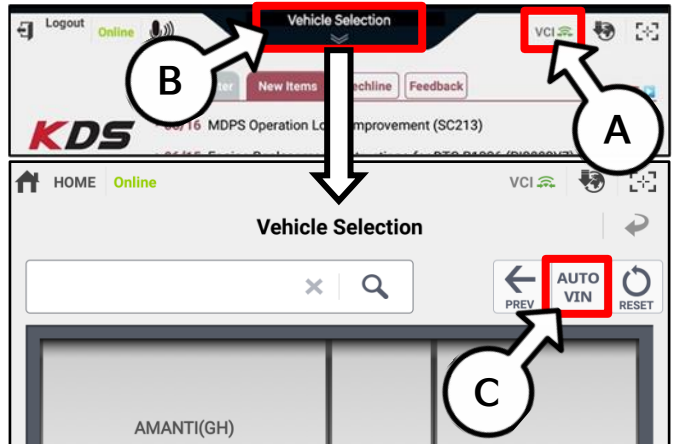
3. Confirm communication with VCI (A) and then configure the vehicle (B) using the 'AUTO VIN' (C) feature.

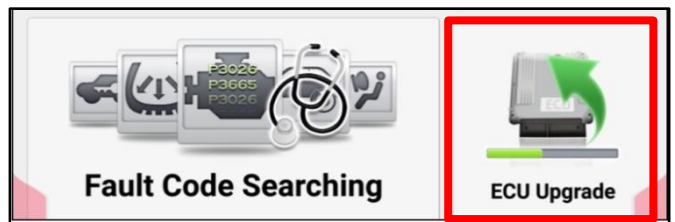
4. Select 'ECU Upgrade'.

- The KDS will check the server for recently uploaded Events and then automatically download Upgrade Event #554 (ON), #555 (DE HEV), #556 (QL), #557 (SK3), or #558 (SP2).

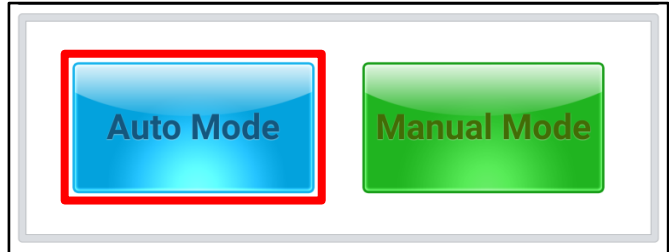
- Select the FR\_CMV system under the System selection menu. Touch ID Check (D) and confirm that the latest update is available. Select Upgrade Event #554 (ON), #555 (DE HEV), #556 (QL), #557 (SK3), or #558 (SP2), and select Upgrade to continue.

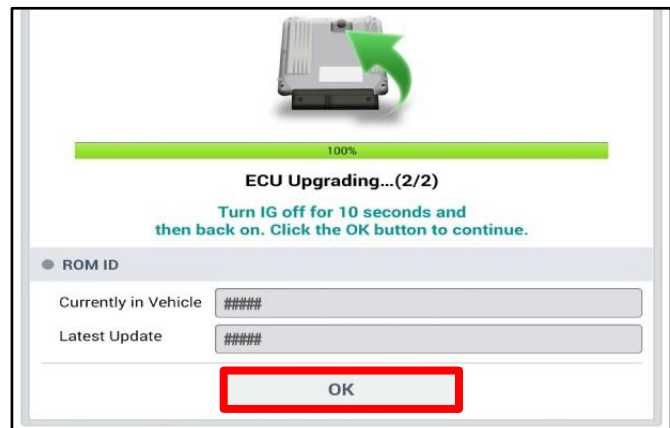
10. When instructed on the KDS, turn the ignition OFF for ten (10) seconds then back on. Select 'OK' to continue.

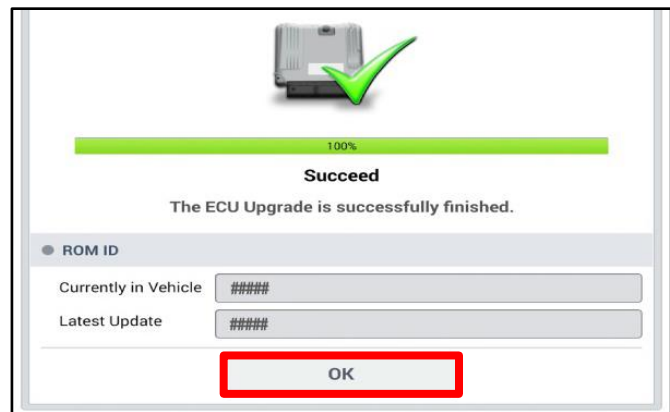
11. Once the upgrade is complete, select 'OK' to finalize the procedure.

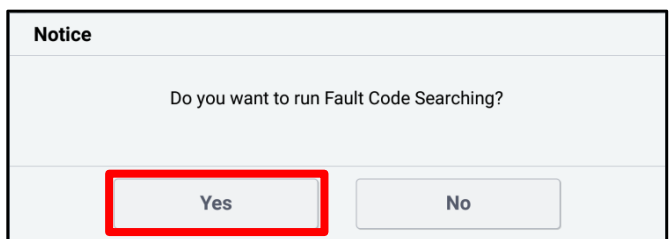
12. When prompted, select 'YES' to check for Diagnostic Trouble Codes (DTC) and erase any DTCs stored such as EPS, ESC, and TPMS that may have been set during the upgrade.
