**Complaint – Charging is Canceled / Check Engine Warning Light is Active: Re-Program High-Voltage Charger (OBC) Control Unit (36/21)**

Vehicle Type: **Cayenne E-Hybrid (9YA / 9YB)**

Concerns: **High-voltage charger (OBC) control unit (3.6 kW)**

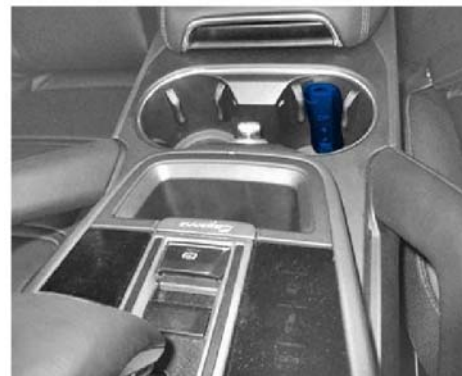
- Work Procedure: 1 Position the driver's key in the rear area of the left cupholder in the center console between the holding struts (emergency start tray) in order to guarantee a permanent radio link between the vehicle and driver's key ⇒ *Emergency start tray*.
- 2 Carry out general preliminary work for control unit programming as described in ⇒ *Workshop Manual '9X00IN Basic instructions and procedure for control unit programming - section on "Preliminary work"*.

*Emergency start tray*

- If the driver's key is not recognized in the vehicle, programming cannot be started or will be interrupted.
- ⇒ Place the driver's key with the back facing down into the front left storage compartment in the center console to guarantee a continuous radio link between the vehicle and the driver's key.

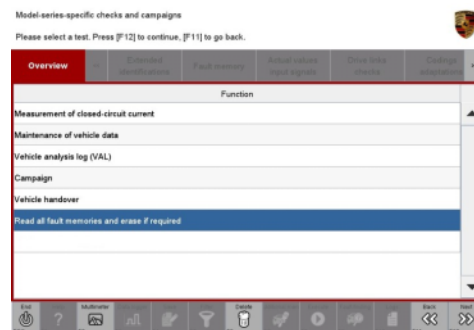
- 2.2 Select the function 'Read all fault memories and erase if required' and press •F12" ('Next') to confirm your selection ⇒ *Erasing fault memories.*

*Erasing fault memories*

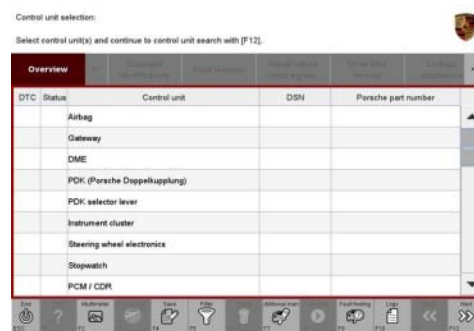
- 2.6 Once you have erased the fault memories, select the '**Overview**' menu to return to the control unit selection screen ⇒ *Control unit selection.*

*Control unit selection*
