| Product Improvement | 2017-2018MY<br>Forte (YD/YDm)<br>w/2.0L GDI |
| PI2106 | October 2021 |

### NU 2.0L GDI - KNOCK SENSOR DETECTION SYSTEM (KSDS) ECU LOGIC IMPROVEMENT (PI2106)

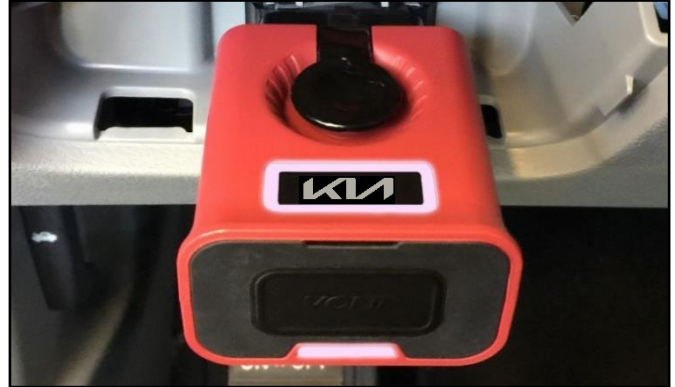
2. With the ignition ON, turn ON the KDS tablet. Select 'KDS' from the home screen.
