SERVICE BULLETIN

Classification: AN15-005D	Reference: NTB15-011D	Date: September 27, 2021
------------------------------	--------------------------	-----------------------------

NISSANCONNECT NAVIGATION SYSTEM SOFTWARE UPDATE

APPLIED SYSTEM: Vehicles equipped with Navigation

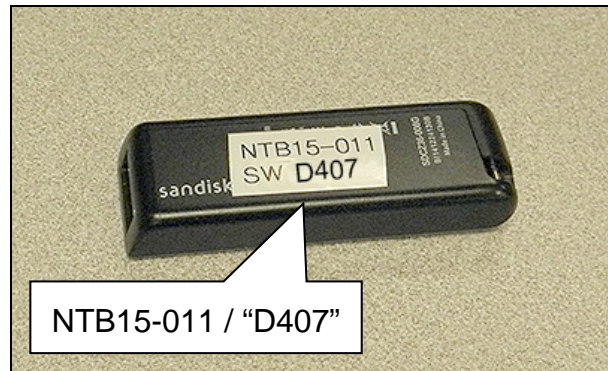
- Each dealer has been mailed one USB drive (Figure 1) free of charge, from Bosch. Please discard any USB drives with the previous software version.

- **If the USB drive shown in Figure 1 cannot be located/used**, download the update-software from ASIST onto a USB drive.

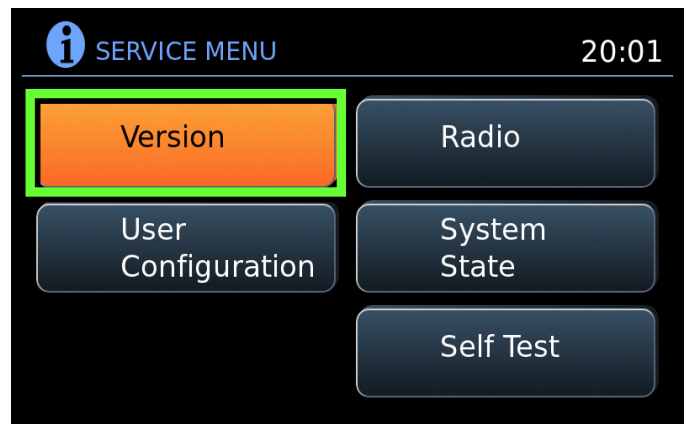
Figure 3

1. Turn the audio system OFF.
2. Access the **SERVICE MENU**.
 - a. Push and hold the **APPS** button.
 - b. Turn the **TUNE-SCROLL** knob as follows:
 - Counterclockwise 3 or more clicks, then
 - Clockwise 3 or more clicks, then
 - Counterclockwise 3 or more clicks, then
 - Clockwise 3 or more clicks, then
 - Continue this pattern until the **SERVICE MENU** screen is displayed (Figure 3).

3. Select **Version**.

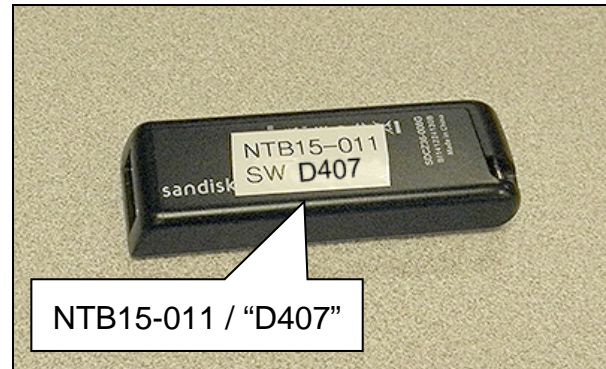
NOTE: If the USB drive shown in Figure 5 is available to use for the reprogramming procedure, skip to **Update the Navigation System** on page 8.

- Special tool USB drive J-52727-1 is the only USB drive approved for use with this procedure if the original USB drive (Figure 5) is not available.
- The update-software is estimated to take 1-2 hours to download to the USB drive.
- The update-software must be the only file on the USB drive.

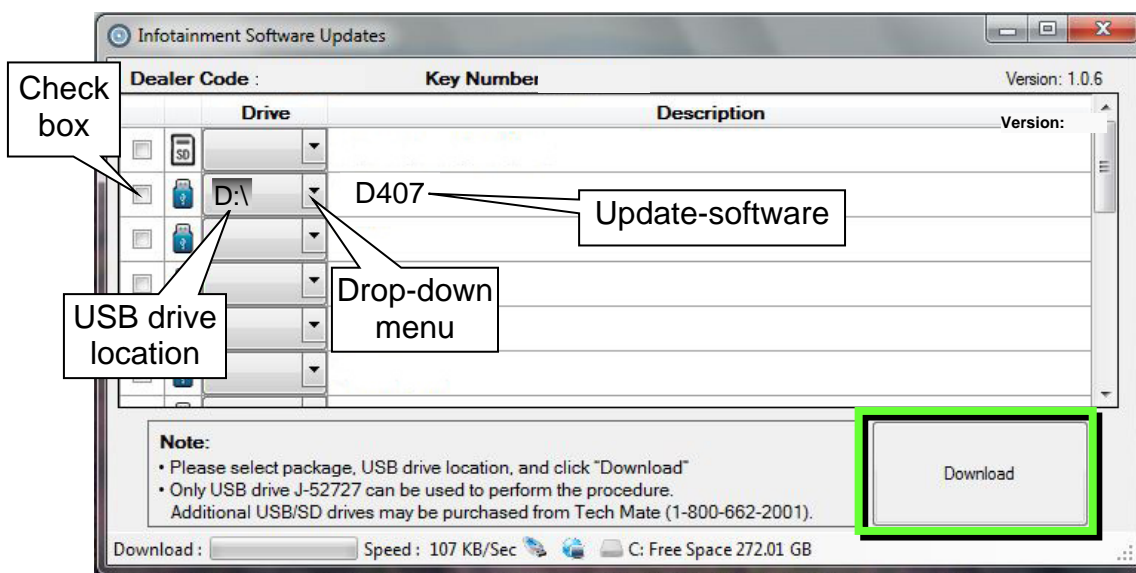
Figure 7

8. Select the check box next to the **D407** update-software (Figure 7).
9. Use the drop-down menu and select the location of the USB drive that was inserted into the CONSULT PC in step 5 on page 4.

10. Select **Download** (Figure 7 on page 5), and then wait for the download to complete.
- The update-software is estimated to take 1-2 hours to download to the USB drive.
 - If, while attempting to download the software, you receive the message shown in Figure 8:
 - a. First, attempt to clear space on the CONSULT PC hard drive.
 - b. If space on the hard drive cannot be cleared, email Bosch at **nissan.dealers@us.bosch.com** for additional options.

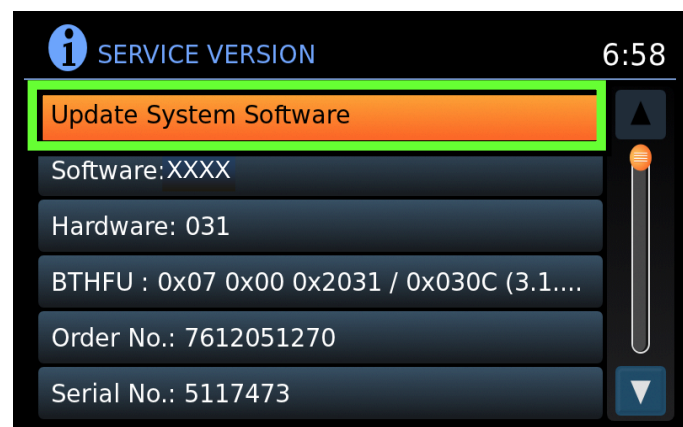
Figure 12

23. Select **Update System Software**.

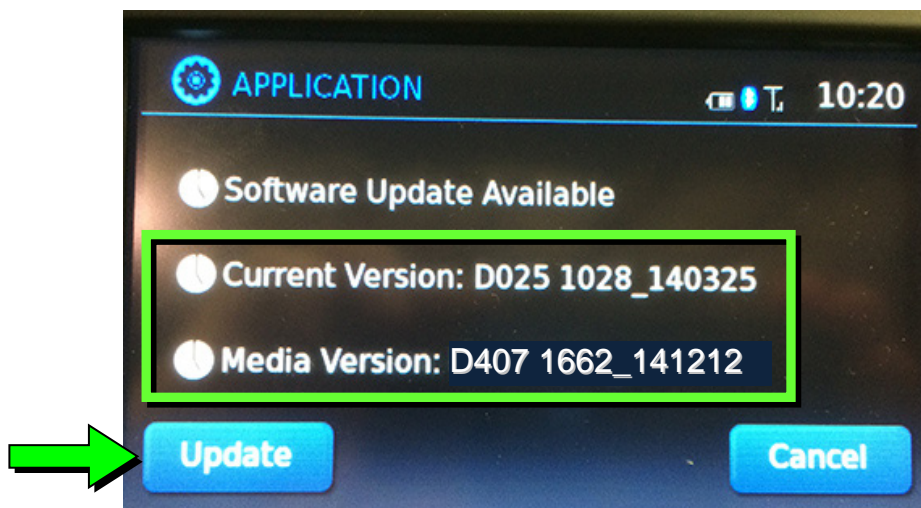
Figure 14

25. Wait for the **APPLICATION** screen to appear (Figure 14).

26. Confirm the **Current Version** and **Media Version** are different.

27. Select **Update**.

- After selecting **Update**, the screen will go black for up to one (1) minute. **This is a normal part of the update.**

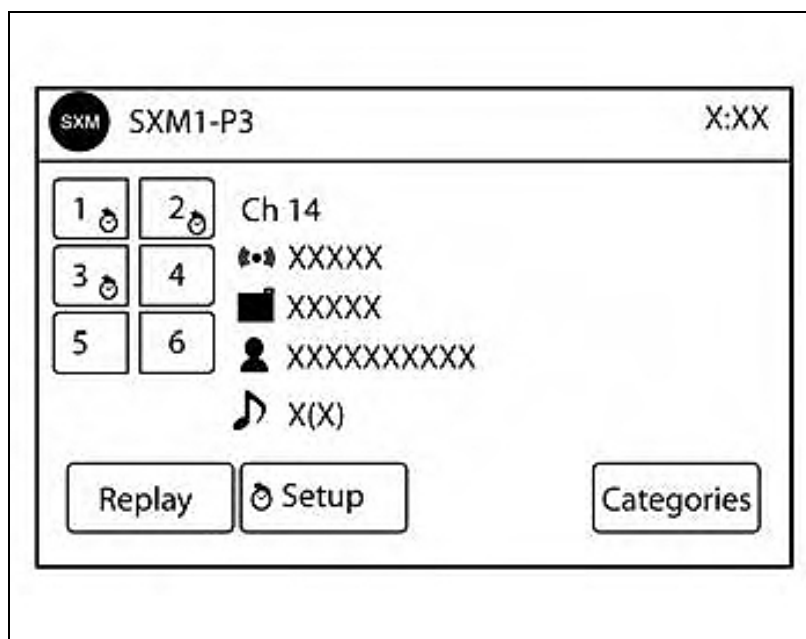
Figure A

The Smart Favorites feature allows the user to designate presets, within the SXM1, SXM2 and SXM3 bands, as their Smart Favorites. When any of the Smart Favorite presets are selected, the current track on that station will play from the beginning of the song.

1. Press the **SXM** button.
2. Touch the **“Setup”** key.
3. Touch the **“Tune Start”** key to activate (ON) or deactivate (OFF) Smart Favorites.
4. Touch the **“Add Preset”** key to select an available preset.
