November 2021
SF637

Subject: FCCC Viper Low Voltage Display

Models Affected: Specific model year 2019-2021 Freightliner Custom Chassis (FCCC) manufactured September 17, 2019, through April 7, 2021.

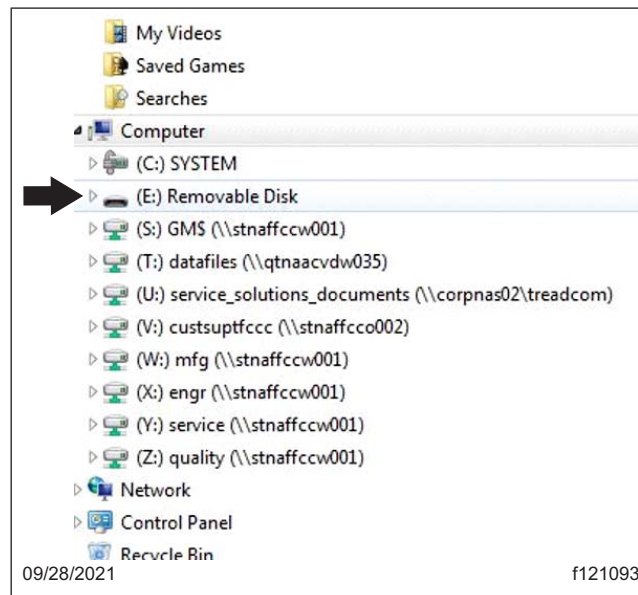
1. Inspect the base label (Form WAR259) for a campaign completion sticker for SF637 (Form WAR260). If a sticker is present for SF637, no work is needed. If there is no sticker, proceed with the steps below.
2. Insert the flash drive into an available USB port on the laptop. Write down the drive letter the computer assigns to that flash drive. See [Fig. 1](#).

Fig. 1, Flash Drive Connected to the Laptop

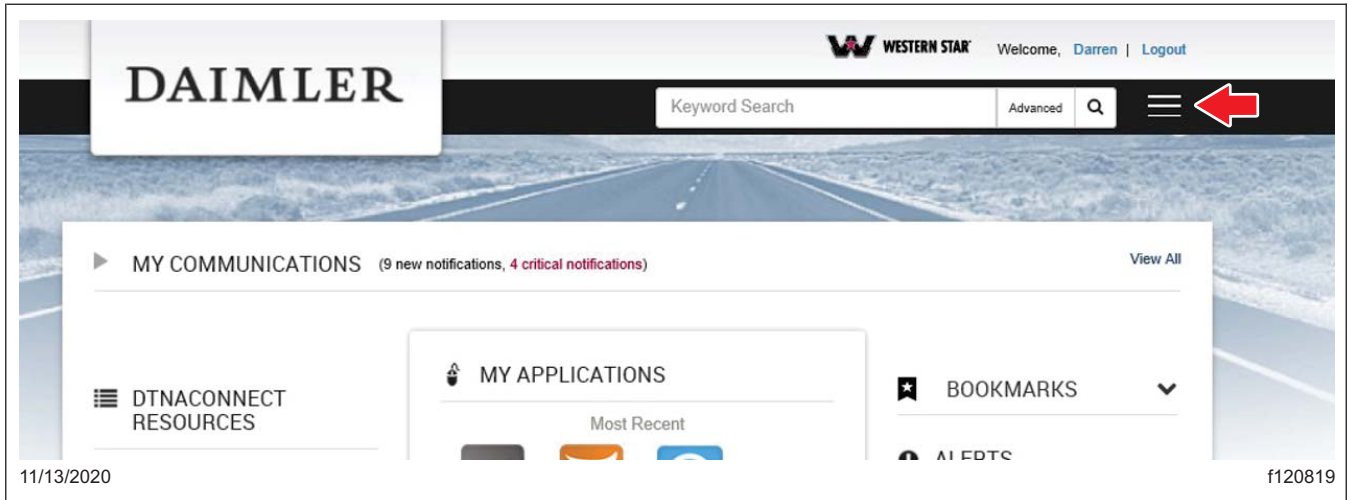
3. On the laptop, go to DTNA Connect, then select the three menu bars at the upper right-hand corner of the web page. See [Fig. 2](#).

Fig. 2, DTNA Connect Home Screen

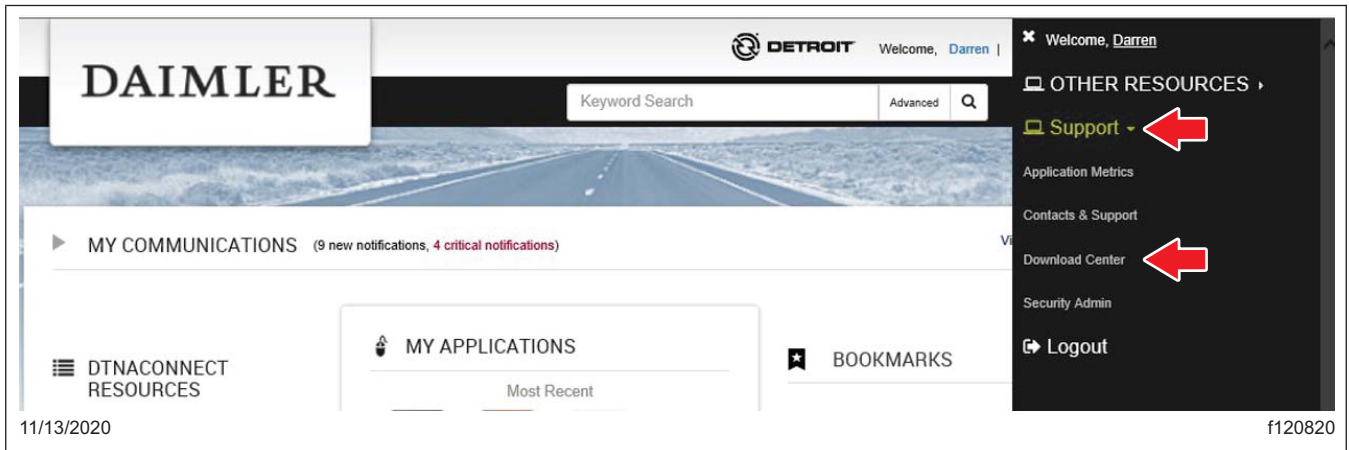
4. Select 'Support,' then select 'Download Center.' See [Fig. 3](#).

Fig. 3, Selecting Download Center

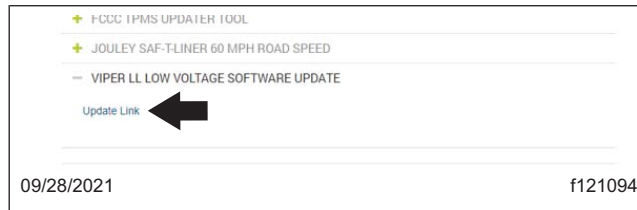
5. Scroll down to 'Viper II Low Voltage Software Update,' then select the '+' symbol. Select 'Update Link.' See **Fig. 4**.

Fig. 4, Viper II Low Voltage Software Update Link

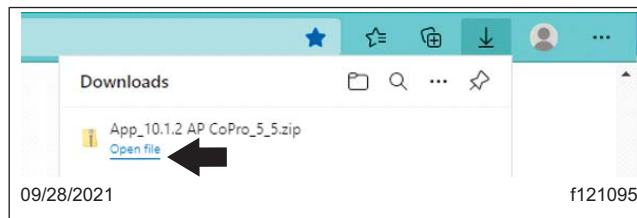
6. A download box will now appear on the upper right corner of the browser window. Once the download is complete, Select 'Open File.' See **Fig. 5**.

Fig. 5, Link to Open the Downloaded File

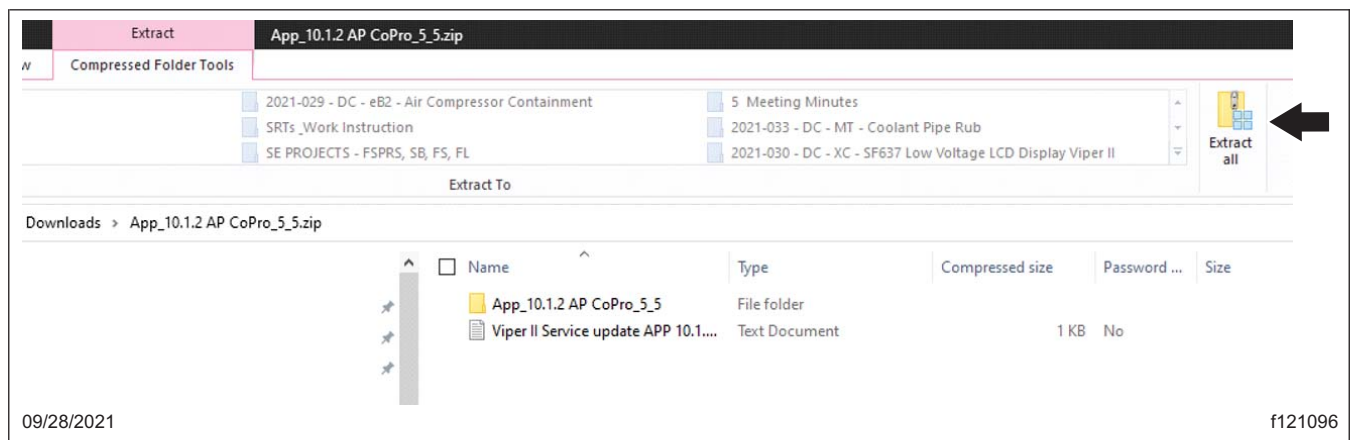
7. Select the 'Extract All' button. See **Fig. 6**.

Fig. 6, Extract All Button

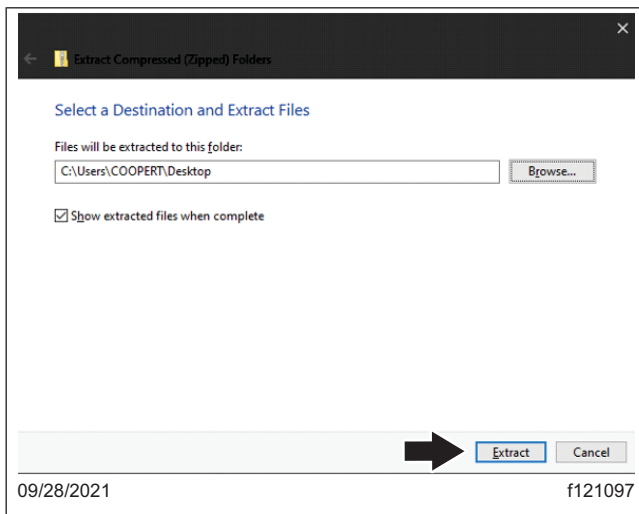
Fig. 7, Extract Compressed Folders Window

8. In the next screen, make sure the destination for the extracted files is 'Desktop.' If not, select 'Browse,' then select 'Desktop.' Select 'Extract.' See [Fig. 7](#) and [Fig. 8](#).
9. If not automatically opened, go to 'Desktop,' then double click on the extracted folder to open it. See [Fig. 9](#).
10. In the extracted folder, select 'Select All,' then select the 'Copy' button. See [Fig. 10](#).

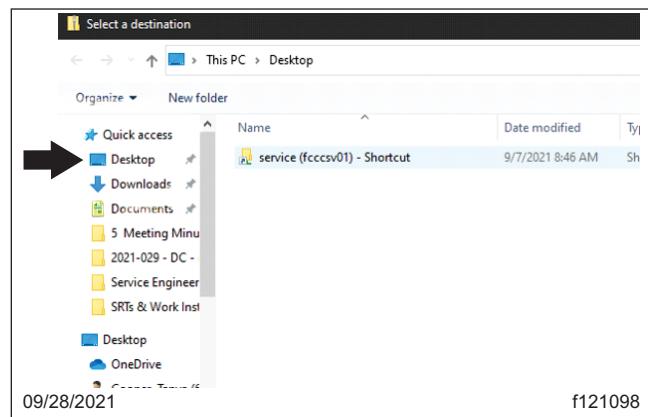
Fig. 8, Selecting the Destination for the Extracted Files

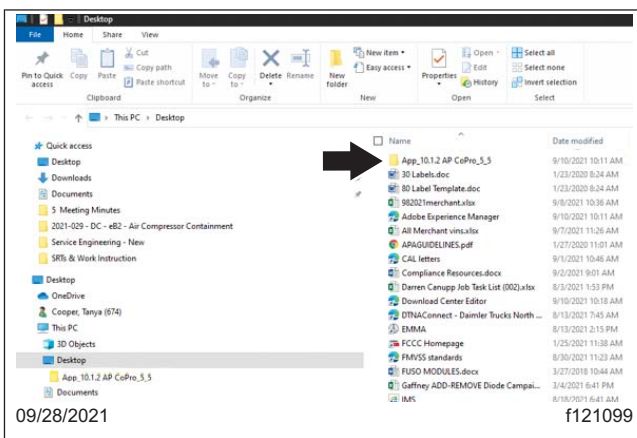
Fig. 9, Extracted Folder

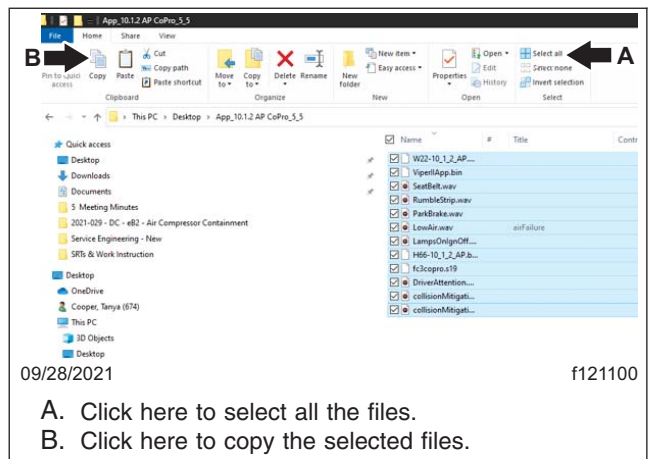
- A. Click here to select all the files.
- B. Click here to copy the selected files.

Fig. 10, Copying Files from the Extracted Folder

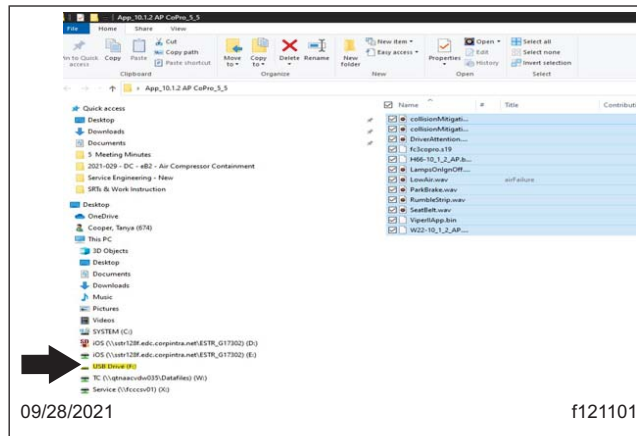
11. Navigate to the drive noted in step 2 to access the flash drive, then select 'Paste.' See [Fig. 11](#).

Fig. 11, Pasting Copied Files to the Flash Drive

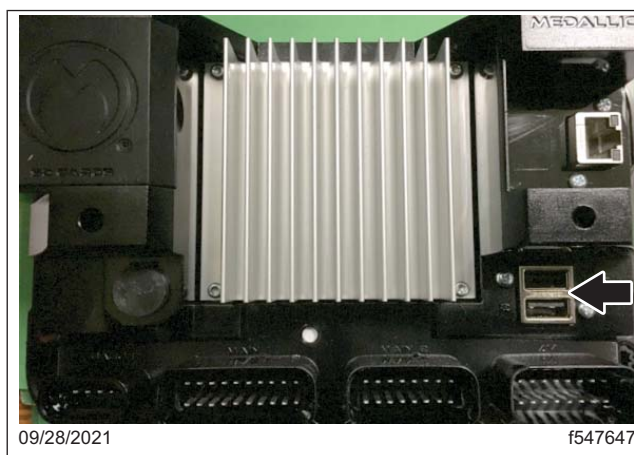
IMPORTANT: A universal serial bus (USB) extension cable that connects the instrument panel electronic control module (ECU) to the diagnostic connector may have been installed on the vehicle by the body builder. If a USB extension cable was not installed, or missing, locate the instrument panel ECU, and plug the flash drive directly into either of the USB ports on the instrument panel ECU. See [Fig. 12](#).

The instrument panel ECU is usually located behind the dash. If unable to locate the ECU, contact the body builder for support.

Fig. 12, Location of the Instrument Cluster ECU USB Ports

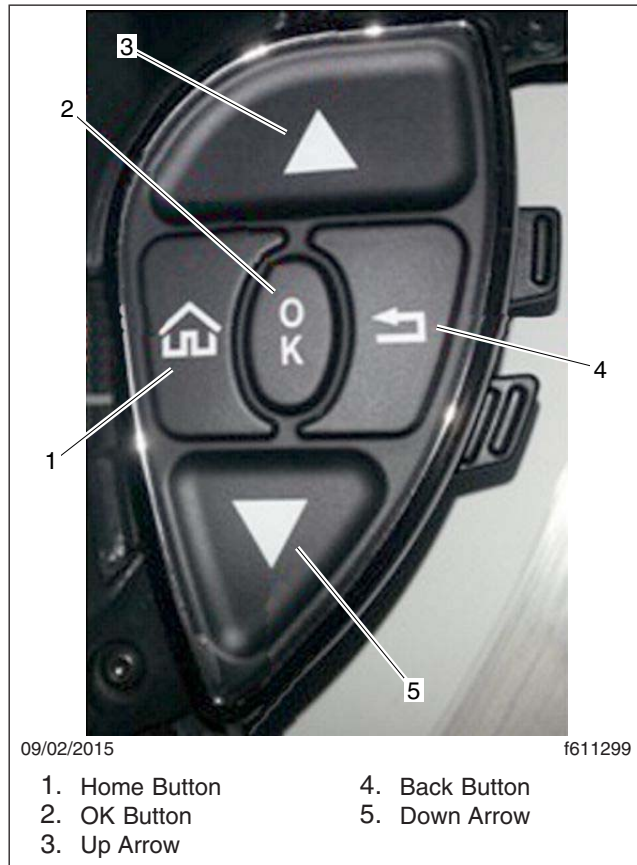
- Using the buttons on the steering wheel shown in **Fig. 13**, navigate to 'Diagnostics,' then 'System Information.' See **Fig. 14** and **Fig. 15**.

Fig. 13, Steering Wheel Buttons

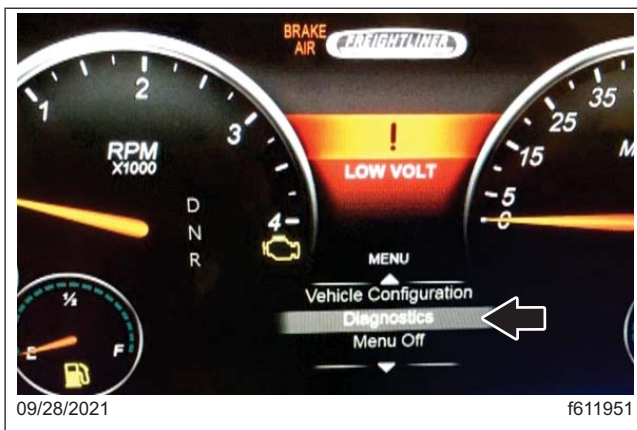
Fig. 14, Diagnostics Menu

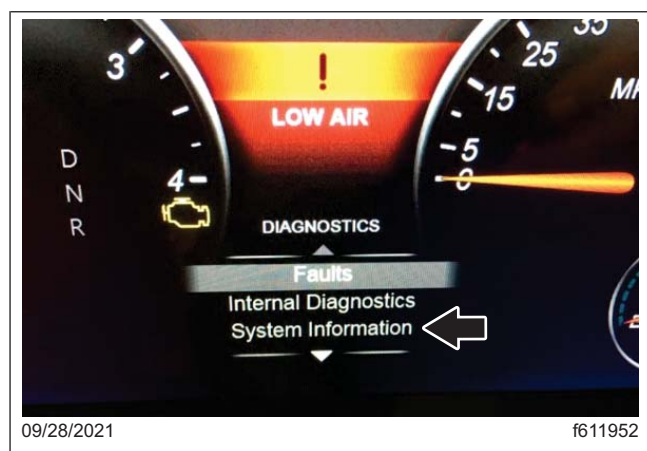
Fig. 15, System Information Option
