## **Volvo Chassis - Equipped With An Automated Manual Transmission Model D or F ( AMT-D, AMT-F, I-Shift ) Missing X1 Value In VDA And Default Settings Guidelines, Parameter P1AOB; Fault Code P1052-54, Error 40, Or Error 18 Encountered During Clutch Or T**

4000-07-04-01 Transmission (Transmission removed)

## 4320-07-03-01 Transmission, clutch, engagement point

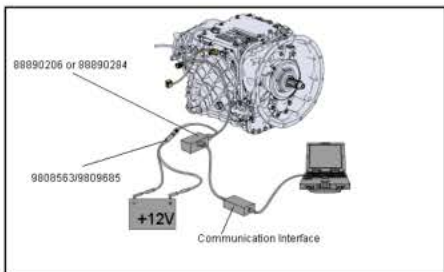
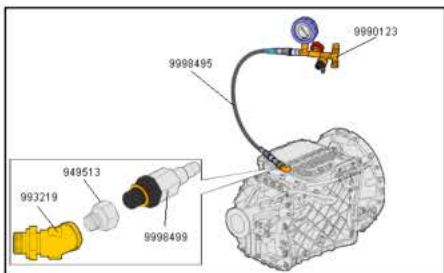
- Connect special tools according to illustration
- Apply compressed air to supply the transmission with a minimum of 700kPa (100 psi) to a maximum of 1000kPa (145 psi)

If performing a transmission removed operation and Tech Tool is connected to the product's main diagnostic connector, you must first click Finish Work under the Product tab, then start a new session once you are connected to the transmission using the special tools displayed in the illustration

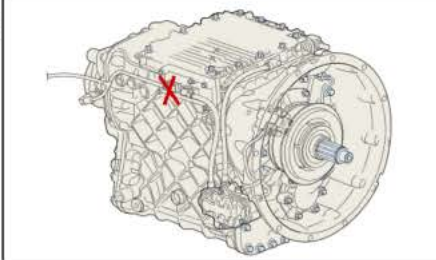
Automatically checked conditions

- 1 Transmission Supply voltage above 10 V
- 2 Air pressure above 94 psi

Manual conditions

- 3 Transmission Control Module (TCM) disconnected from vehicle communication connector

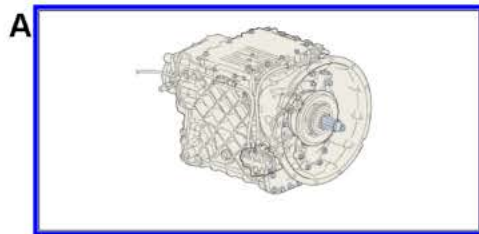
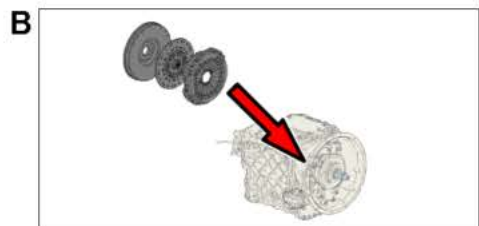
Illustrations are used for reference only, may differ slightly from the actual vehicle  
The essential information in the illustrations is, however, always correct.

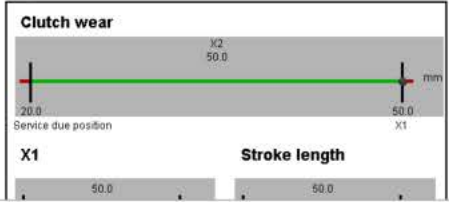
### 4320-07-03-01 Transmission, clutch, engagement point

Calibration successful

Note: The X2 value might vary slightly between each test execution due to different conditions, such as oil temperature. On a relatively new clutch, these variations might cause an indication of a small negative wear (X2 > X1). This is normal and not a fault indication

#### Detailed information
