# Technical Service Bulletin

## 00 Software Version Management (SVM), operating instructions

This Technical Service Bulletin (TSB) details the general process for carrying out a Software Version Management (SVM) software update for any TSB or Update.

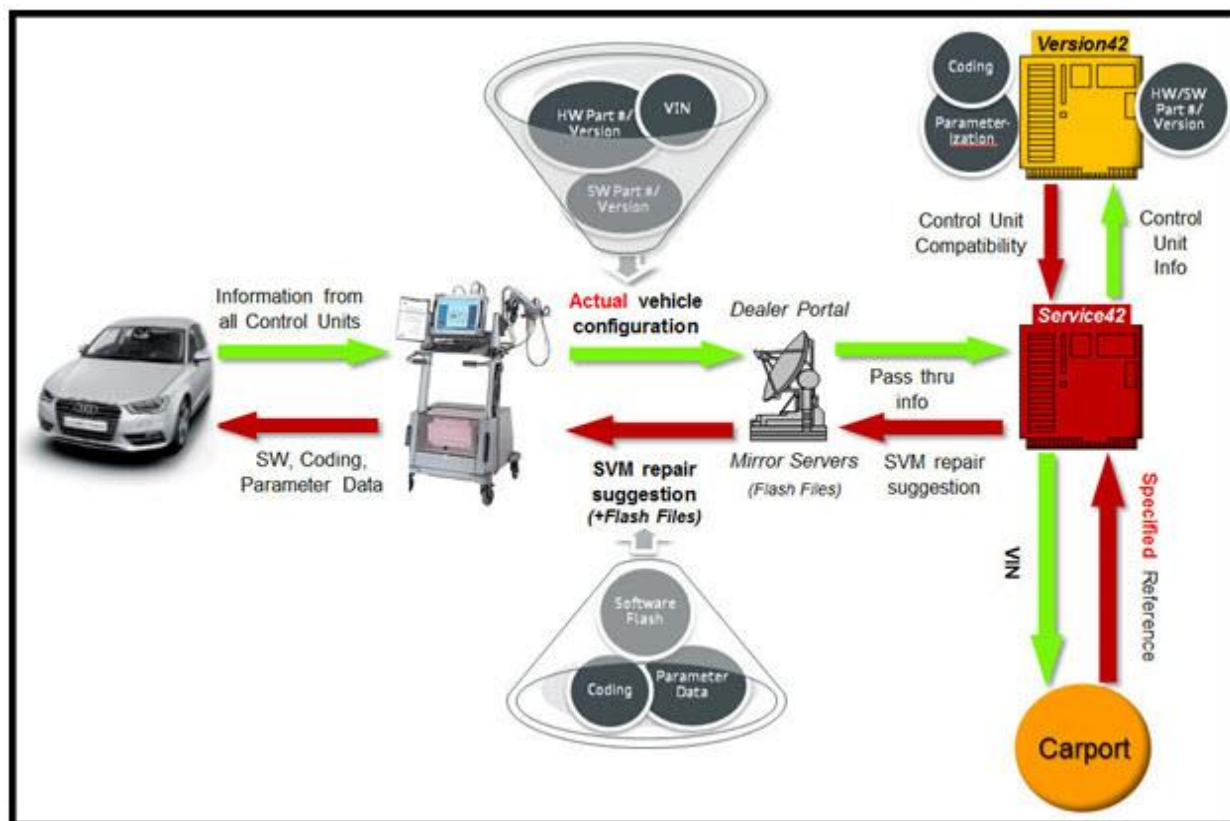
A VAS 5051B, VAS 5052A, VAS 6150(A/B/C) or VAS 6160 diagnostic tool is required for reading the vehicle control module data and sending it to the SVM server (also called an "SVM communication"). The SVM communication data flow is illustrated below (Figure 1).

Figure 1. SVM communication data flow.

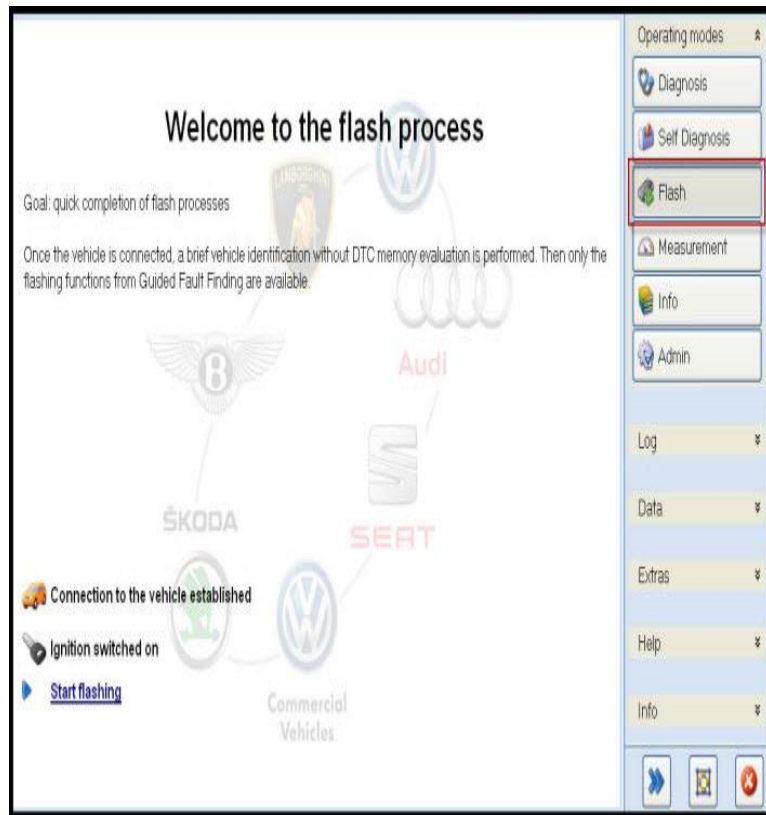
8. If no previous diagnosis was performed, select **Flash** from the homepage of ODIS. (unless otherwise directed by the bulletin or by TAC) (Figure 4). This is the quickest way to execute an SVM code.

**Figure 4.** Selecting the Flash option in ODIS.

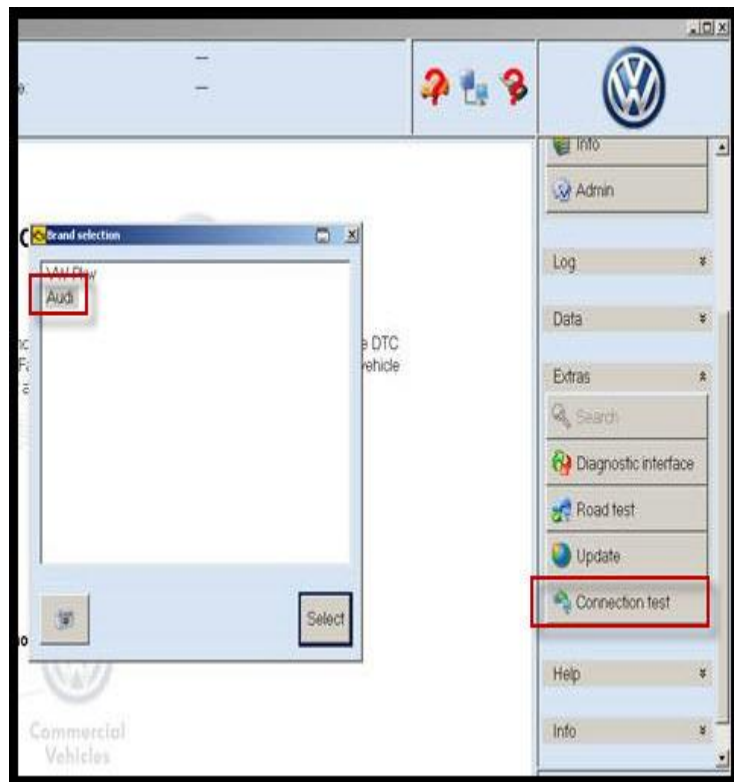
To carry out an SVM communication test, first, go to the main ODIS start screen and navigate to (Figure 5): *Extras >> Connection test >> AUDI >> SVMService >> Start*.

Figure 5. ODIS Connection test.

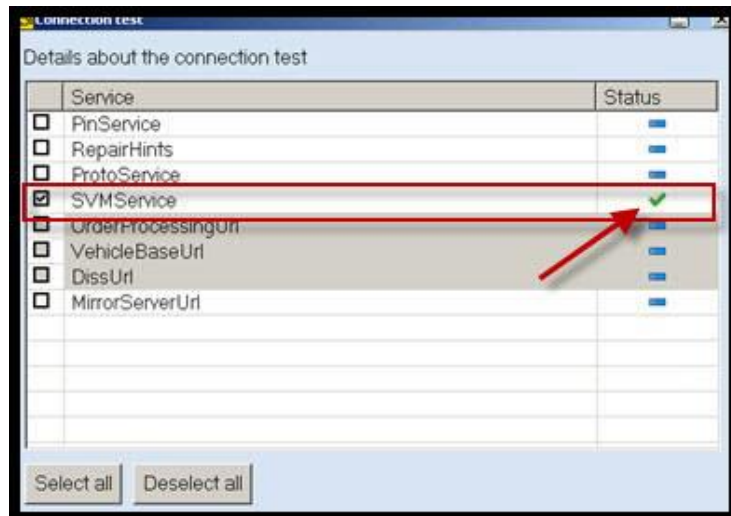
Next, input a GeKo ID and verify the response:

- Green Checkmark = Good Connection.
- Red X = Bad Connection.

**Figure 6.** SVM Service Check.
