Techstream ECU Flash Reprogramming Procedure

Service Category Engine/Hybrid System

Section Emission Control

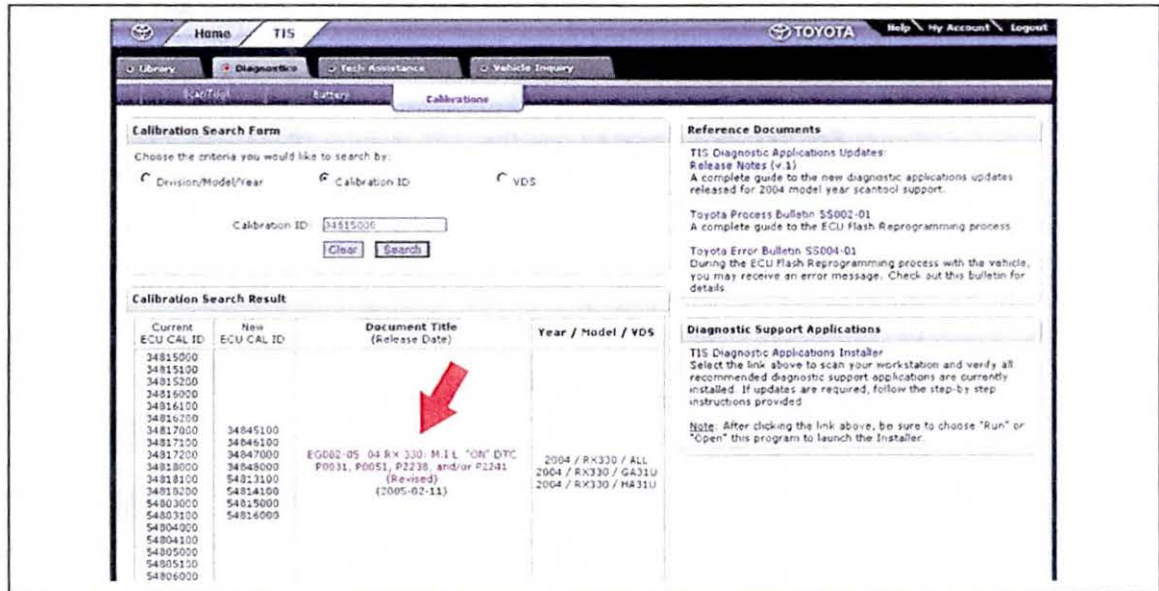
Figure 6.

- H. To review the Service Bulletin and access the calibration file, click the Service Bulletin link in the *Document Title* column of the *Calibration Search Result* portlet.

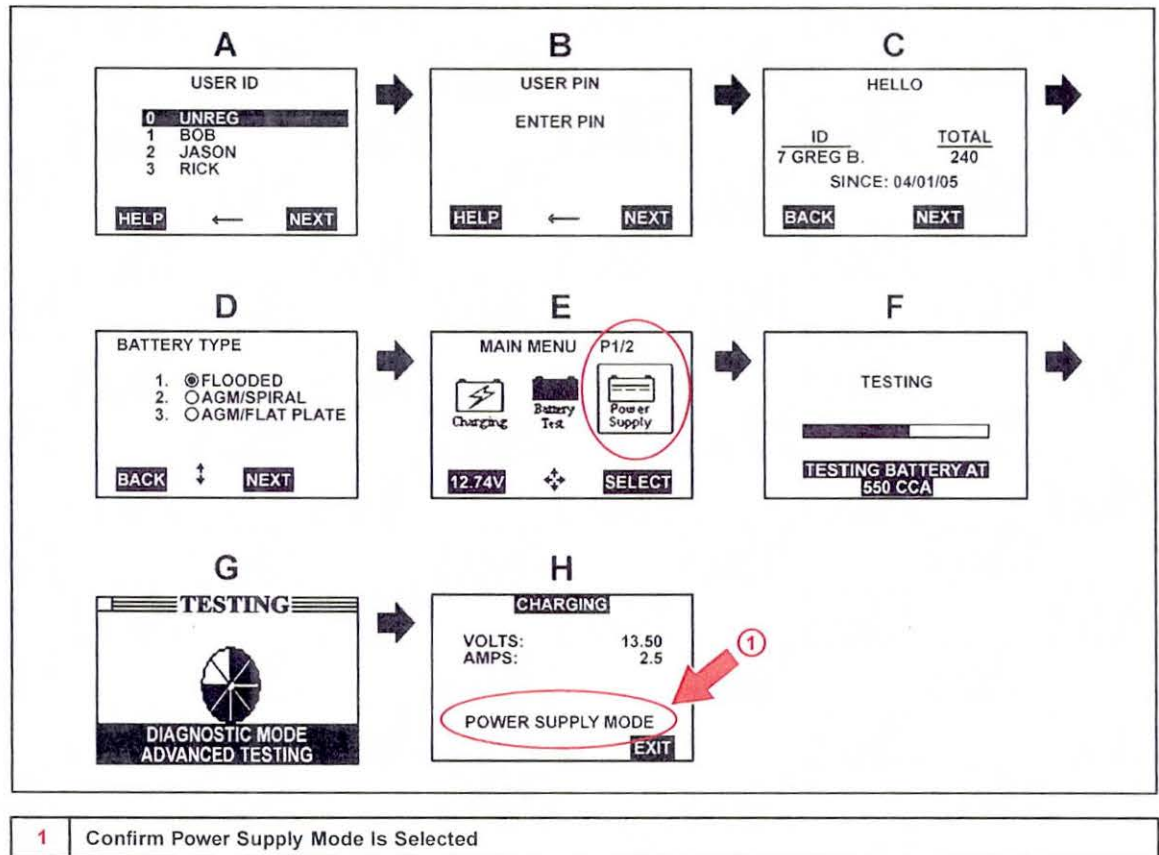
Figure 7.

2. Connect the GR8 Battery Diagnostic Station.
 - A. Connect the GR8 Battery Diagnostic Station to the vehicle and turn it ON.
 - B. Select Power Supply Mode by following the screen flow below.

- ECU damage may occur if the correct battery charger and mode setting are NOT used.
- Power Supply Mode is used to maintain battery voltage at 13.5 volts while flash reprogramming the vehicle.
- For details on how to use the GR8 Battery Diagnostic Station, refer to the [GR8 Instruction Manual](#) located on TIS, *Diagnostics – Tools & Equipment – Battery Diagnostics*.

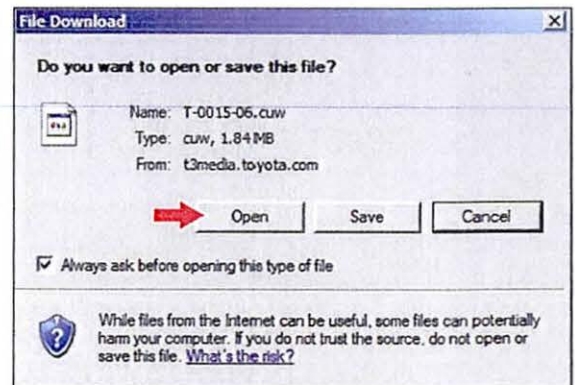
Figure 9.

- B. Click *Open* to load calibration file information.

Techstream pulls calibration files as needed to ensure the latest calibration file is used. Do NOT save calibrations locally on the hard drive or other media.
