Mack Chassis - Diagnostic Trouble Code (DTC) P20CF, Diagnosis And Repair - US14+OBD15 Emissions, Common Model Year 2016

(June 2018)

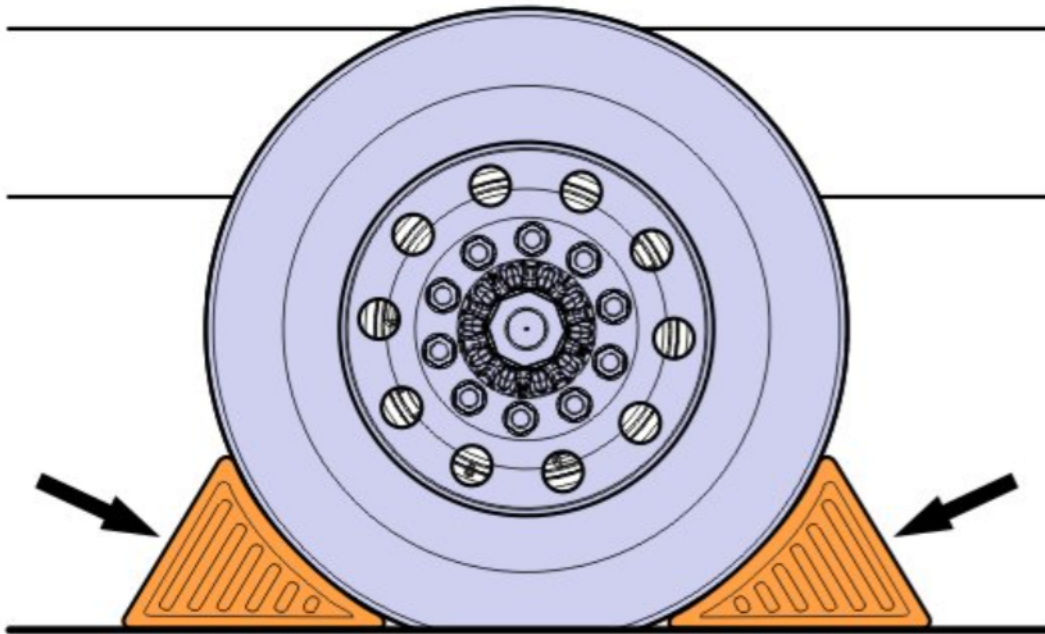
5. Connect Premium Tech Tool (PTT) to the vehicle diagnostics connector using the 16 pin OBD cable 88890304 and Communication Interface 88890300. Connect the PC to a functional LAN or modem connection and a 120 Volt AC source.
6. Turn the ignition switch "ON".
7. Log in to PTT and Identify Vehicle is displayed.
8. Once the vehicle has been identified, enter the Work Order Number information, then click Start Work.

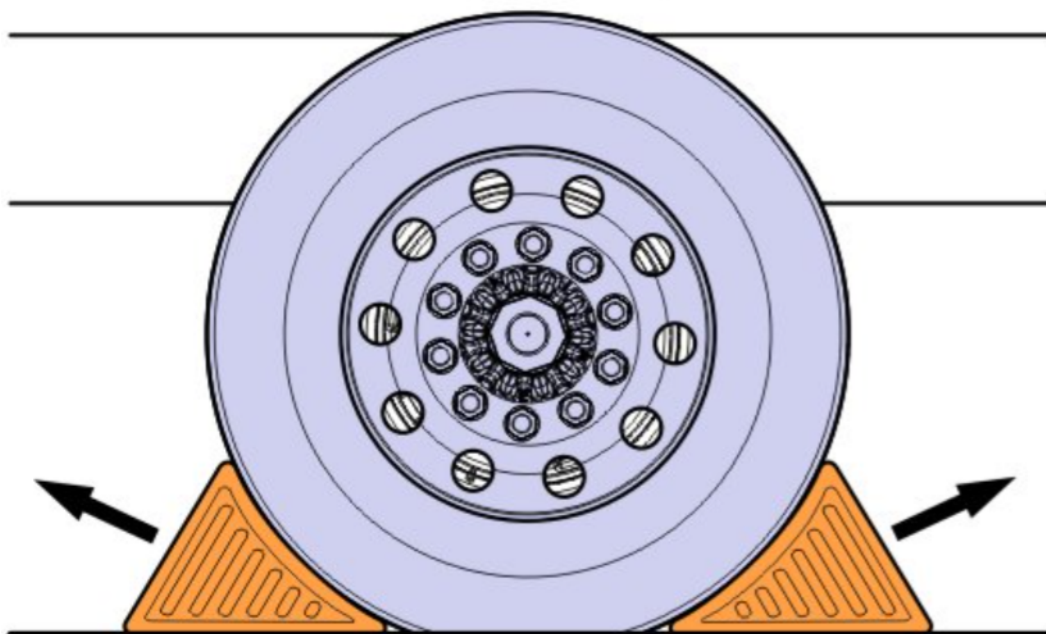
14. When programming is complete, click Exit to return to Main Menu to program the ACM.
15. When all programming is complete, clear any diagnostic trouble codes (DTC) and Finish Work.
16. Remove the wheel chocks.
