# Volvo Chassis - Diagnostic Trouble Codes ( DTC ) P208E And P103B Logging With Possible Derate ( SCR Inducement ) - US14+OBD13, US14+OBD15, US14+OBD16 And US17+OBD16 And Newer

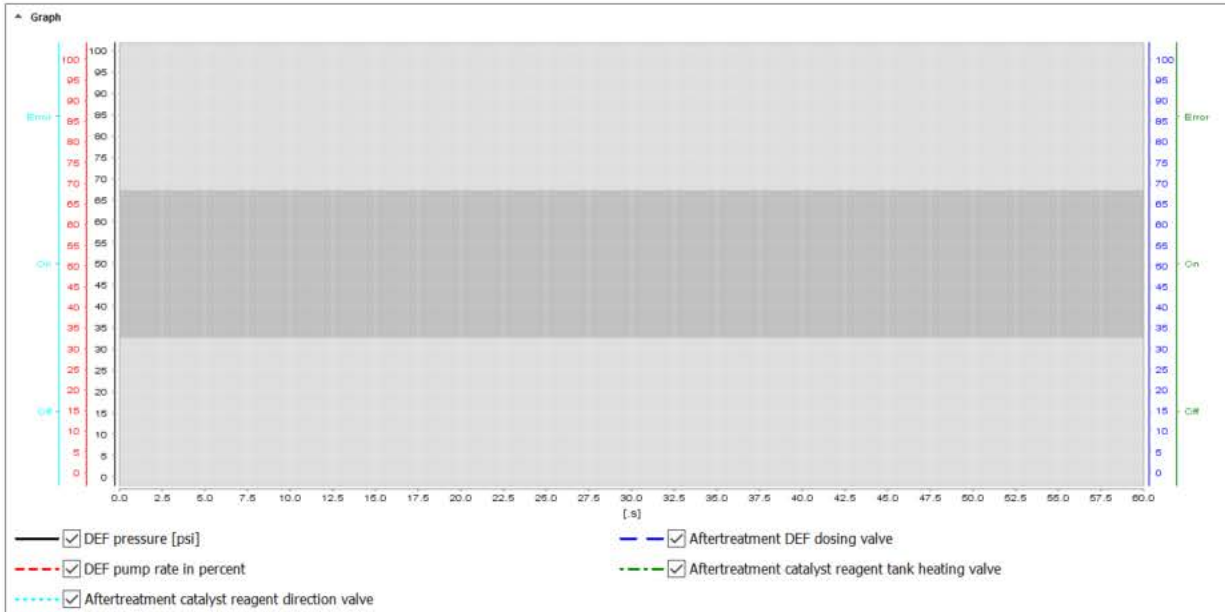
DEF System Status:

Waiting for start

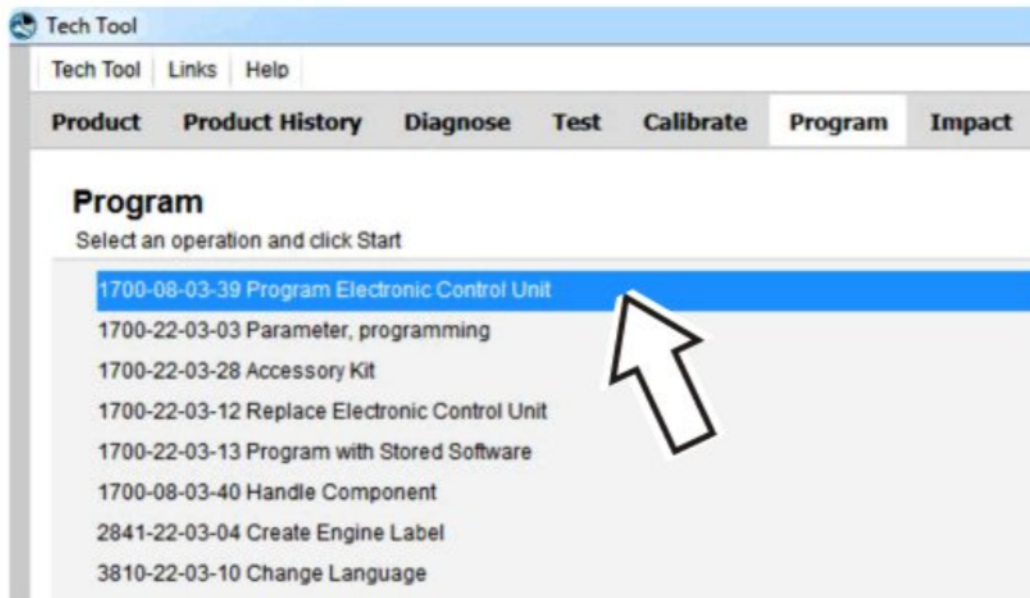
9. From the Main Menu select Program and then Program Electronic Control Unit 1700-08-03-39. Then click Start.

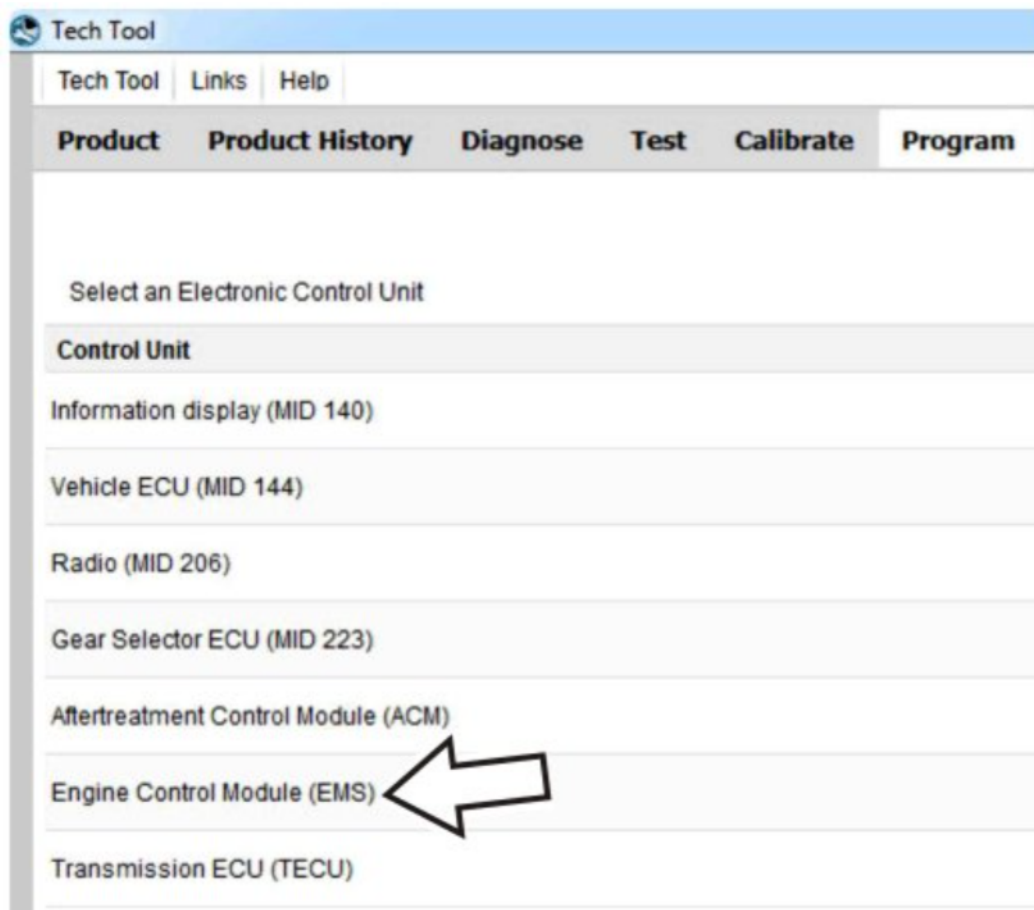
10. Select Engine Control Module (EMS).

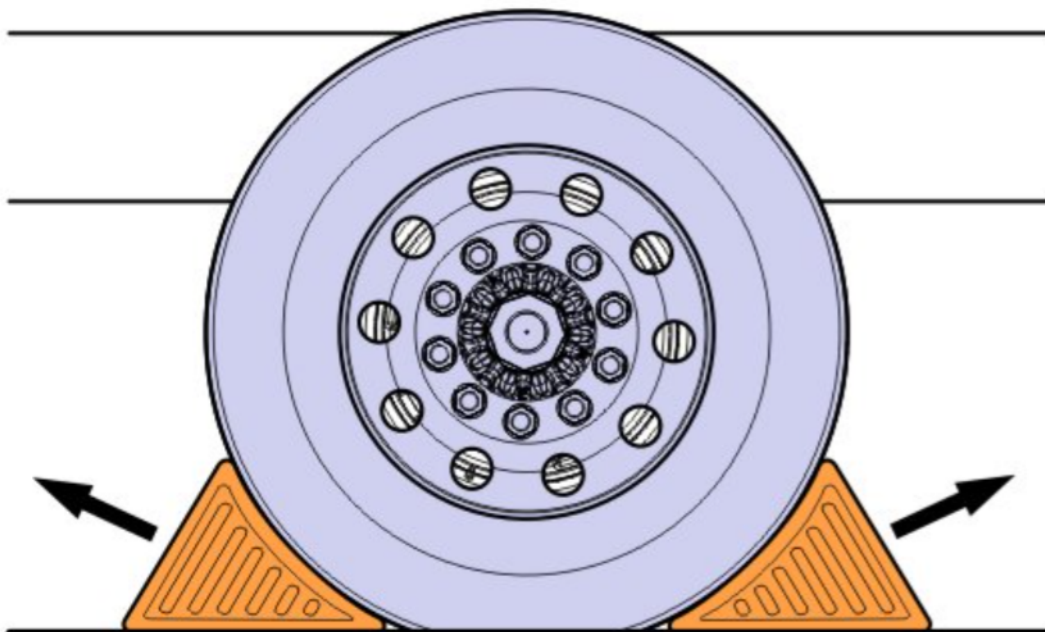
14. When programming is complete, click Exit to return to Main Menu to program the ACM.
15. When all programming is complete, clear any diagnostic trouble codes (DTC) and Finish Work.
16. Remove the wheel chocks.

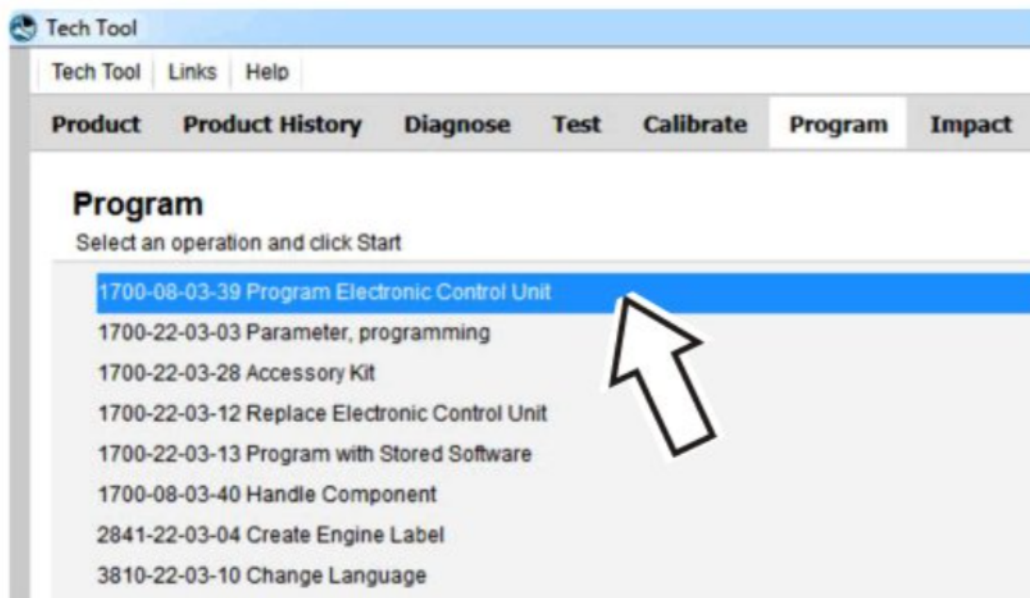
9. From the Main Menu select Program and then Program Electronic Control Unit 1700-08-03-39. Then click Start.

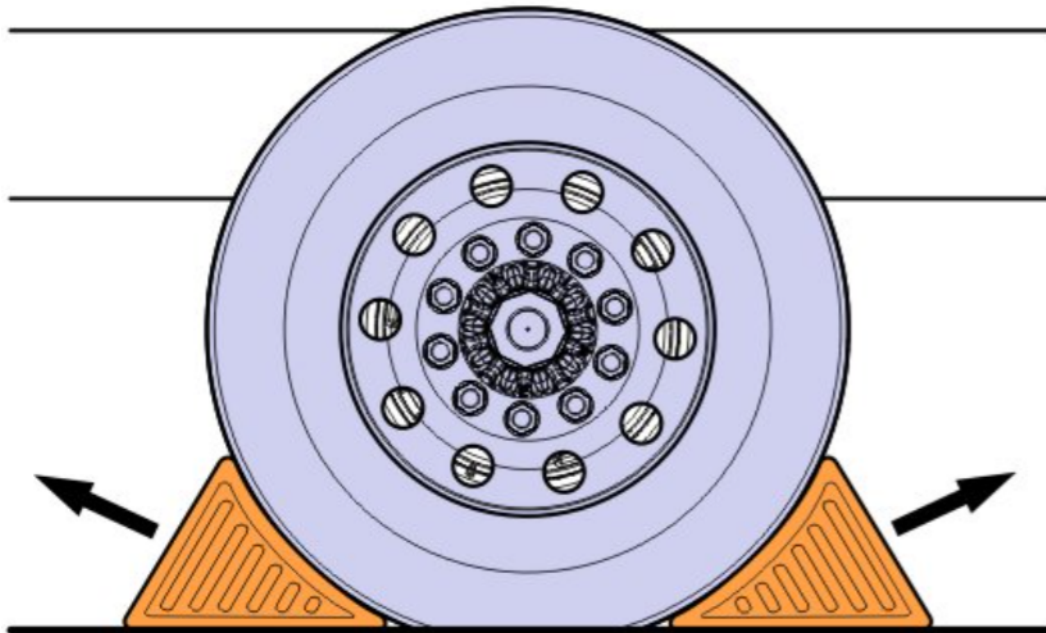
14. When programming is complete, click Exit to return to Main Menu to program the ACM.
15. When all programing is complete, clear any diagnostic trouble codes (DTC) and Finish Work.
16. Remove the wheel chocks.
