Classification:
AN20-026C

SOFTWARE UPDATE FOR INFOTAINMENT ISSUES

APPLIED VEHICLES: 2020-2021 Q50 (V37)
2020-2021 Q60 (CV37)
2020-2021 QX50 (J55)

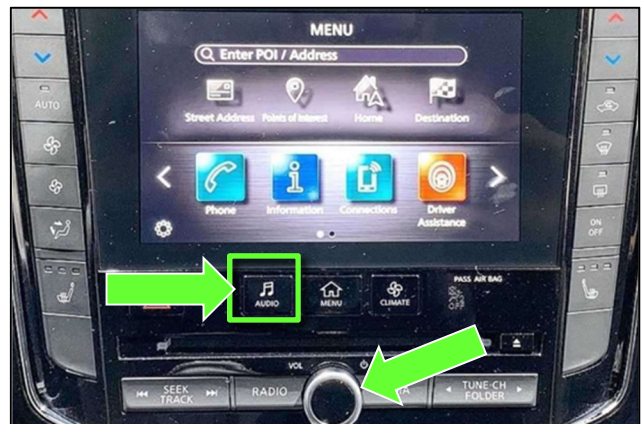
Figure 2

1. Press and hold the **AUDIO** button, and at the same time rotate the volume knob left and right until the **System Diagnostic Menu** displays (Figure 2 and Figure 3).

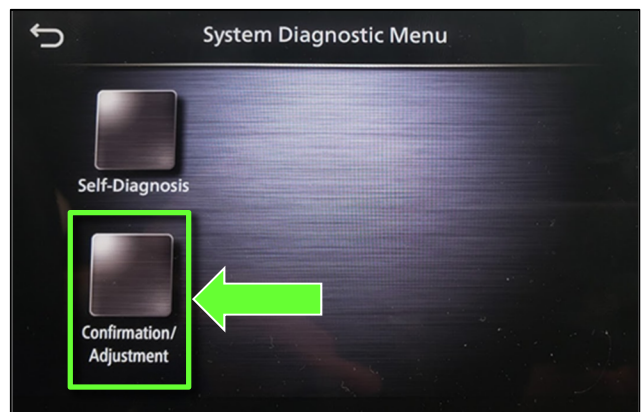
Figure 3

2. Select **Confirmation/Adjustment**.

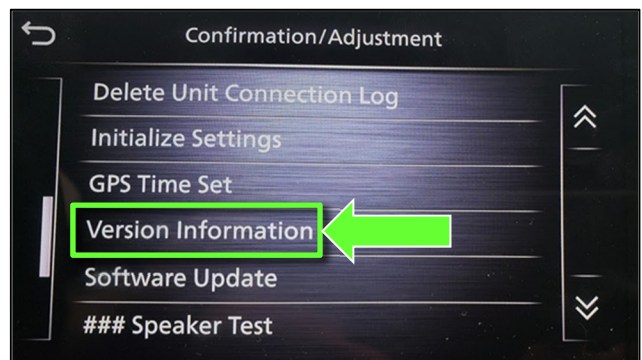
Figure 4

3. Scroll down and select **Version Information**.

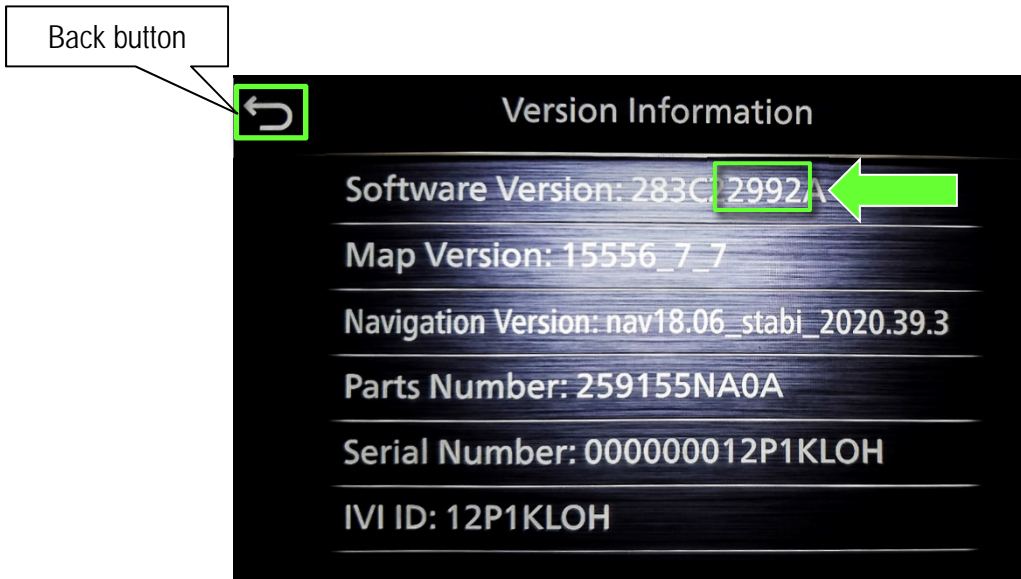
Figure 5

4. Confirm the **Software Version** number (Figure 5).

- If the Software Version (digits 6-9 as shown in Figure 5) is **lower** than xxxxx**2992**x, select the back button and continue to step 5 on the next page.
- If the Software Version is xxxxx**2992**x or higher (digits 6-9), select the back button; this bulletin does not apply. Refer to ASIST for further diagnostic information.

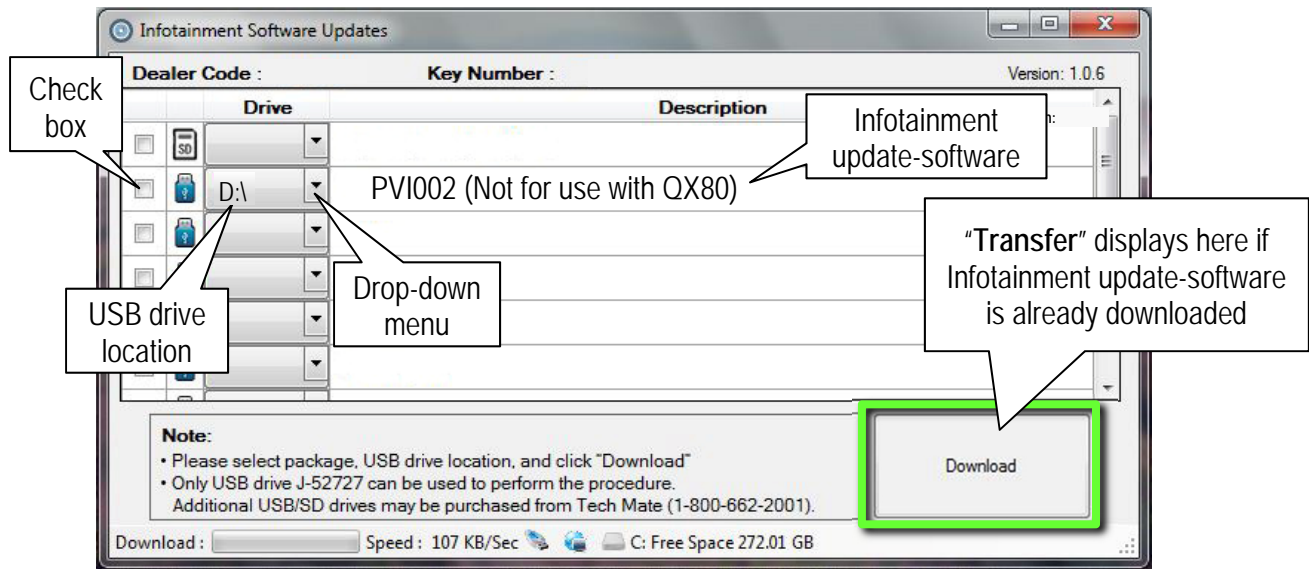
8. Select the check box next to the **PVI002 (Not for use with QX80)** infotainment update-software (refer to Figure 7 below).
 - If the **PVI002 (Not for use with QX80)** infotainment update-software has already been downloaded, **“Transfer”** will be displayed instead of **Download** when the infotainment software update box is checked.
9. Use the drop-down menu to select the location of the USB drive that was inserted in step 5 on page 5.

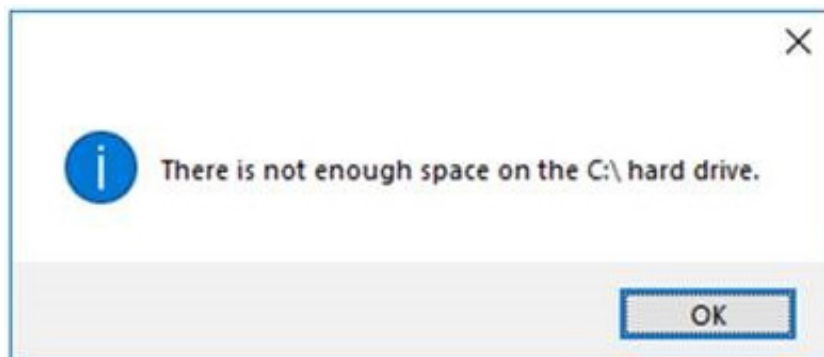
Figure 8

- The update is estimated to take **6 hours** to download to the USB drive.
- If while attempting to download the update-software to the CONSULT PC, you receive the message shown in Figure 8:
 - a. First attempt to clear space on the CONSULT PC hard drive (40 GB required).
 - b. If space cannot be cleared and a second CONSULT PC is available with space, use it and start over from step 5.

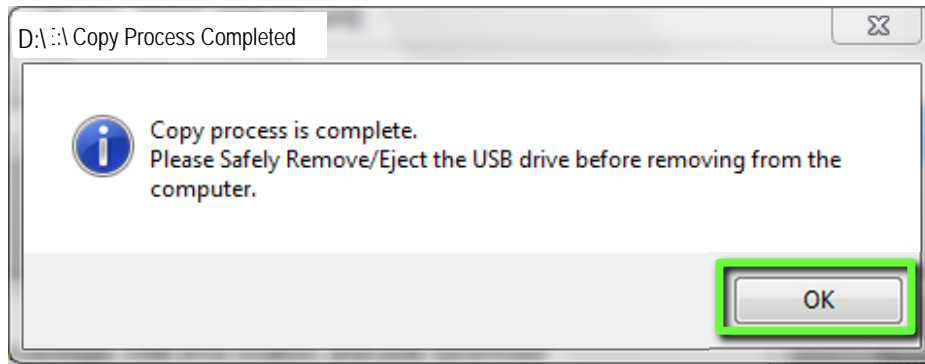
Figure 9

11. Select **OK**.

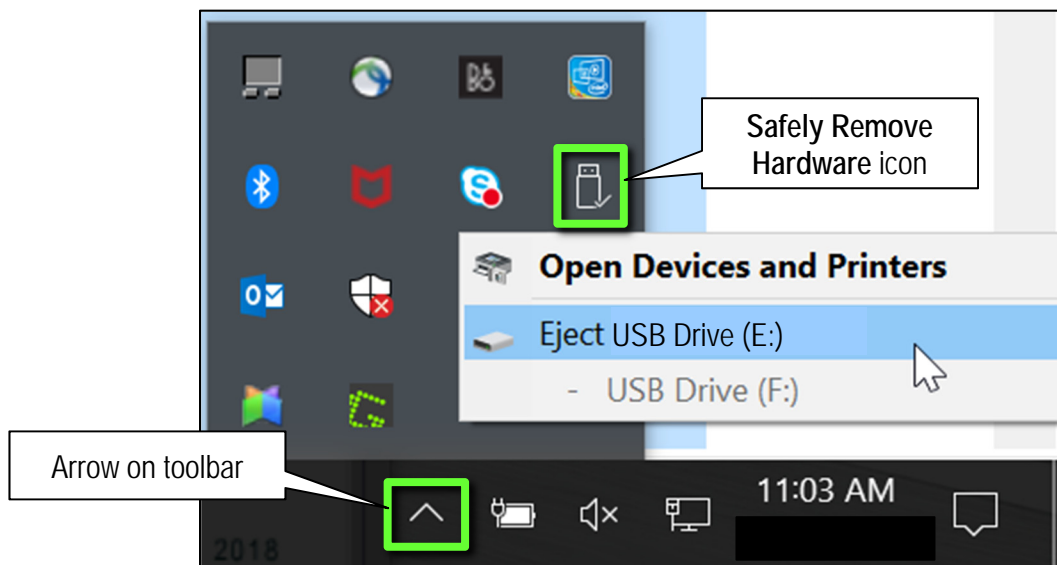
Figure 10

12. Once the transfer is complete, safely remove the USB drive from the CONSULT PC.

- a. From the PC toolbar, select the **Safely Remove Hardware** icon.
 - o The icon is on the toolbar, or can be found after selecting the arrow.
- b. Select the USB drive to be removed, and then remove the USB drive from the CONSULT PC.

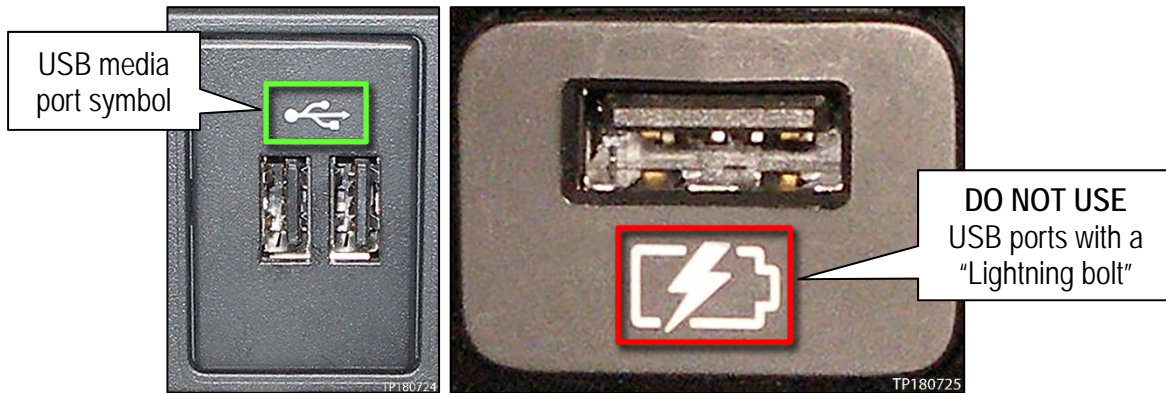
Figure 11

16. Insert the USB drive with infotainment update-software into the vehicle's USB media port (Figure 11).
- Do not remove the USB drive during the update to the vehicle until instructed.

HINT: Charging ports are marked in the vehicle with a "lightning bolt" symbol.

Do not insert the USB drive into a charging port. If used, the update-software and/or USB drive may become damaged. Only insert the USB drive in a USB media port.

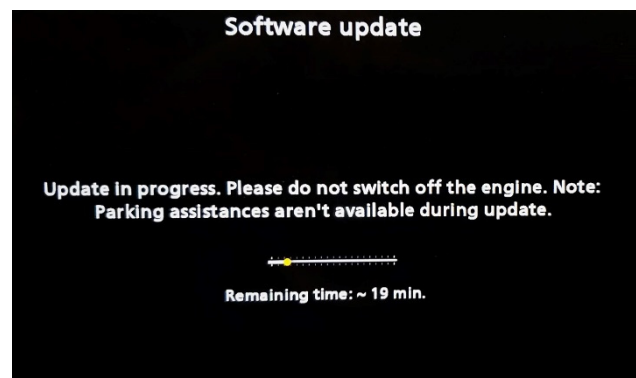
Figure 13

17. Wait for the update to complete.
- Follow the on-screen instructions while waiting.

HINT: The update lasts 15-25 minutes.

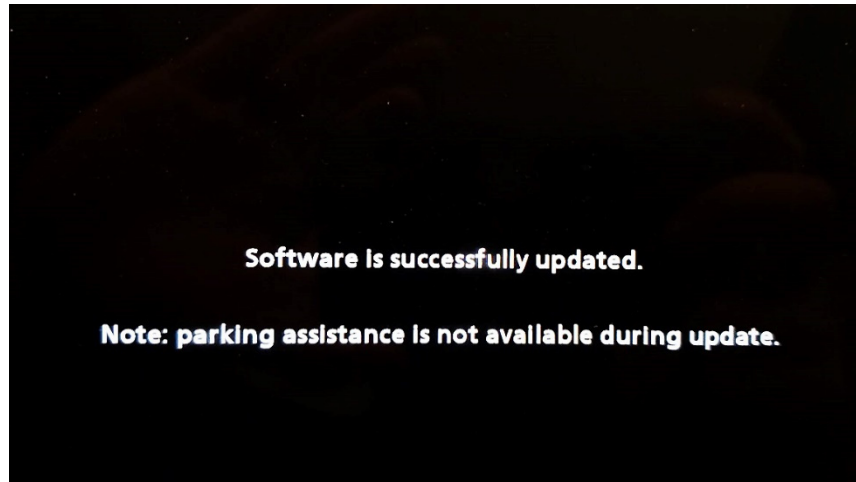
Figure 14

18. Once the update is complete (Figure 14), remove the USB drive; the system will reboot (restart).
HINT: The system will not reboot until the USB drive is removed.

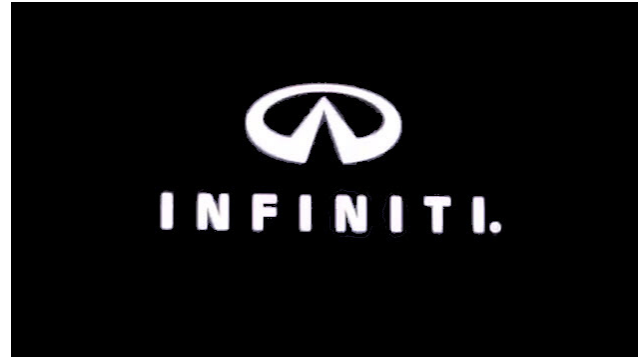
Figure 16

19. Allow the reboot to complete (approximately 30 seconds).
 - The Infiniti logo will be displayed during the reboot.
20. Turn the ignition OFF.

23. Turn the ignition ON (engine OFF) and wait for the Infiniti logo to appear (Figure 16).
 - If the Infiniti logo does not appear (this might take up to 30 seconds), start over from step 20.

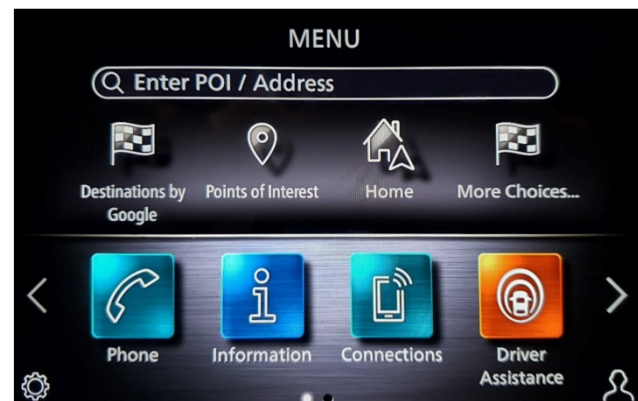
24. After the Infiniti logo appears, wait about 1 minute.
 - The MENU (Home) screen in Figure 17 will be displayed.
