HA21-007

## A/C INOPERATIVE WITH DTC B20C8-14 STORED IN THE IPDM E/R

**APPLIED VEHICLES:** 2022 QX60 (L51)

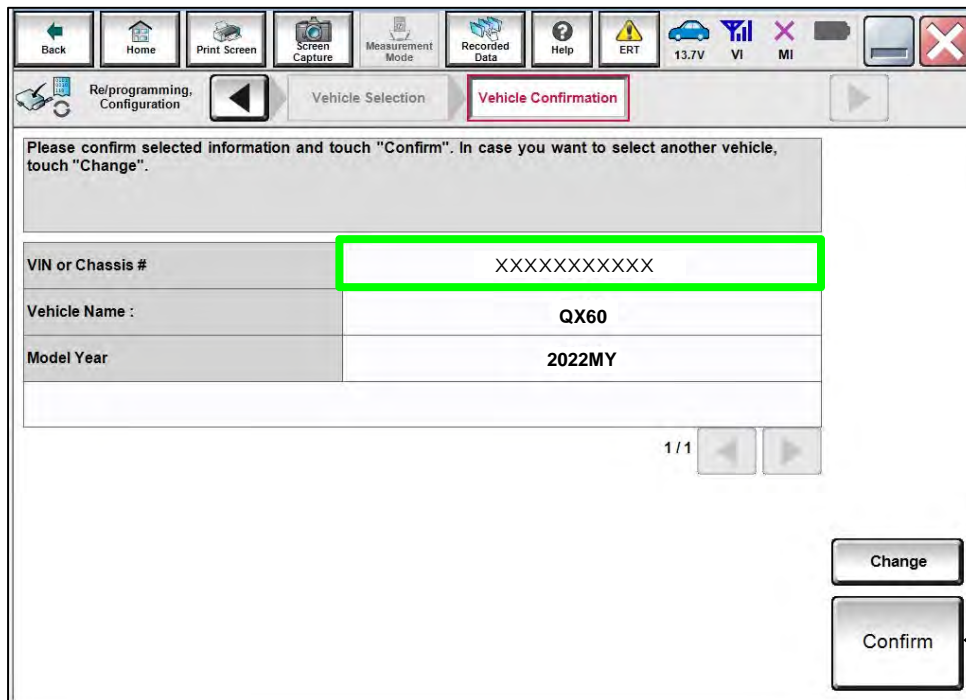
Figure 4

8. Confirm the VIN or Chassis # is correct, and then select Confirm.
