SERVICE BULLETIN

Classification: AN21-019A	Reference: NTB21-085A	Date: February 1, 2022
------------------------------	--------------------------	---------------------------

SOFTWARE UPDATE FOR INFOTAINMENT ISSUES

APPLIED VEHICLES: 2021 Rogue (T33)
APPLIED GRADES: S grade only

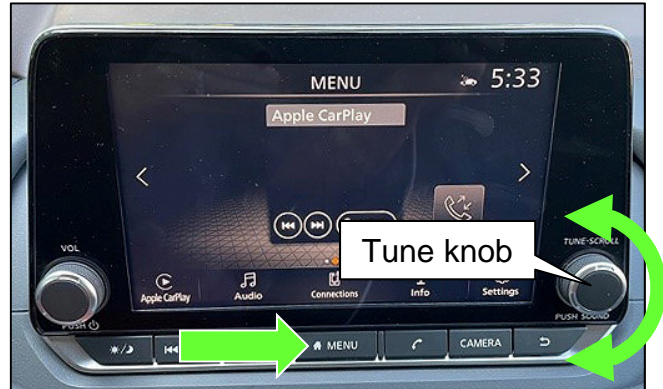
Figure 2

1. While holding the menu button down, turn the tune knob left-right-left.

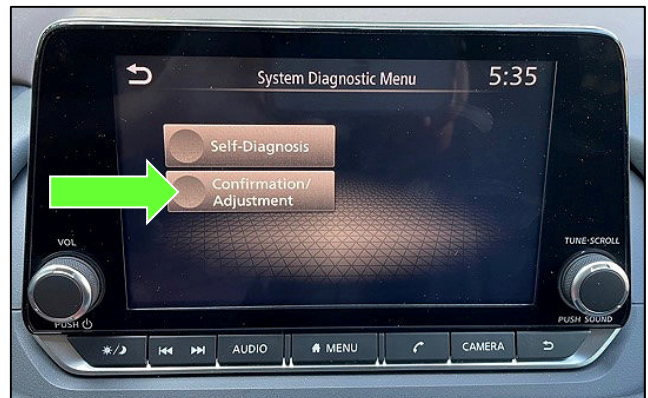
Figure 3

2. Select **Confirmation/Adjustment**.

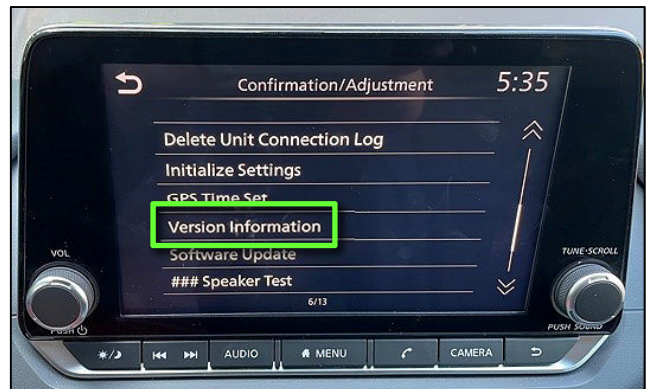
Figure 4

3. Select **Version Information**.

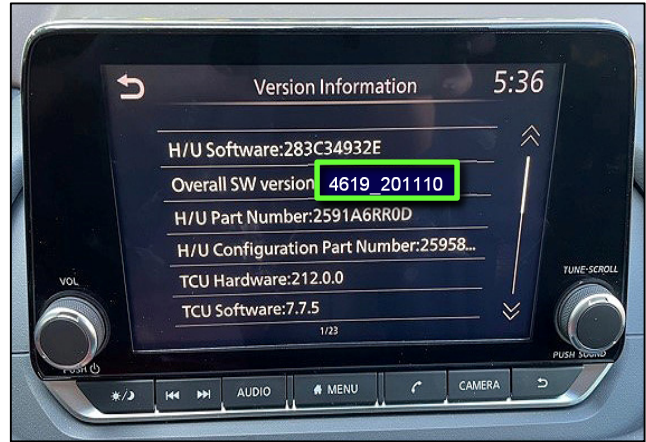
Figure 5

4. Confirm if the "Overall SW version" is 4619.

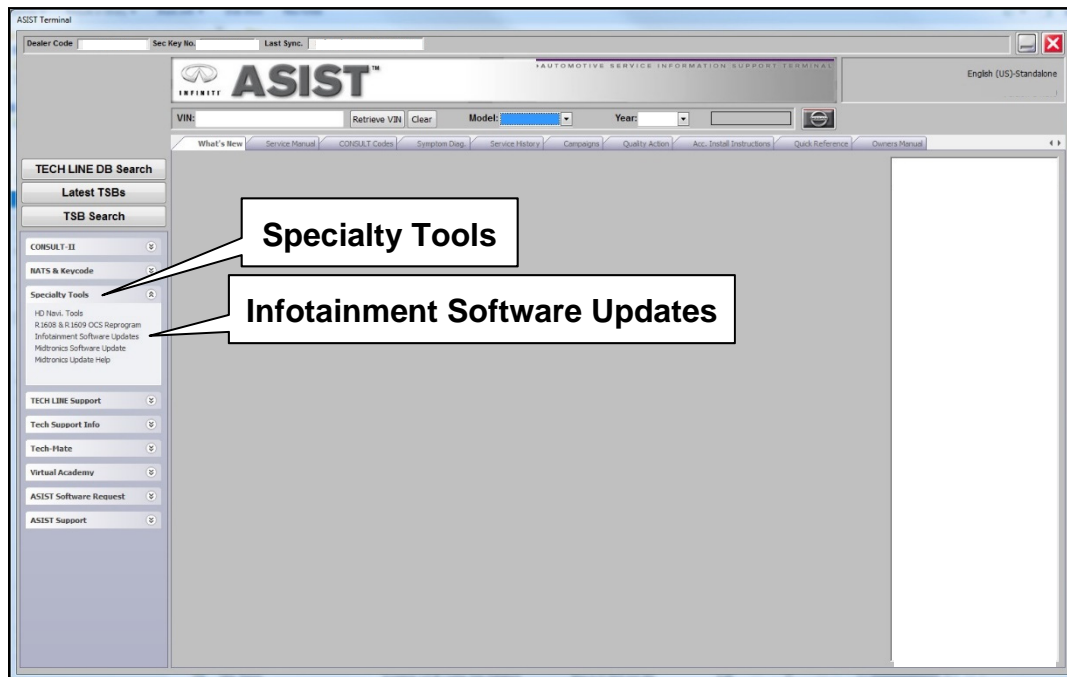
Figure 7

7. Select **Specialty Tools**, and then select **Infotainment Software Updates**.
