Service Action

Code: 91DE

Subject Connected Services (OCU3 High Module) Software Update

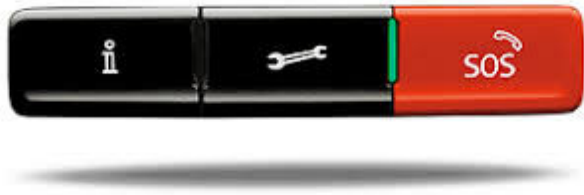
- Observe the status of the overhead light.

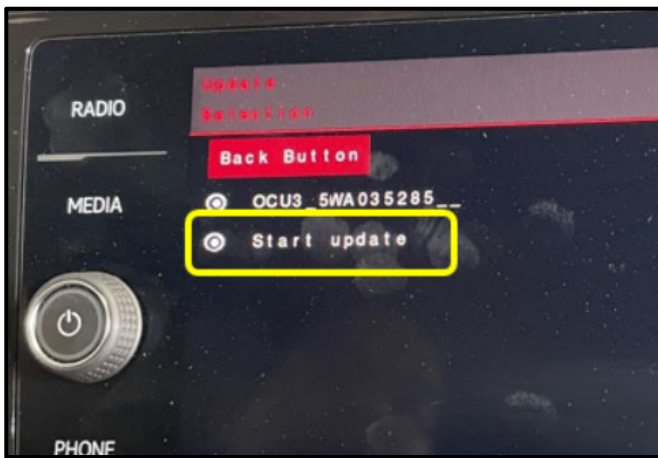
- Select "Start Update."

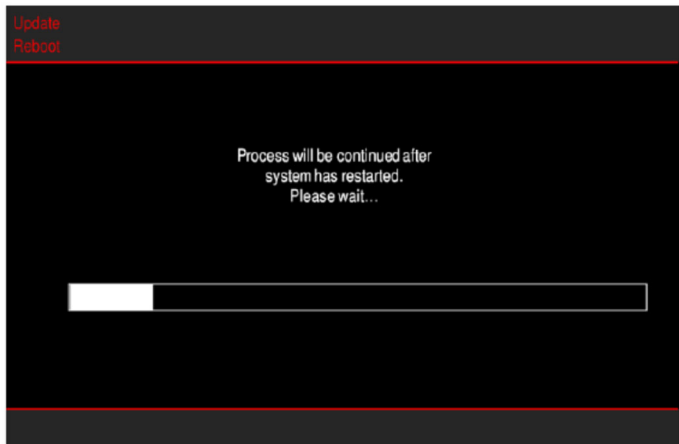
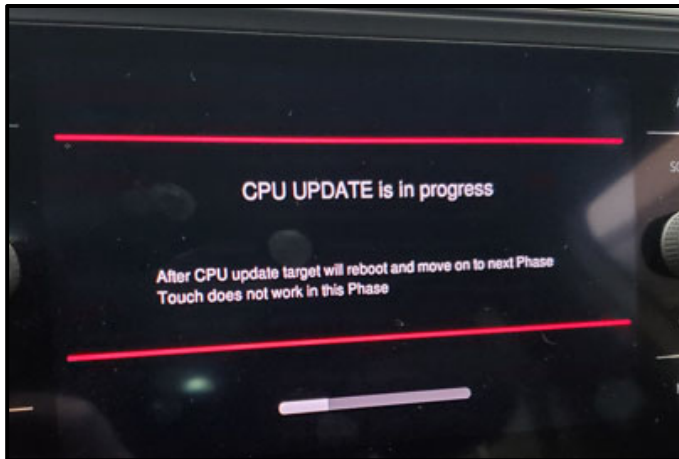
- Example Software Update progress screens shown here.

NOTE
The screen may go blank a few times during the update.
