# Technical Service Bulletin

SUBJECT:		No:	<b>TSB-22-54-002</b>
<b>SOFTWARE UPDATE FOR SMARTPHONE LINK DISPLAY AUDIO</b>		DATE:	<b>March 2022</b>
		MODEL:	<b>See below</b>
<b>CIRCULATE TO:</b>	<input type="checkbox"/> GENERAL MANAGER	<input checked="" type="checkbox"/> PARTS MANAGER	<input checked="" type="checkbox"/> TECHNICIAN
<input checked="" type="checkbox"/> SERVICE ADVISOR	<input checked="" type="checkbox"/> SERVICE MANAGER	<input checked="" type="checkbox"/> WARRANTY PROCESSOR	<input type="checkbox"/> SALES MANAGER

A software update is now available for the Smartphone Link Display Audio (SDA). This update resolves several issues that may occur in various models equipped with SDA, as listed below.

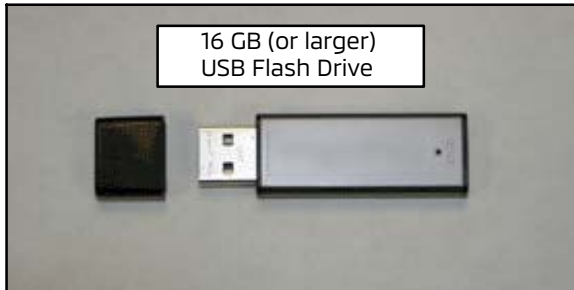
A USB version 2.0 standard flash drive (thumb drive) with a **minimum capacity of 16.0 GB**, formatted to FAT32 is required for this procedure. Formatting to FAT32 will erase all data from the flash drive. The flash drive must have no other files or folders saved to it.

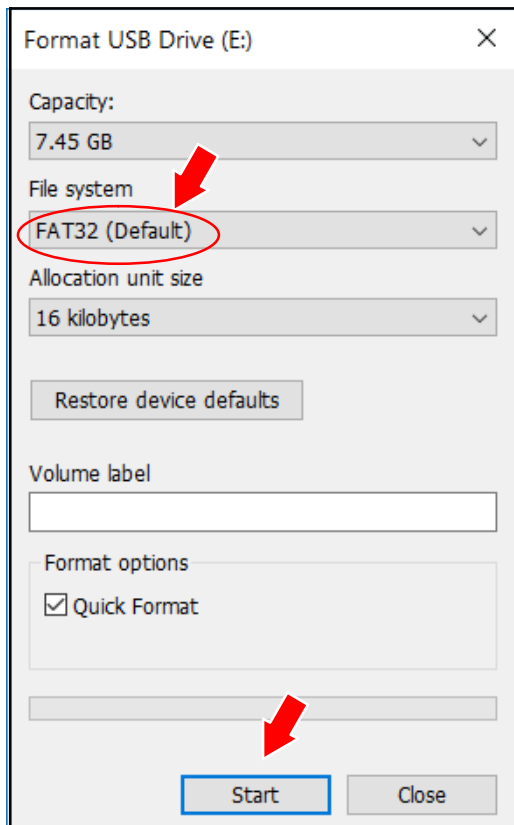
- d. Select "FAT32" in the list for "File system" and press "Start."

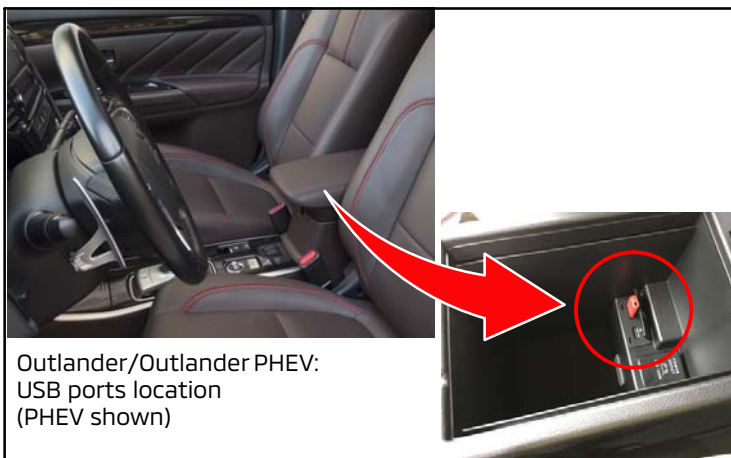
1. **For Outlander and Outlander Sport / RVR vehicles:** Turn vehicle ON, and keep the engine idling for the entire update procedure.  
**For Outlander PHEV:** Put vehicle in READY mode for the entire update procedure.
2. Plug in the USB flash drive containing the **CORRECT software update file\* for that vehicle** into the vehicle's USB port (either port may be used for the update).  
**\*Refer to step 4 of "B. Transfer Files to USB Flash Drive" in this TSB for correct file identification.**
  - For Outlander and Outlander PHEV, two USB ports are located inside the center console.
  - For Outlander Sport / RVR, two USB ports are located in the front lower dash.

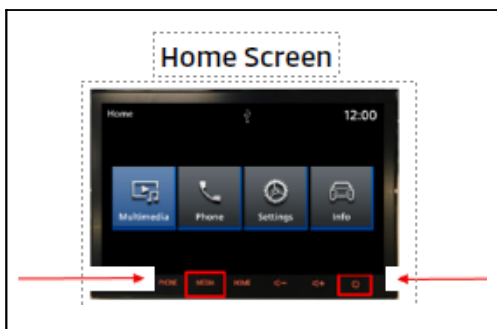
3. Before starting the update process, confirm the current software version.
  - a. Push both [MEDIA] + [ ⏻ ] at the same time and hold for 5 seconds.

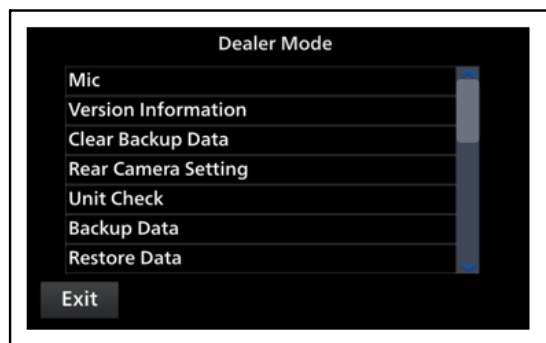
- b. The Dealer Mode screen will appear. At this screen, push and hold the HOME button for 5 seconds (shown below).

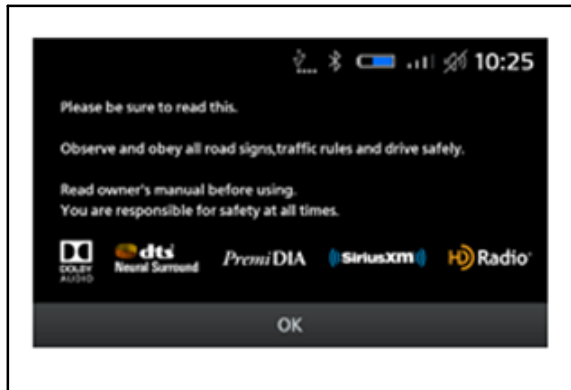
- a. ACC on.
- b. Press "OK" and wait for the Home Screen to appear.

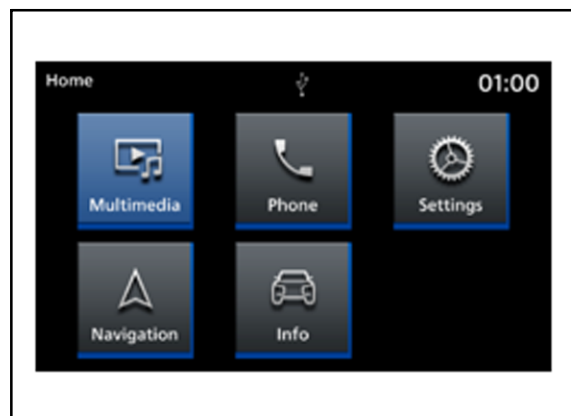
- c. Insert USB flash drive into the vehicle USB port.
- d. The software auto update will begin. If the software update doesn't start automatically, please push "OK" on the disclaimer screen.

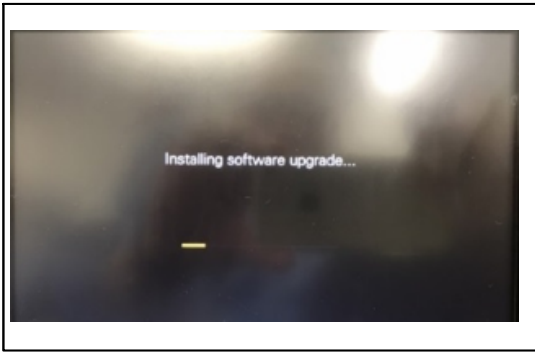
g. This screen will be displayed for about 13 minutes.

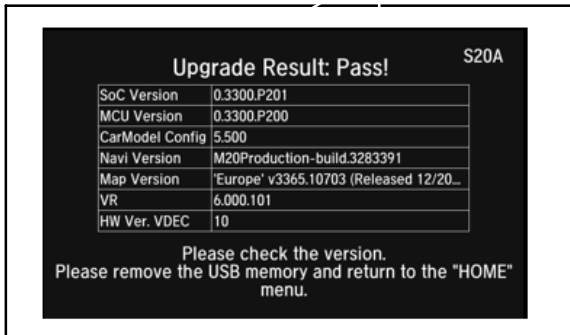
i. When "Update result: Pass!" appears, the update is complete the USB flash drive may be removed. The home screen will then return.

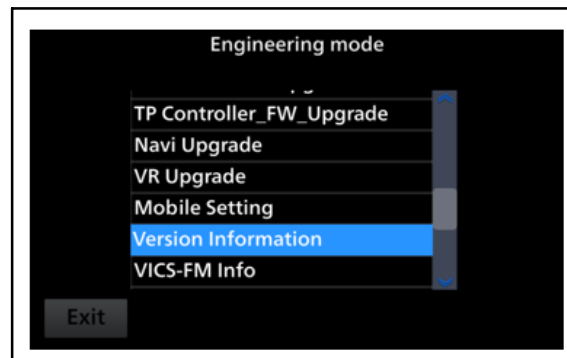
5. Scroll down to "Version Information" and push "Version Information".
