Emissions Service Action

Code: 24EF

Subject Engine and/or Transmission Control Module Software

Release Date April 8, 2022

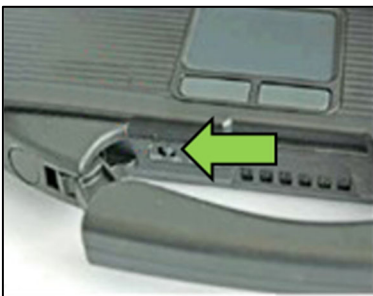
- ✓ **The Bluetooth function of the scan tool is physically switched off <see pictures below>.**

VAS 6150 & VAS 6150A
(Front panel behind handle)
