# MIL ON With DTC P059A71

YEAR(S)	MODEL(S)	ADDITIONAL INFORMATION
2022	Tundra

Some 2022 model year Tundra vehicles may exhibit a MIL ON condition with the Diagnostic Trouble Code (DTC) P059A71 (Active Grille Air Shutter “A” Actuator Stuck) present. The Engine Control Module (ECM) (SAE term: Powertrain Control Module/PCM) logic has been modified to reduce the possibility of this condition. Follow the Repair Procedure in this bulletin to address this condition.

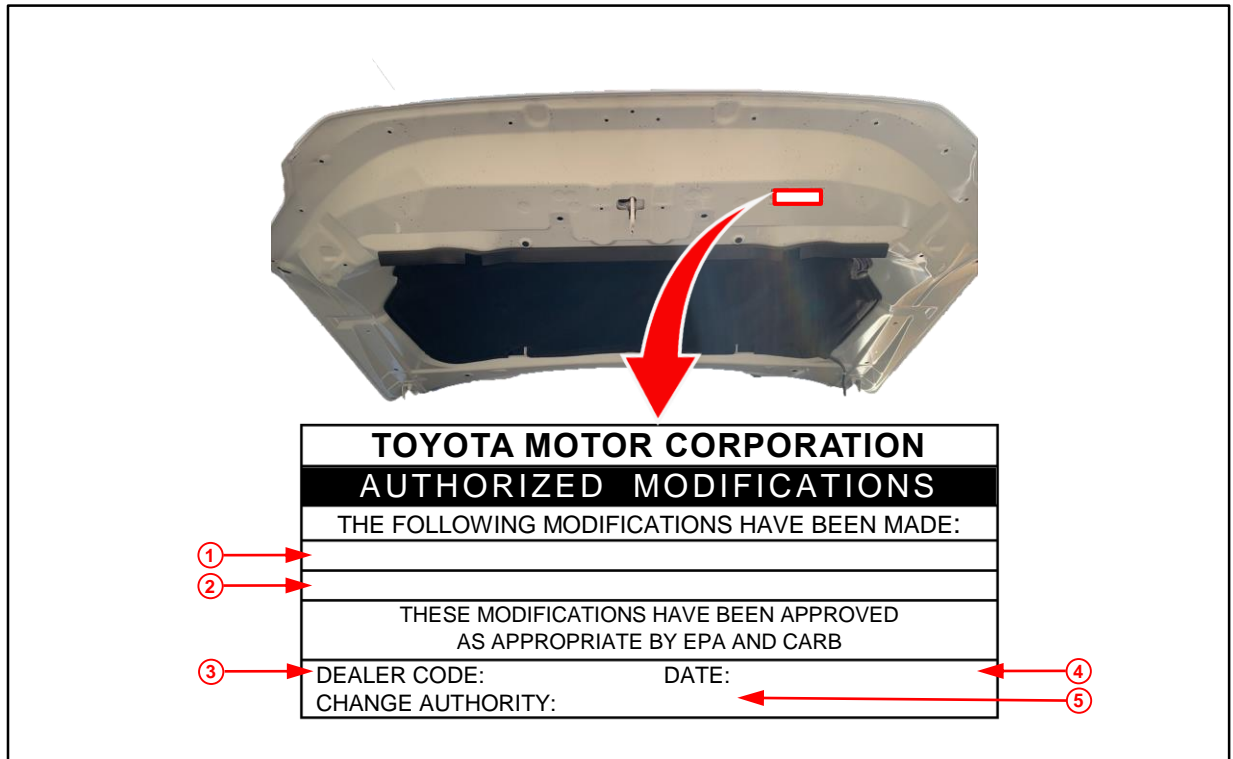
**Figure 1. Location of Authorized Modifications Label on 2022 Tundra**

<b>1</b>	Replacement ECM (PCM) Part Number (e.g., 89661-0C###)
<b>2</b>	New Calibration ID (e.g., 896630CR7101)
<b>3</b>	Dealer Code

<b>4</b>	Date Completed
<b>5</b>	This SB Number

- Prepare and install the Authorized Modifications Label.
  - Using a permanent marker, enter the following information on the label:
    - ECM (PCM) part number [*Refer to the **Parts Information** section for the **NEW PART NUMBER***]
    - Calibration ID(s) [*Refer to the **Calibration Information** section for the **NEW CALIBRATION ID***]
    - Dealer Code
    - Repair Date
    - Change Authority [***This bulletin number***]
  - Install the Authorized Modifications Label onto the vehicle at the location shown in Figure 1. The Authorized Modifications Label is available through the MDC, P/N 00451-00001-LBL.
- Test-drive the vehicle to confirm proper operation.
