TECHNICAL INSTRUCTIONS

22TC01

DATA COMMUNICATION MODULE (DCM) REPROGRAMMING

2021 MODEL YEAR C-HR, RAV4 PRIME, TUNDRA

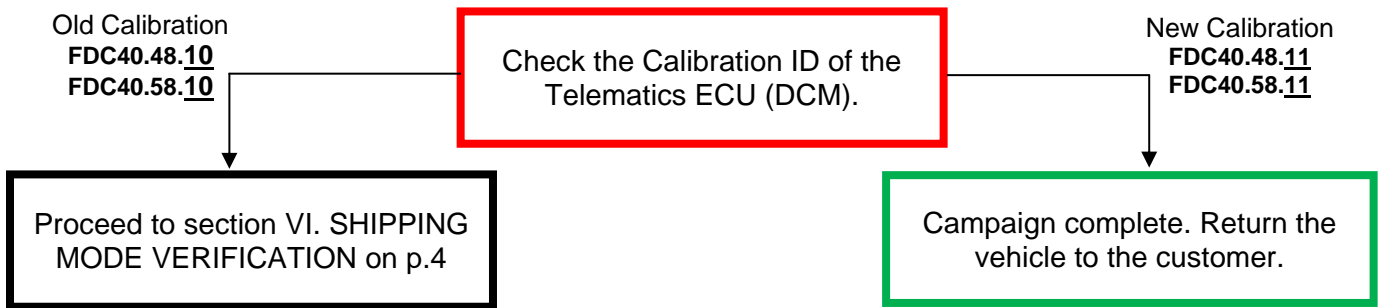
- Locate the Calibration column for the Telematics in the Stored Data tab for this vehicle.
- Check the Calibration ID of the Telematics ECU (DCM).

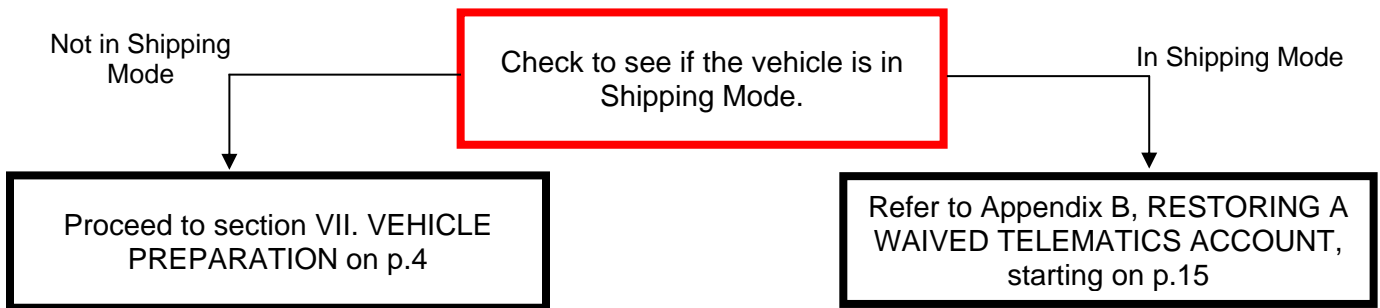
- Select the "System Select" tab at the top left of the screen, select "Telematics" and click the right-arrow.
- Select "Data List."
- Check to see if the Telematics Activation Status value is "Shipping."

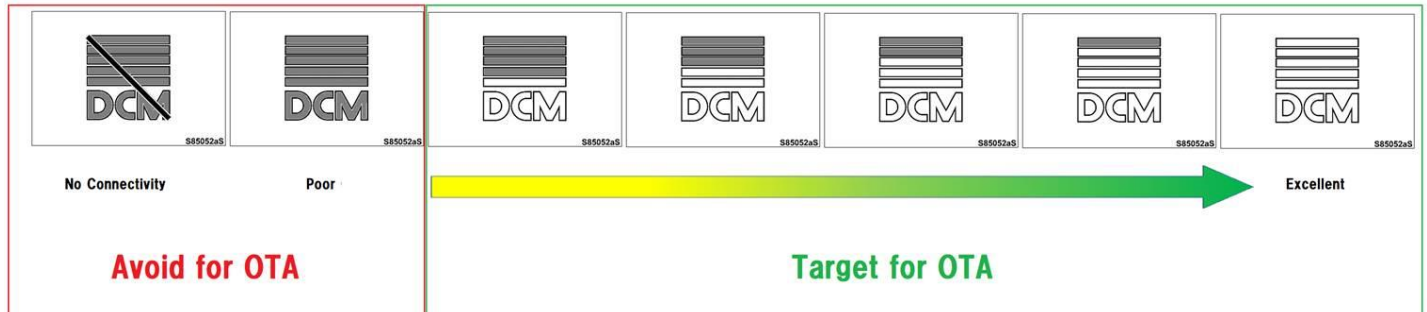
- a) Confirm that the DCM signal reception level shown in the upper right corner of the head unit display is not out of range. If the display shows poor or no connectivity, move the vehicle to another safe location with adequate signal reception.

- Refer to the image below for target signal reception.
- Full signal is not required but you must have at least one bar.

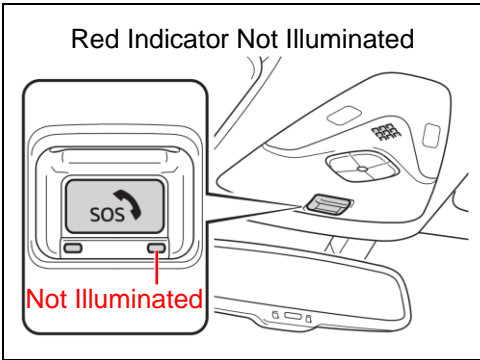
- a) Confirm that the red indicator next to the SOS button is not illuminated. If the red indicator remains illuminated for longer than 2 seconds after IG-ON, there is a problem with the system that must be resolved before continuing.

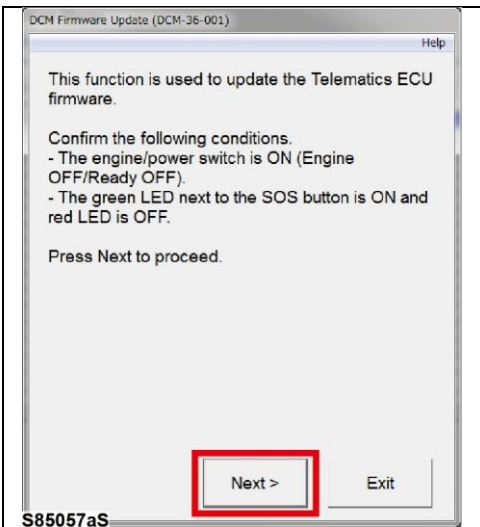
- d) Click “Next”.

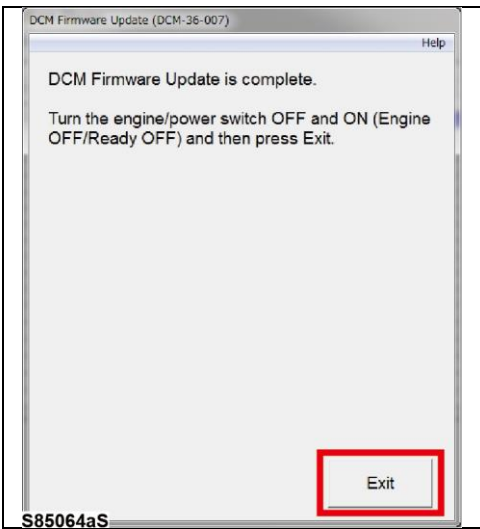
g) Turn the IG ON, then OFF, then ON, then click “Exit”.

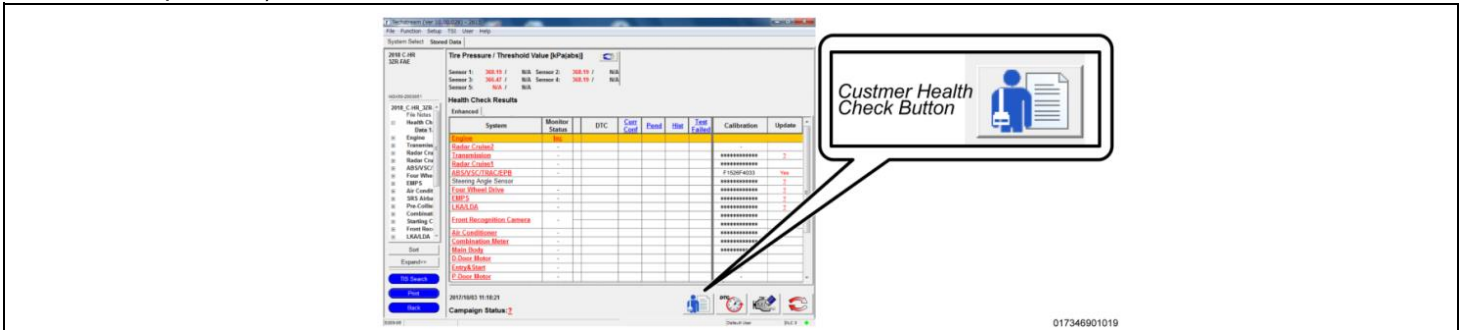
- a) From the Stored Data tab, select the Customer Health Check Report button (TIS will launch when button is pressed).

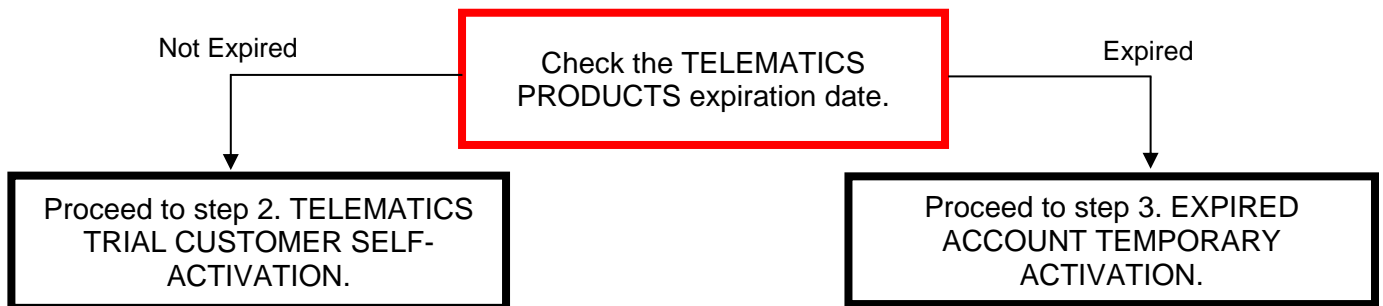
- Navigate to <https://one.tis.toyota.com/serviceLane/>.
- Enter the VIN in Vehicle One-View and click Search.
- Scroll down to the Telematics tab and check the expiration date of TELEMATICS PRODUCTS.
