AN22-009

March 31, 2022

ENABLING WIRELESS APPLE CARPLAY® FEATURES

APPLIED VEHICLES: 2020-2021 Q50 (V37)
 2020-2021 Q60 (CV37)
 2020-2021 QX50 (J55)

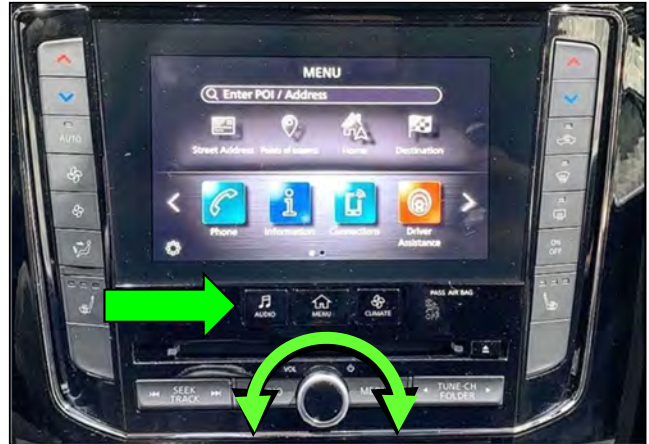
Figure 2

1. Press and hold the **AUDIO** button while, at the same time, rotating the volume knob left-right-left.

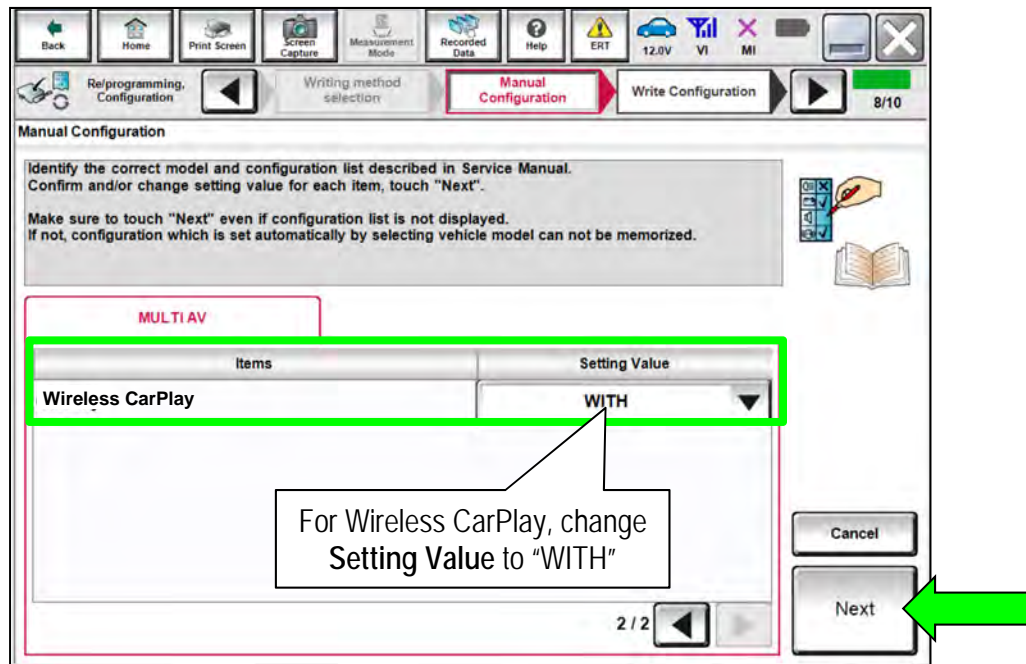
Figure 27

42. Use the drop down menus to select the configuration options that were printed or written down in step 38 on page 14, and then select **Next**.

IMPORTANT: The default **Setting Value** for **Wireless CarPlay** is "WITHOUT". Be sure to change this **Setting Value** to "WITH" (Figure 27).
