Volvo Chassis - Bendix ABS6 TO ABS8 Service Information

Changes to the Bendix ABS System Affecting ESP Control Unit Configuration

Configuration of Replacement Electronic Control Unit for Bendix® Antilock Brake System with Electronic Stability Program (ESP)

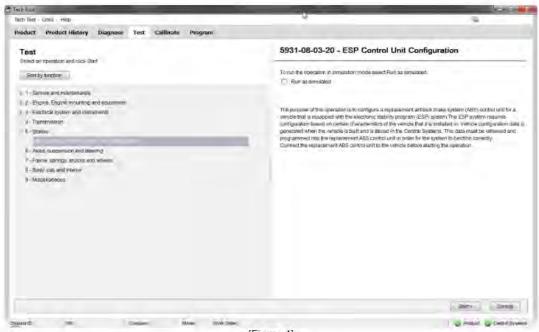
[Figure 4]

After performing the actions outlined in the Preparation section above, connect the PC to the vehicle's diagnostic connector and complete the vehicle identification process displayed in Tech Tool's 'PRODUCT' tab. (Make sure that the PC has the possibility to connect to Central Systems via a network/internet connection). Select the "TEST" tab and expand group '5 – Brakes' and open the 'ESP Control Unit Configuration' operation. [see figure 4]

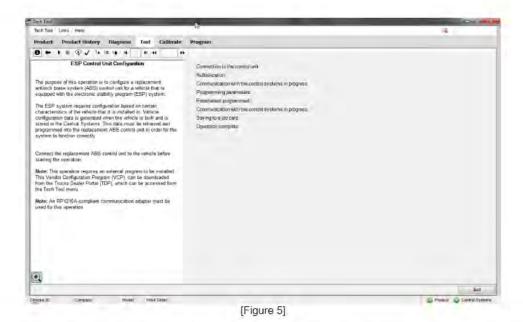
The ESP Control Unit Configuration operation is structured as a checklist of actions, similar to control unit software programming operations. [see figure 5]

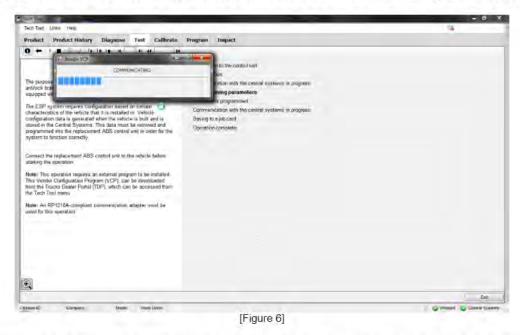
After the ESP system configuration file is downloaded, a configuration window containing a status bar will appear while the ESP control unit is configured. [see figure 6]

<u>Note</u>: On some occasions, the status bar window may appear blank. Although it appears that no action is occurring, the process is proceeding. In this case, allow the process to continue. The ABS ECU will be restarted and the configuration window will disappear when its task is complete and the process will continue in the main operation window.
