Service Bulletin

Bulletin No.: 21-NA-187

Subject: Unable to Set PIN to Enable Teen Driver Feature

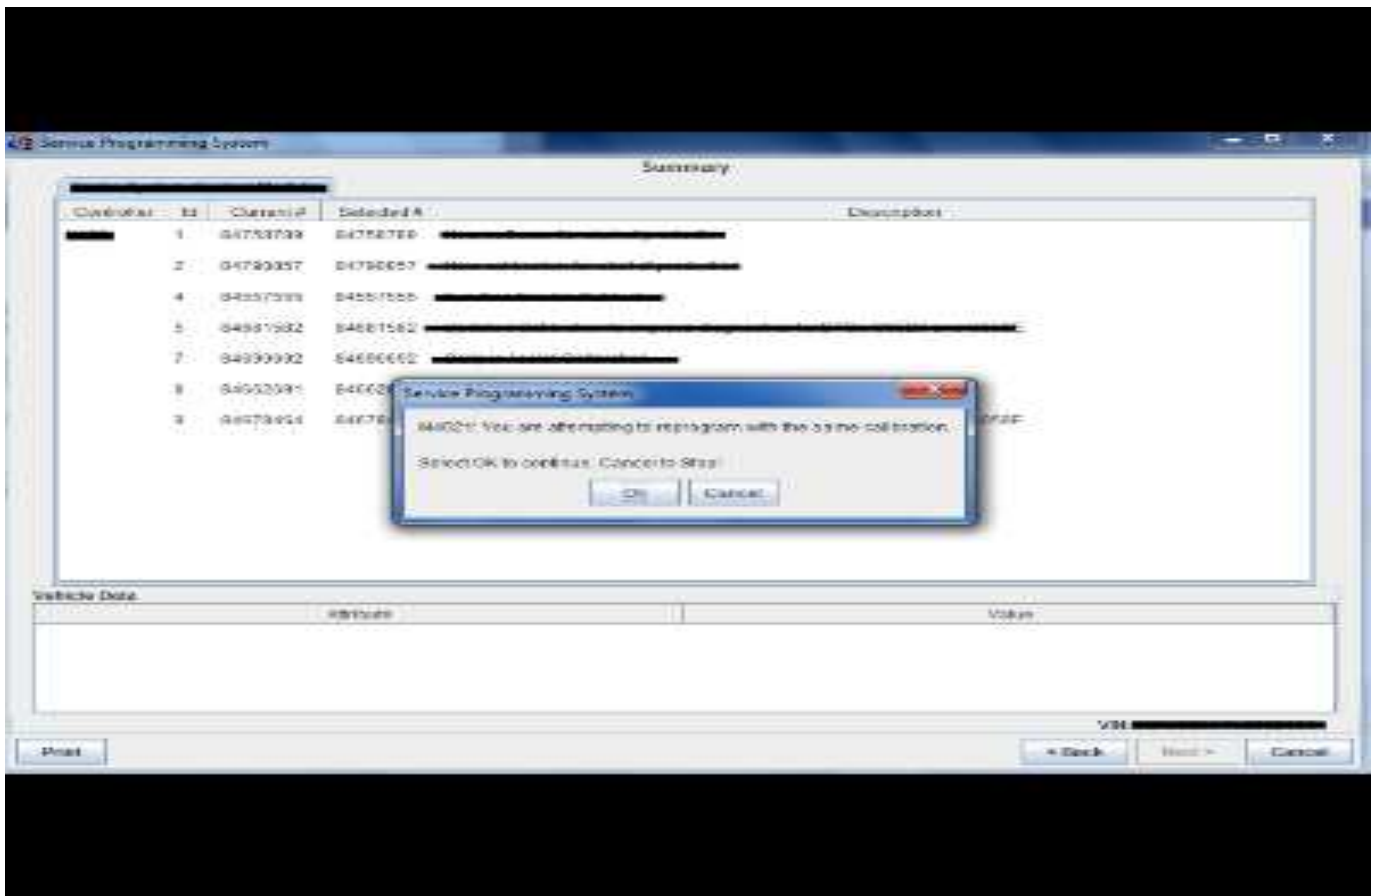
5431207

Important: Techline Connect and TIS2WEB screens shown above.

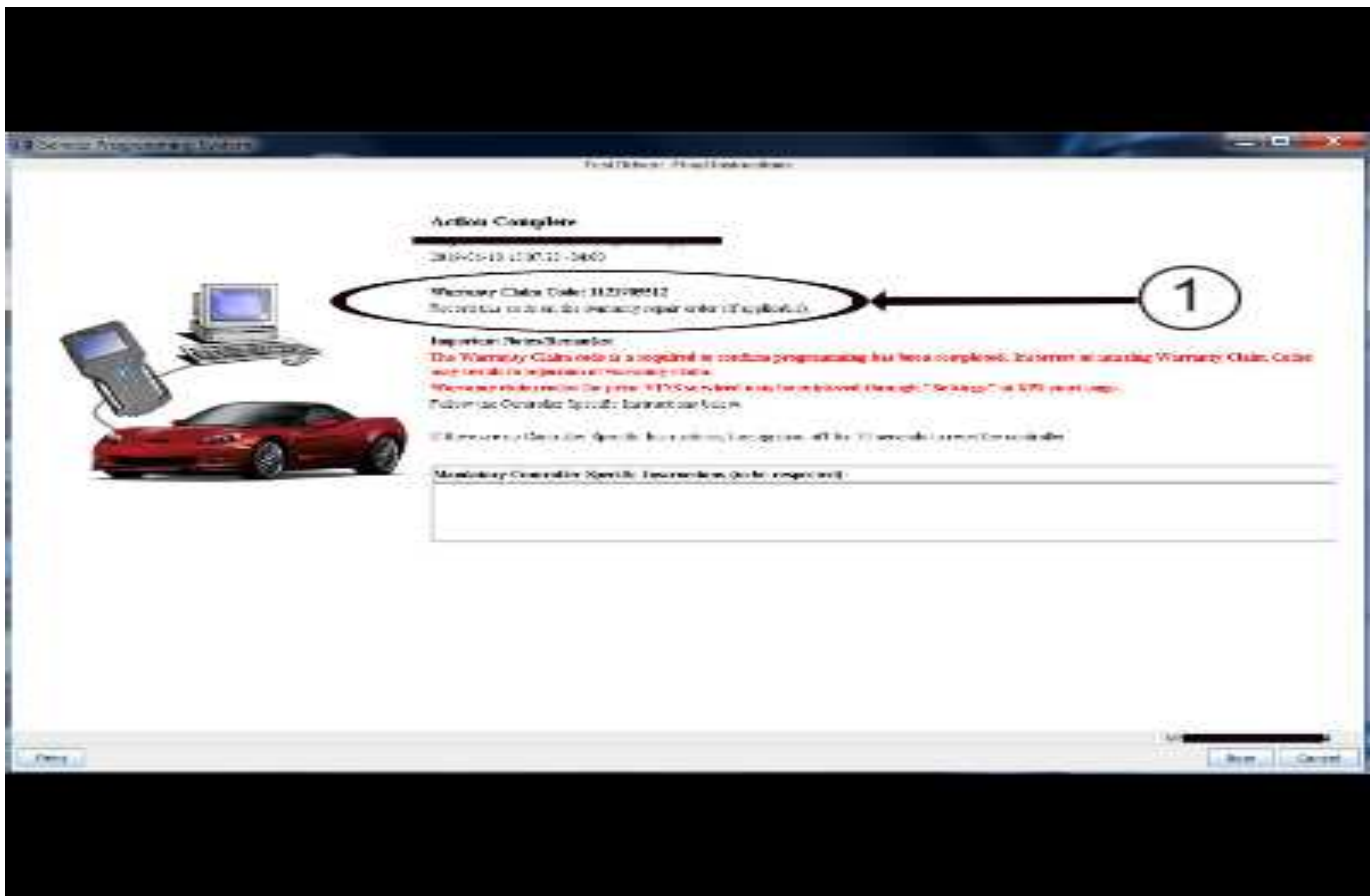
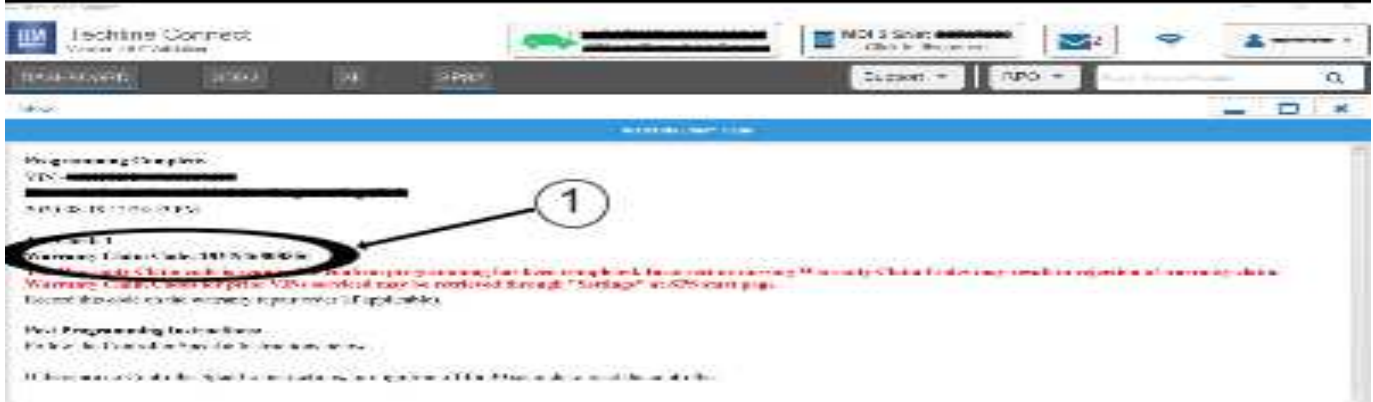
5431209

Note: The screenshots above are an example of module programming and may not be indicative of the specific module that is being programmed. Module selection and VIN information have been blacked out.
