Release Date	06/16/2022	Technical Service Bulletin	
9308 UPDATE

Audi
Service Package for Audi e-tron GT – (NVLW)

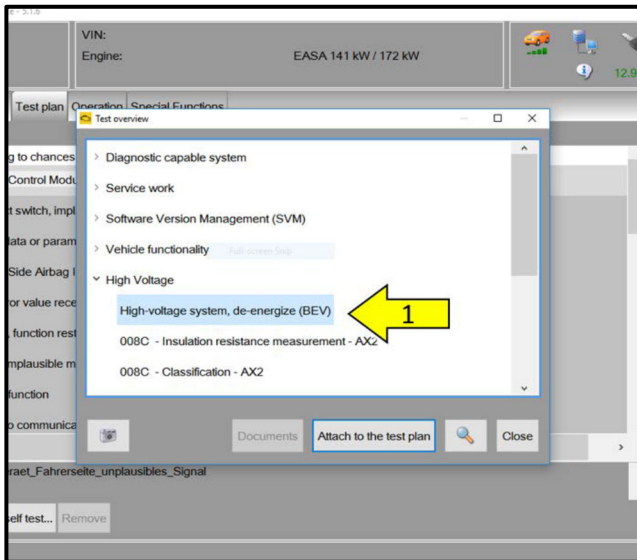
- Ensure that a high-voltage charger is not connected to the vehicle.
- De-energize high-voltage system:
 - Select and perform the “High-voltage system, de-energize (BEV)” test plan <1>.
 - Follow all of the test plan steps until the high-voltage system is successfully de-energized.
- Open the hood.
- Open the battery cover.
- Attach a battery charger **capable of minimum 90 Amp continuous supply** to the vehicle’s 12V battery or underhood charging posts.

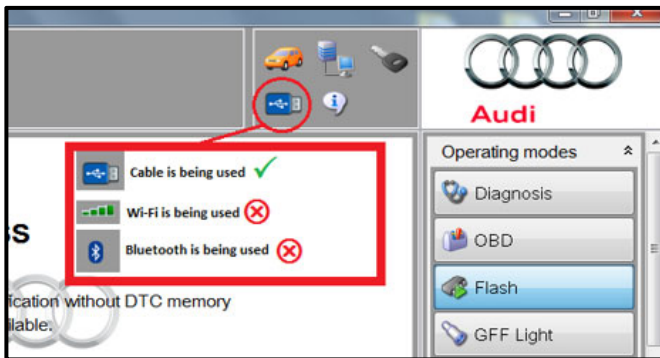
- Connect the VAS6150X/VAS6160X Diagnostic Tester to the vehicle.
- Start the ODIS program.
- Confirm that scan tool is communicating with the diagnostic head by USB cable.
 - If the Bluetooth or WiFi symbol is shown, then disconnect the diagnostic head from the vehicle and reconnect the USB cable to the diagnostic head and then reattach to the vehicle.

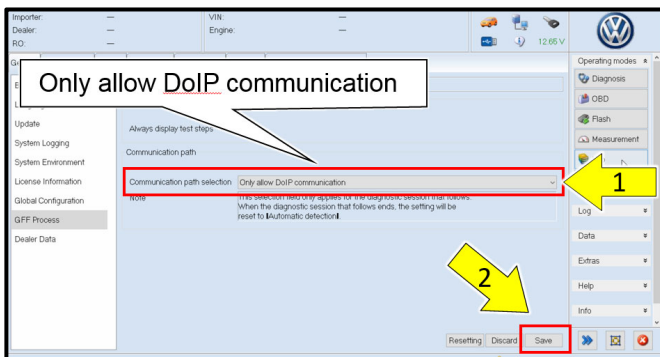
- From the “Communication path selection,” select “Only allow DoIP communication” <arrow 1>.
- Select “Save” <arrow 2>.

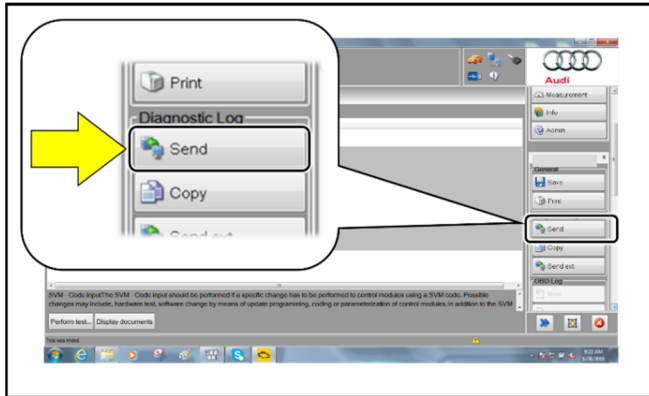
- After receiving confirmation that the flash completed successfully, select “Send” <arrow> to send the diagnostic protocol online.
- Follow the on-screen prompts.

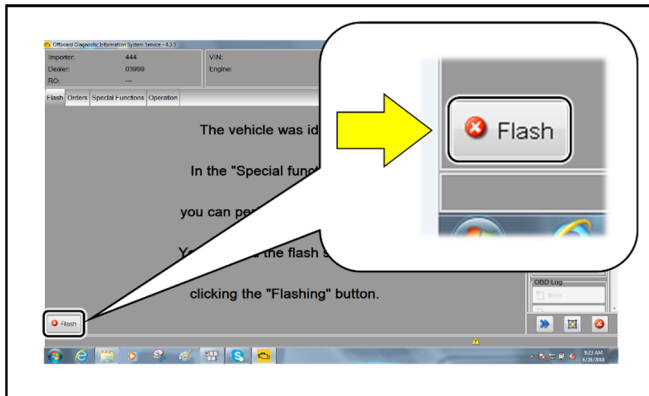
- Click “Flash” <arrow> to exit the flash session.

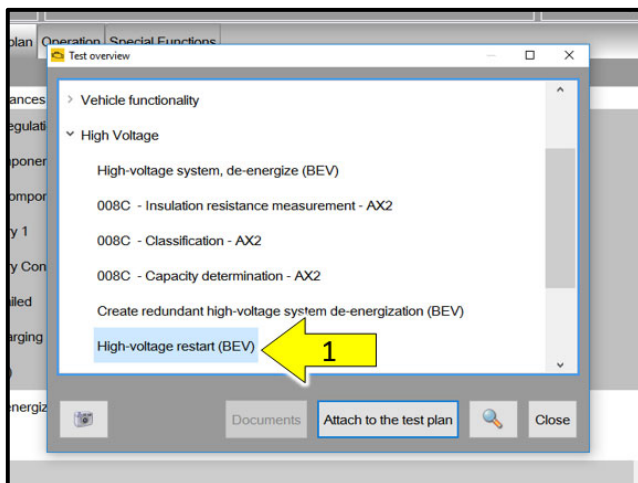
- Attach a 12V battery maintainer/charger.
- Select and perform the “High-voltage restart (BEV)” test plan <1>.
- Follow all of the test plan steps until the high-voltage system is successfully re-energized.

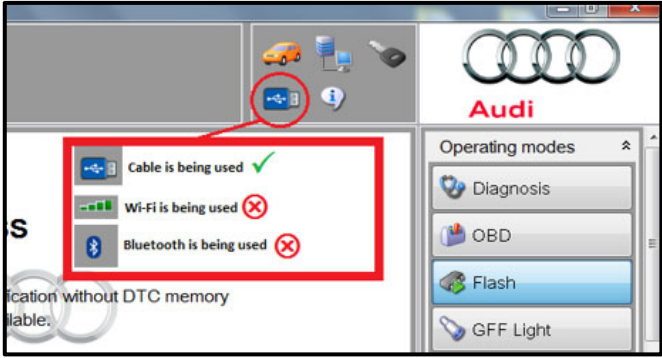
- Connect the VAS6150X/VAS6160X Diagnostic Tester to the vehicle.
- Start the ODIS program.
- Confirm that scan tool is communicating with the diagnostic head by USB cable.
 - If the Bluetooth or WiFi symbol is shown, then disconnect the diagnostic head from the vehicle and reconnect the USB cable to the diagnostic head and then reattach to the vehicle.

- From the home screen of the scan tool highlight “Flash” <1>.
- Follow the on-screen prompts.
