Topic	Bentayga - Outside Air Temperature - Incorrect reading in Fahrenheit
Market area	Bentley: worldwide (2WBE)
Brand	Bentley
Transaction No.	2060102/3
Level	EH
Status	Approval
Release date

Outside air temperature reading within the Driver Instrument Panel (DIP) is incorrect when reading in Fahrenheit

Incorrect outside air temperature displayed, the issue relates to an incorrect algorithm

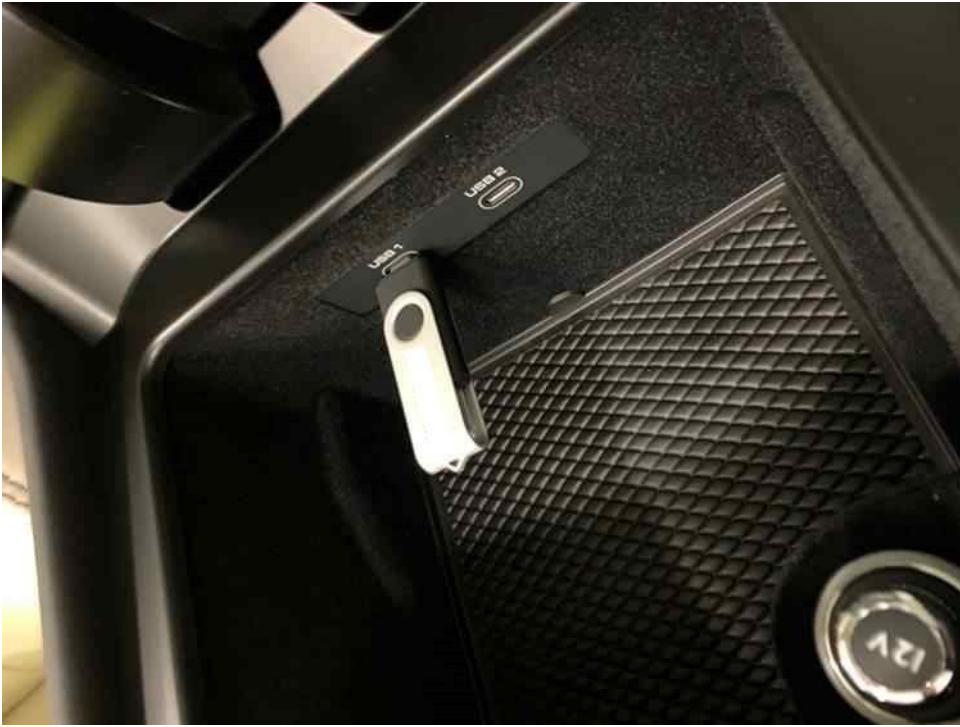
Figure 1

1. Insert the USB-C stick into USB 1 socket (Figure 1)

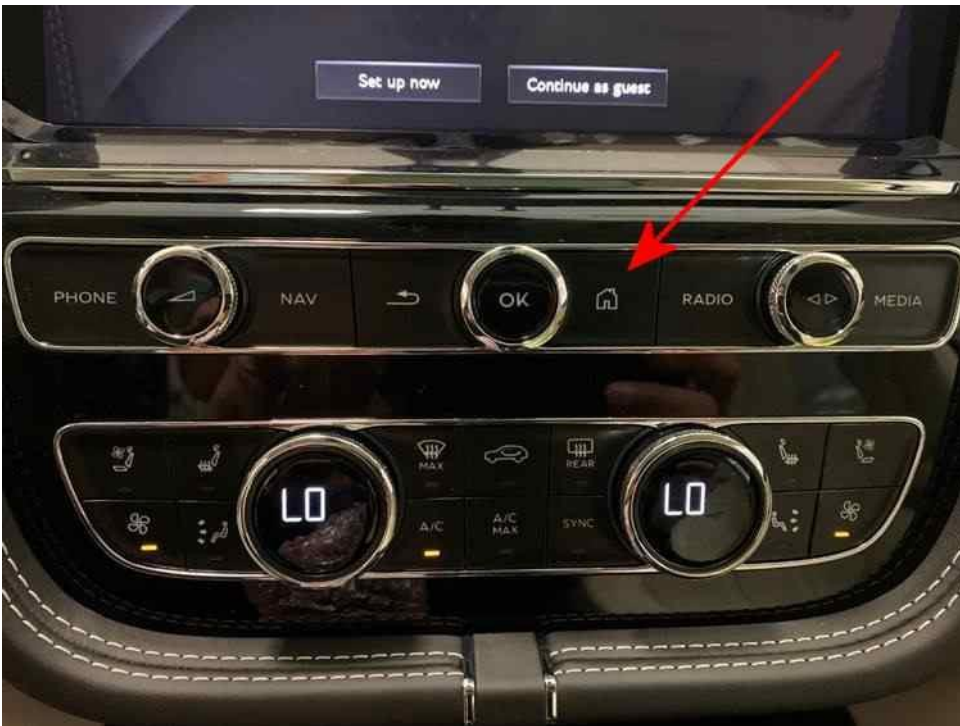
Figure 2

2. Press the home screen button (Figure 2)

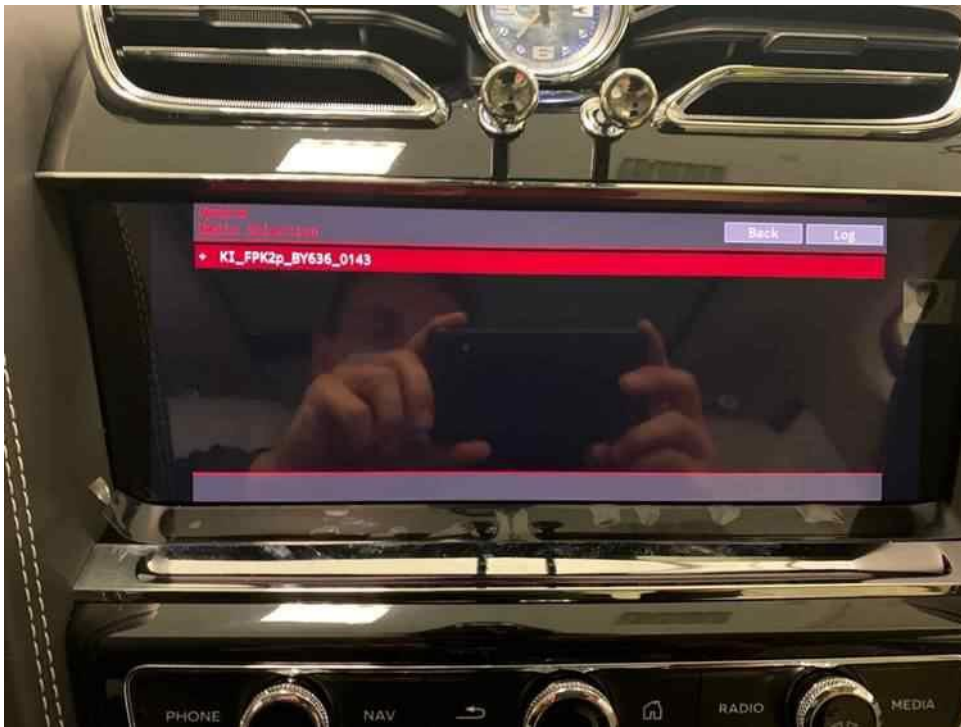
Figure 5

5. Select the suggested update. (Figure 5)

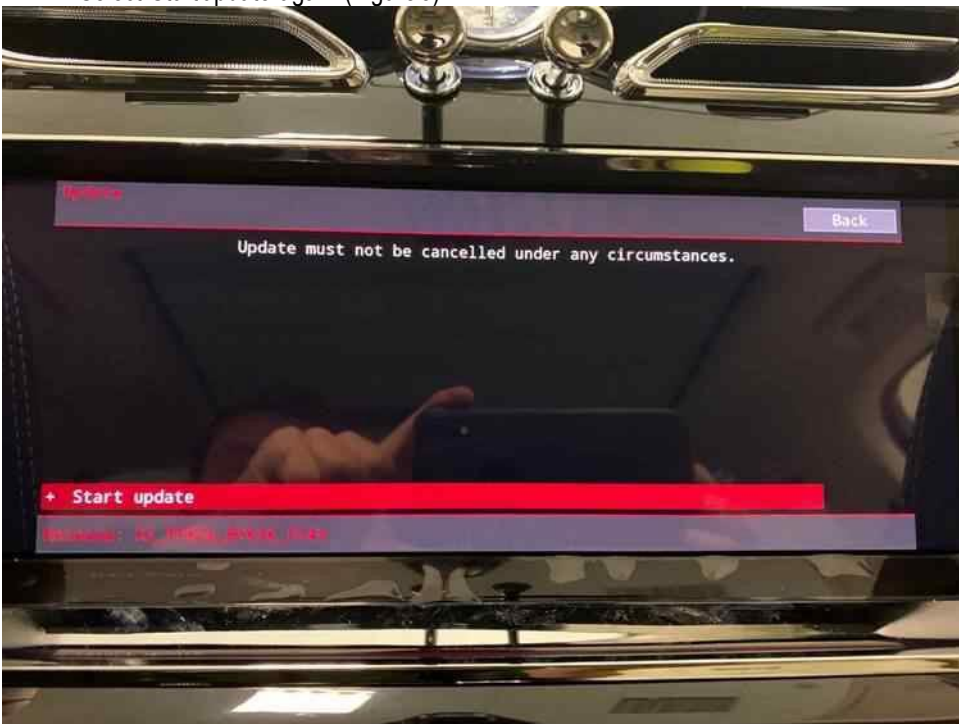
Figure 8

- Select 'Start update' again. (Figure 8)

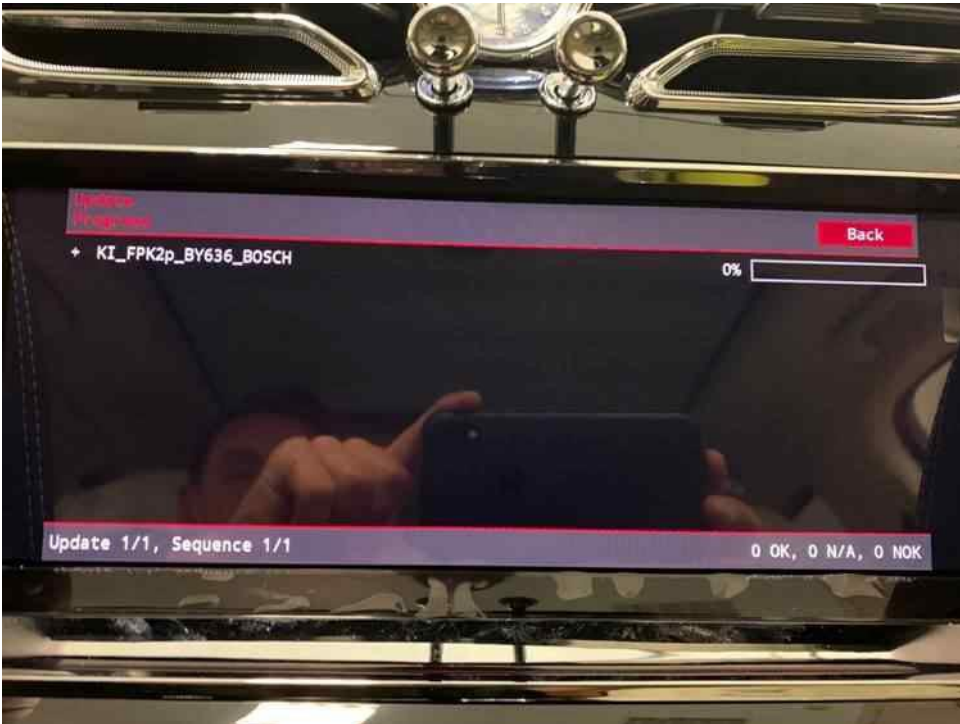
Figure 9

8. The software update will then begin (Figure 9)

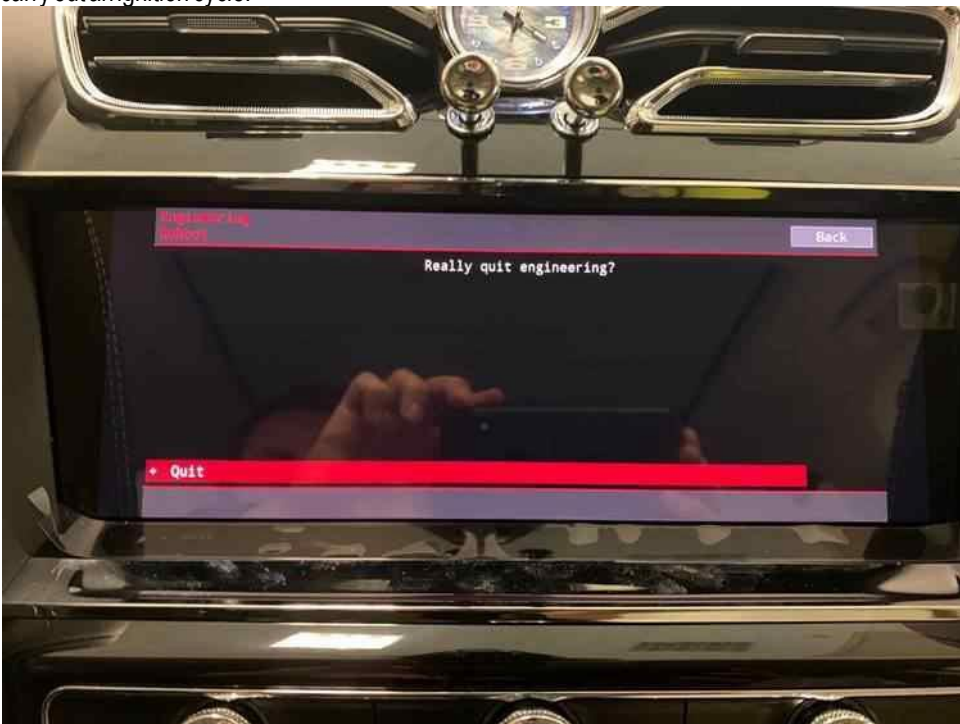
Figure 12

10. On the next screen select 'Quit' (Figure 12), the system will then reboot. Once the home screen is displayed, remove the USB-C stick and carry out an ignition cycle.

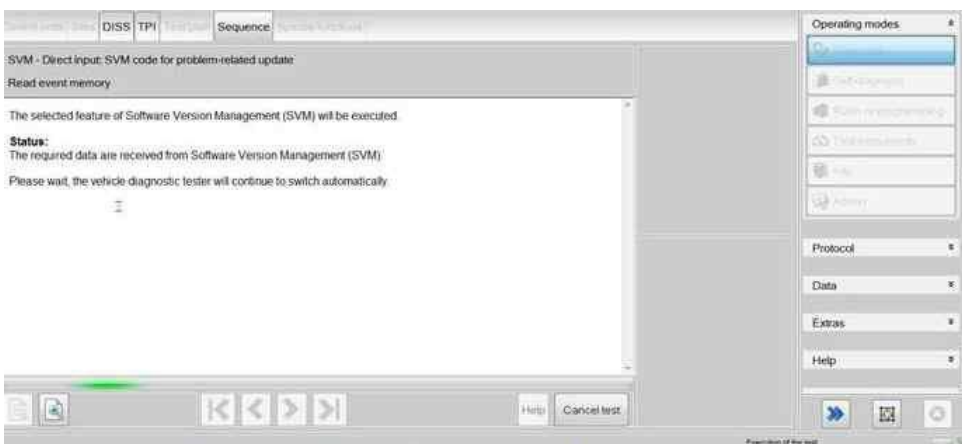
Figure 15

- All control modules will be interrogated.
- The SVM action will then take place (Figure 15)

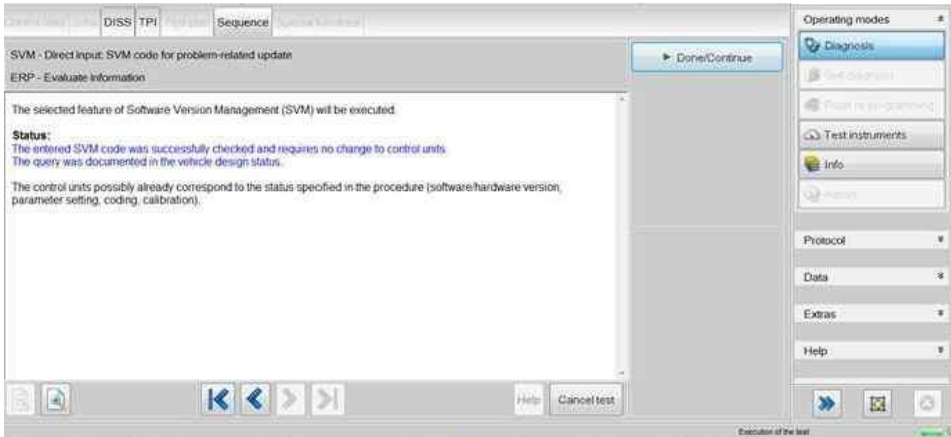
Figure 16

15. Once complete a summary screen will appear (Figure 16), this confirms successful completion. Follow any on screen prompts until program end
