General Information

Western Star 47X and 49X vehicles manufactured from September 12, 2018 through March 22, 2021 that are equipped with WABCO Anti-Lock Braking System (ABS) controllers log excessive 629-11 fault codes, which can lead to additional downstream fault codes. The ABS controller will receive a software update to eliminate erroneous fault codes and ensure proper function. After the software update, the vehicle will require a recalibration drive for the steering angle sensor.

Western Star
Service Bulletin

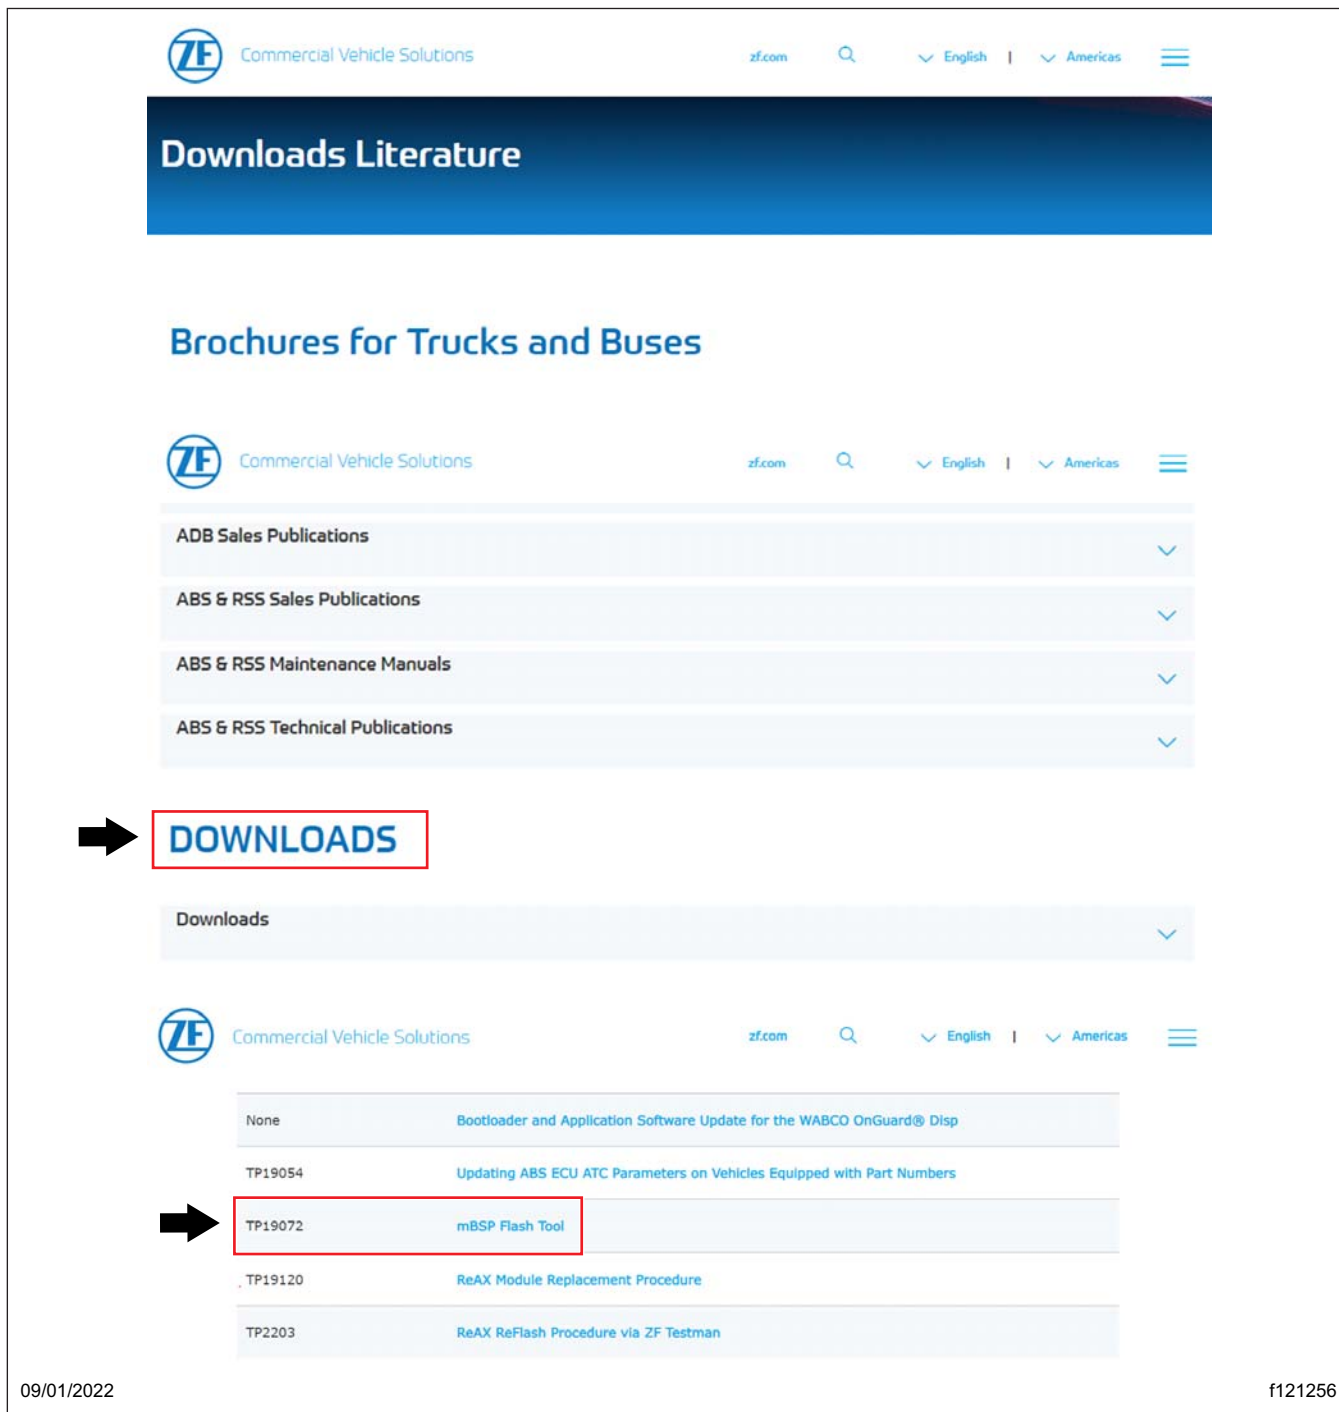
Fig. 1, mBSP Flash Tool Link in Downloads Section

- 5.1 Go to the WABCO website at https://www.wabco-auto.com/americas_en/Get-in-touch/Literature.
- 5.2 Scroll down to the 'Downloads' section, and select 'mBSP Flash Tool.' See [Fig. 1](#).

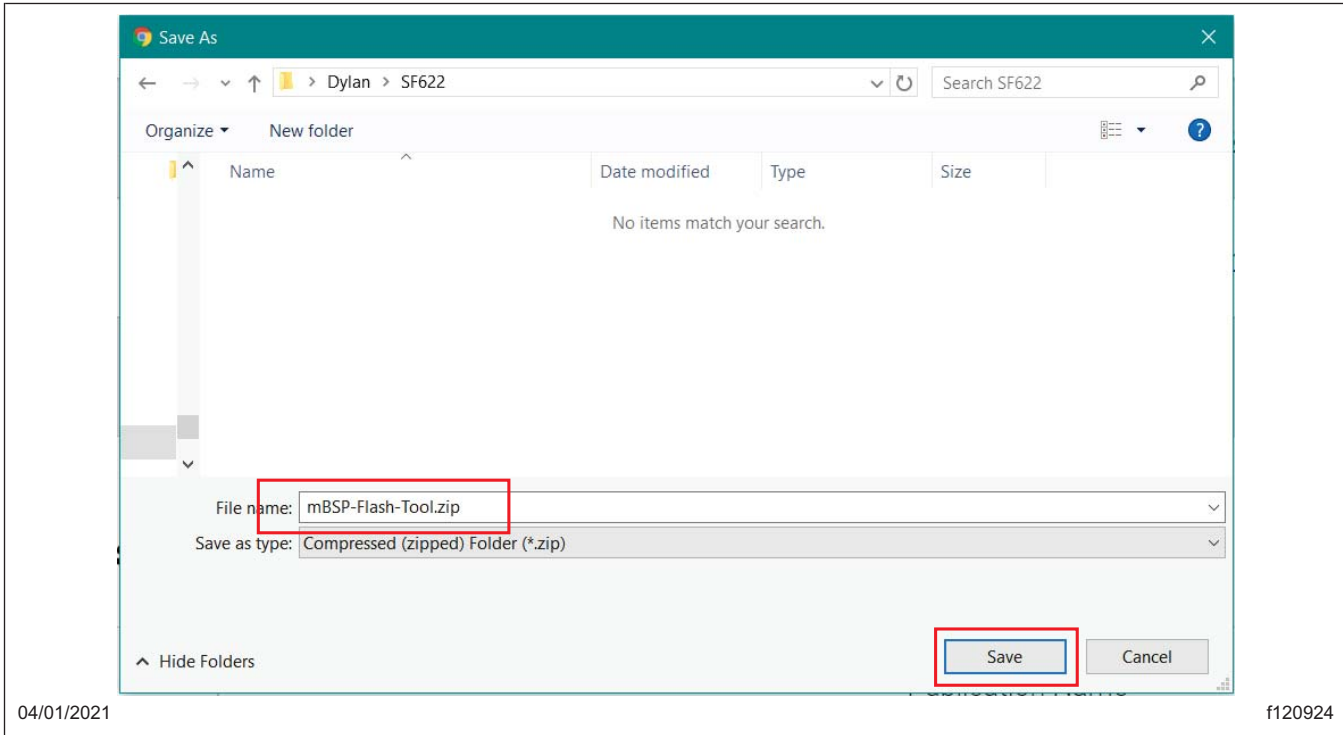
Fig. 2, Saving mBSP Flash Tool Package

5.3 Save the 'mBSP-Flash-Tool.zip' file to a location on the local hard drive. See Fig. 2.

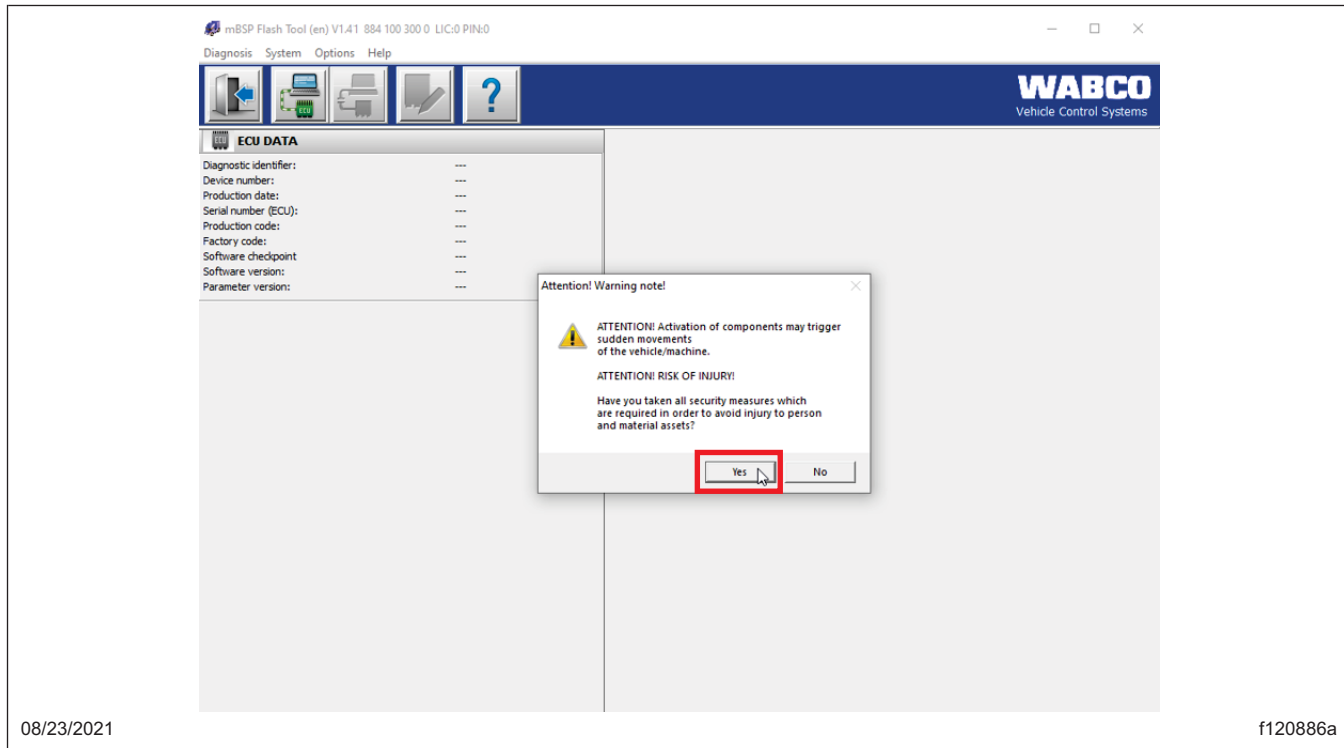
Fig. 4, Accepting the Warning

- The vehicle battery voltage must remain at 12.4 volts or above during programming. To ensure good battery voltage during programming, it is recommended to connect an appropriate battery charger to the vehicle batteries.
 - Verify that the selected RP1210 adaptor is updated to the latest driver software. Using an adaptor equipped with an outdated software version may result in update failure.
9. Connect an RP1210 adaptor to the vehicle's Deutsch 9-pin connector. The mBSP flash tool software should be closed. If opened, close it before connecting the adaptor. No other diagnostic program should be running on the laptop (WABCO TOOLBOX, DiagnosticLink, etc.).
 10. Double-click the mBSP flash tool shortcut to open the software.
 11. The program will open with a warning note. See **Fig. 4**. Read the warning note. If the vehicle is secure, select 'Yes.'

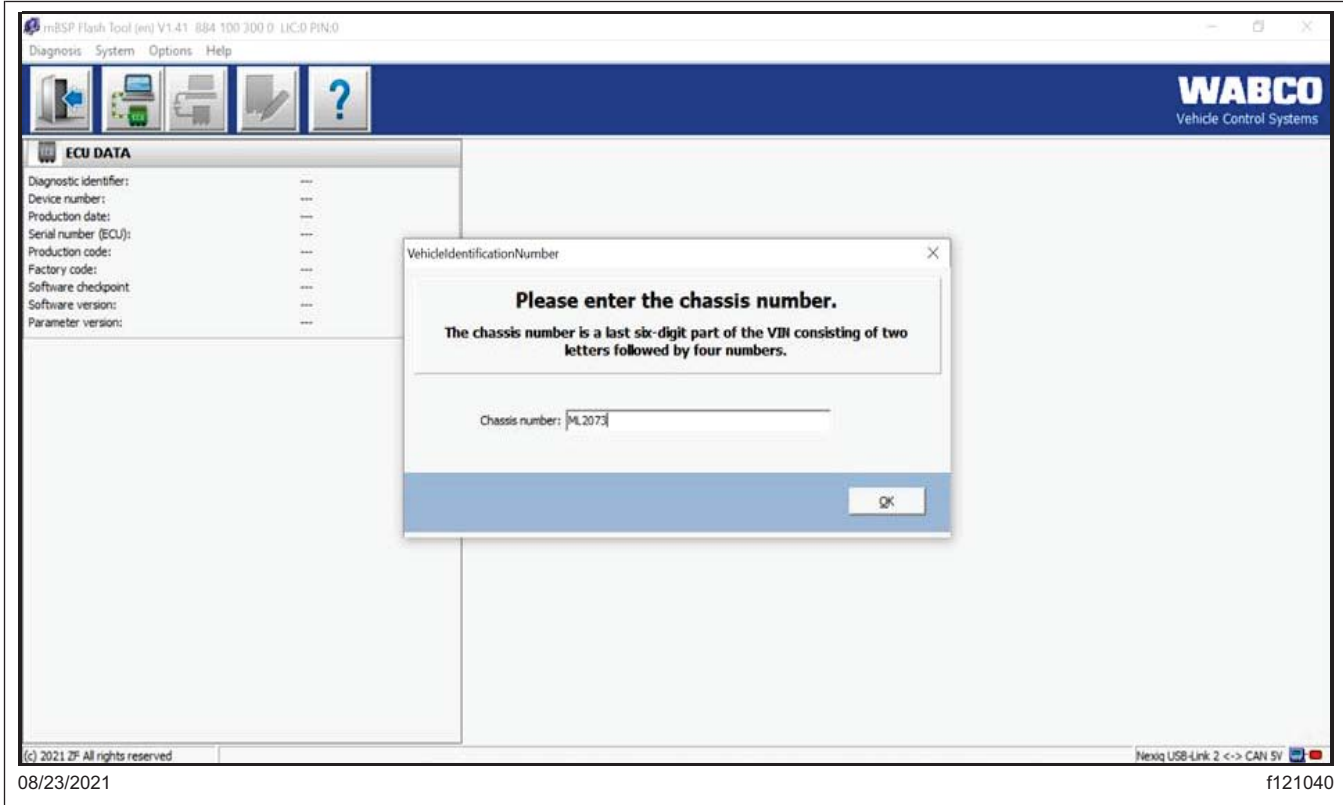
Fig. 6, Entering the Chassis Number

13. A window will open, requesting the chassis number to be entered. Enter the vehicle chassis number. See Fig. 6.

NOTE: The chassis number is the last six-characters of the VIN, which consists of two letters followed by four numbers (also known as the serial number).

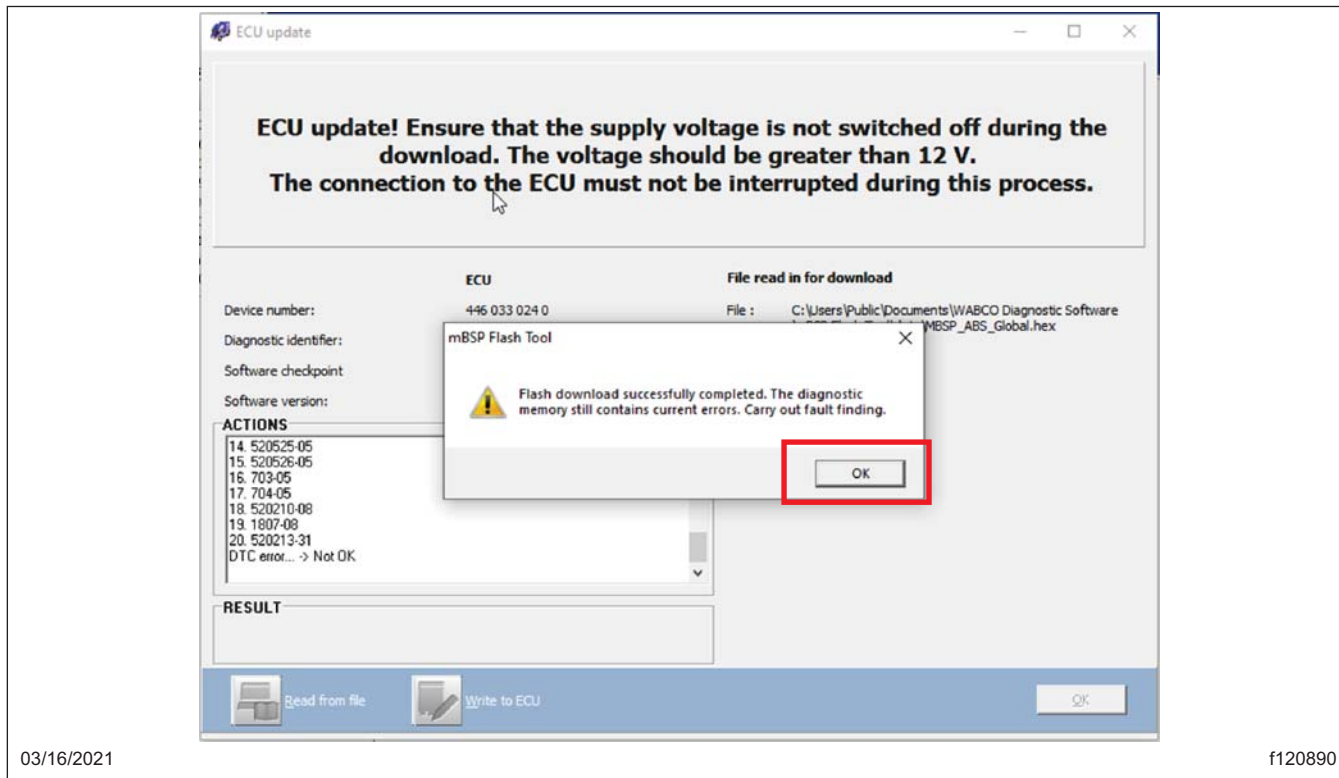
Fig. 9, Carrying Out Fault Finding

16. Once the ECU update is complete, some ECU errors may be present. Select 'OK' and close the flash tool and start calibration mode. See [Fig. 9](#).
