Customer Satisfaction Program

N212354521 Heated Vented Seats Retrofit Due to Chip Shortage - Front Seats Only

Condition	Due to the industry-wide semiconductor shortage, the front heated/ventilated seats, front heated seats, or rear heated seats are not functional on certain 2022 model year vehicles listed above, built beginning November 15, 2021. The affected vehicle owners should have been made aware of the condition at sale, and notified that once parts are available, they would be eligible for a no additional cost retrofit to enable the feature.
Correction	Dealers are to replace the front seat heater control module, replace the front HVAC user interface control, reprogram the body control module and on some vehicles, reprogram the HVAC control module.

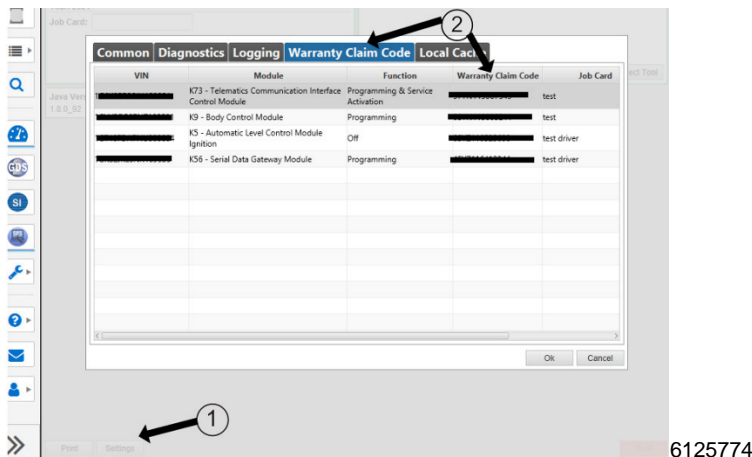
Warranty Claim Code Information Retrieval

If the Warranty Claim Code was not recorded on the Job Card, the code can be retrieved in the SPS2 system as follows:

1. Open TLC on the computer used to program the vehicle.

The VIN, Warranty Claim Code and Date/Time will be listed on a roster of recent programming events. If the code is retrievable, dealers should resubmit the transaction making sure to include the code in the SPS Warranty Claim Code field.

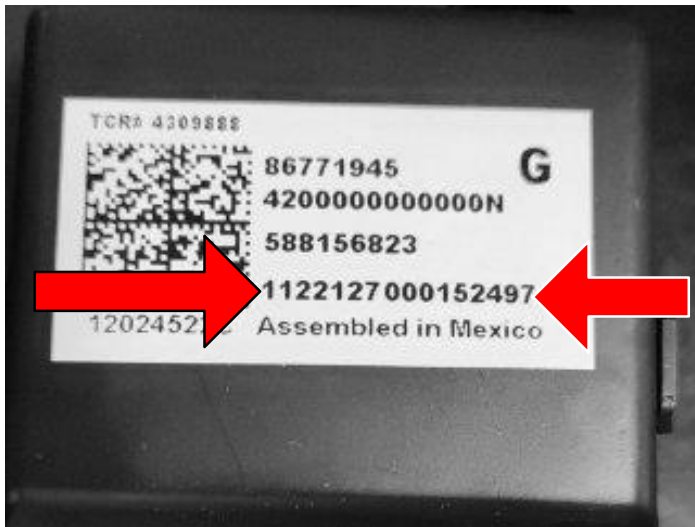
6098078

Record the serial number on the seat heater vent control module label.

RECORDING REQUIREMENT. The replacement Front Seat Heater Vent Control Module serial numbers must be captured by the technician and recorded on the job card. The Warranty Administrator **MUST** enter the replacement Front Seat Heater Vent Control Module serial numbers in GWM (Global Warranty Management) or in DMS (Dealer Management System). Enter the serial number of the **replacement** Front Seat Heater Vent Control Modules in the **'General Comments'** comments section. Failure to enter this serial number will cause the claim to reject.

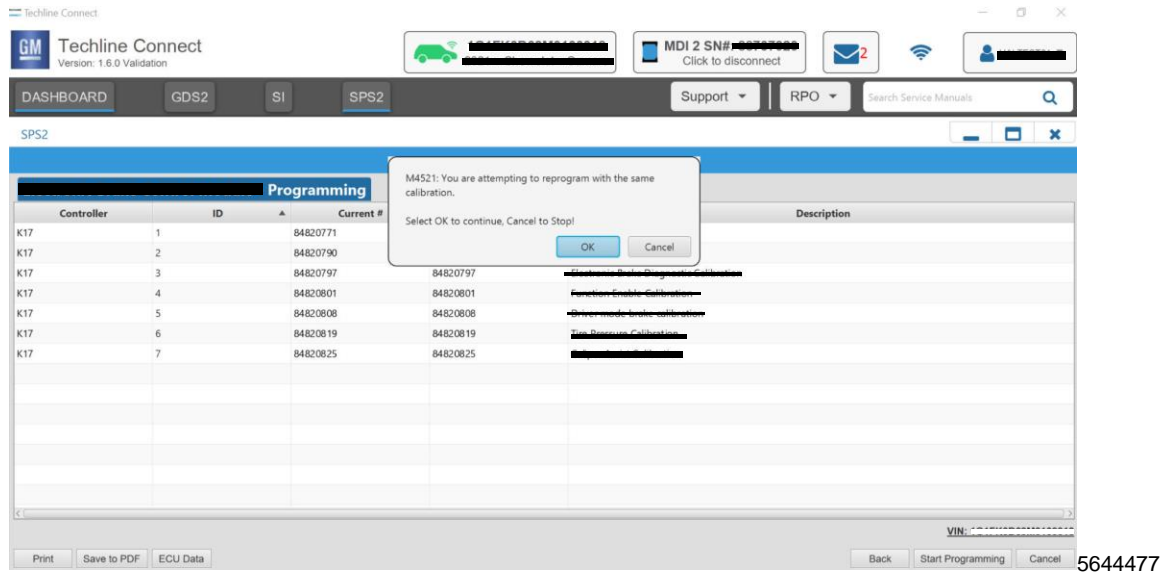
Important: Techline Connect screens shown above.

Important: If the same calibration/software warning is noted on the TLC Summary screen, select OK and follow screen instructions. After a successful programming event, the WCC is located in the Service Programming System dialogue box of the SPS Summary screen. No further action is required. Refer to the Warranty section of the bulletin.

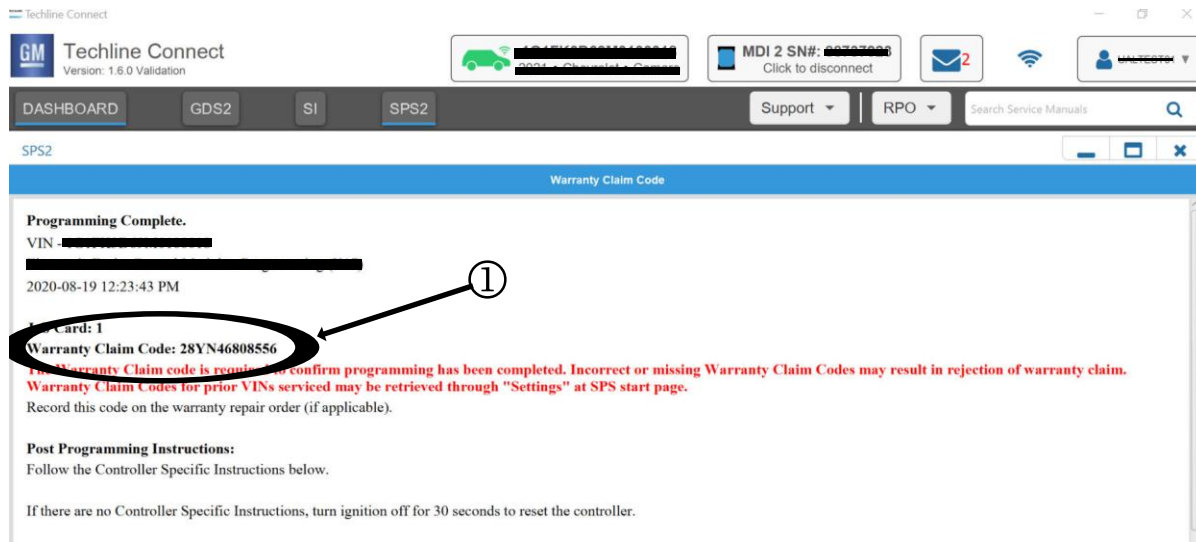
5644478

Note: The screenshot above is an example of module programming and may not be indicative of the specific module that is being programmed. Module selection and VIN information have been blacked out.

6. Reprogram the body control module. Refer to *K9 Body Control Module: Programming and Setup* in SI.
- **Traverse only.** Reprogram the HVAC Control Module. Refer to *HVAC Control Module Reprogramming with SPS* in SI.
