Turbo Compound 2nd Generation - EGR And/Or DPF Diagnostic Trouble Codes (DTC), Diagnostic And Repair Information

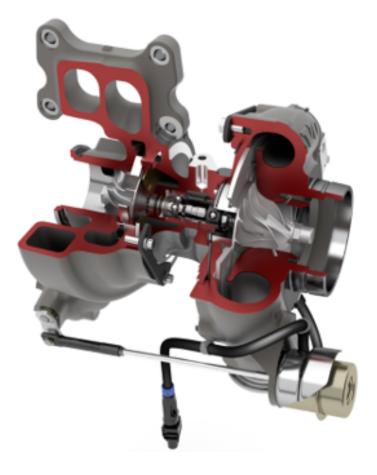
Vehicles equipped with a 2nd Generation Turbo-compound unit will have a turbocharger equipped with a wastegate as seen below.
