Service Bulletin

Bulletin No.: 22-NA-221

Subject: No Start, Slow Crank or Low 12V Battery

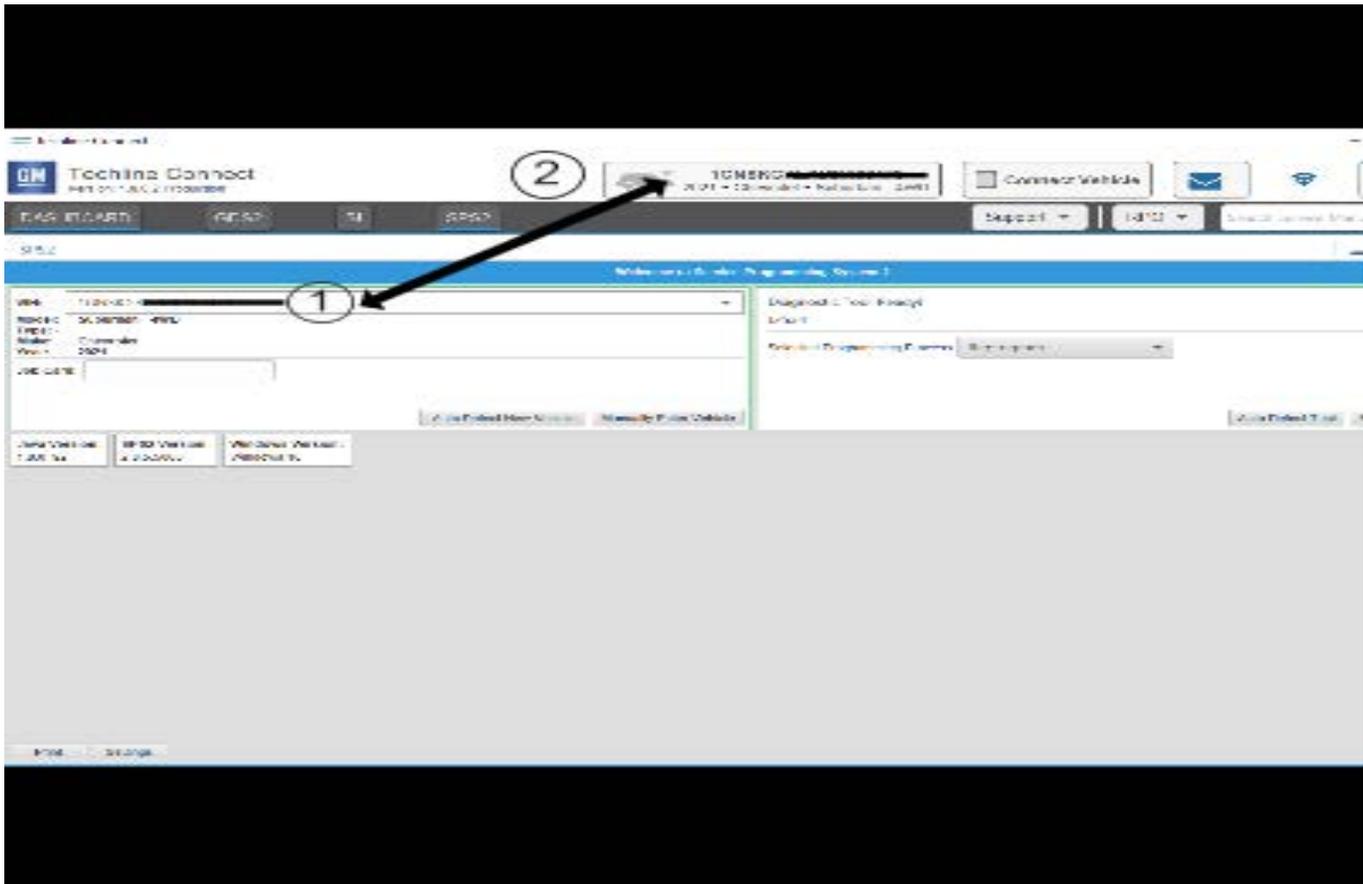
Caution: Be sure the VIN selected in the drop down menu (1) is the same as the vehicle connected (2) before beginning programming.

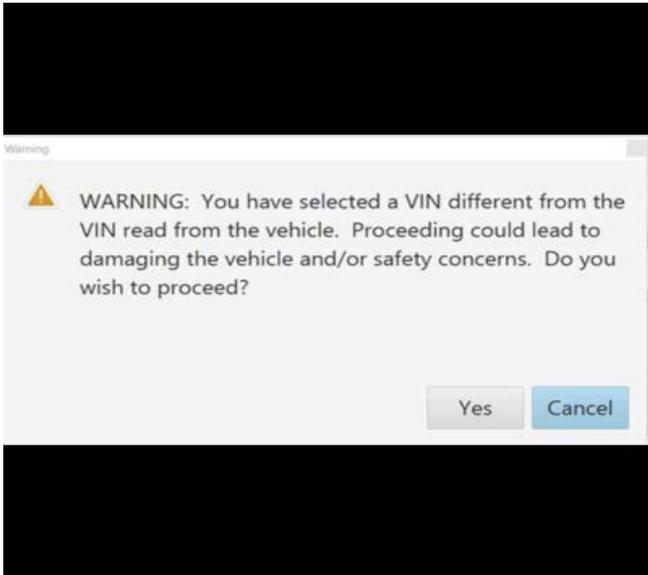
5877000

Important: If the vehicle VIN DOES NOT match, the message below will be shown

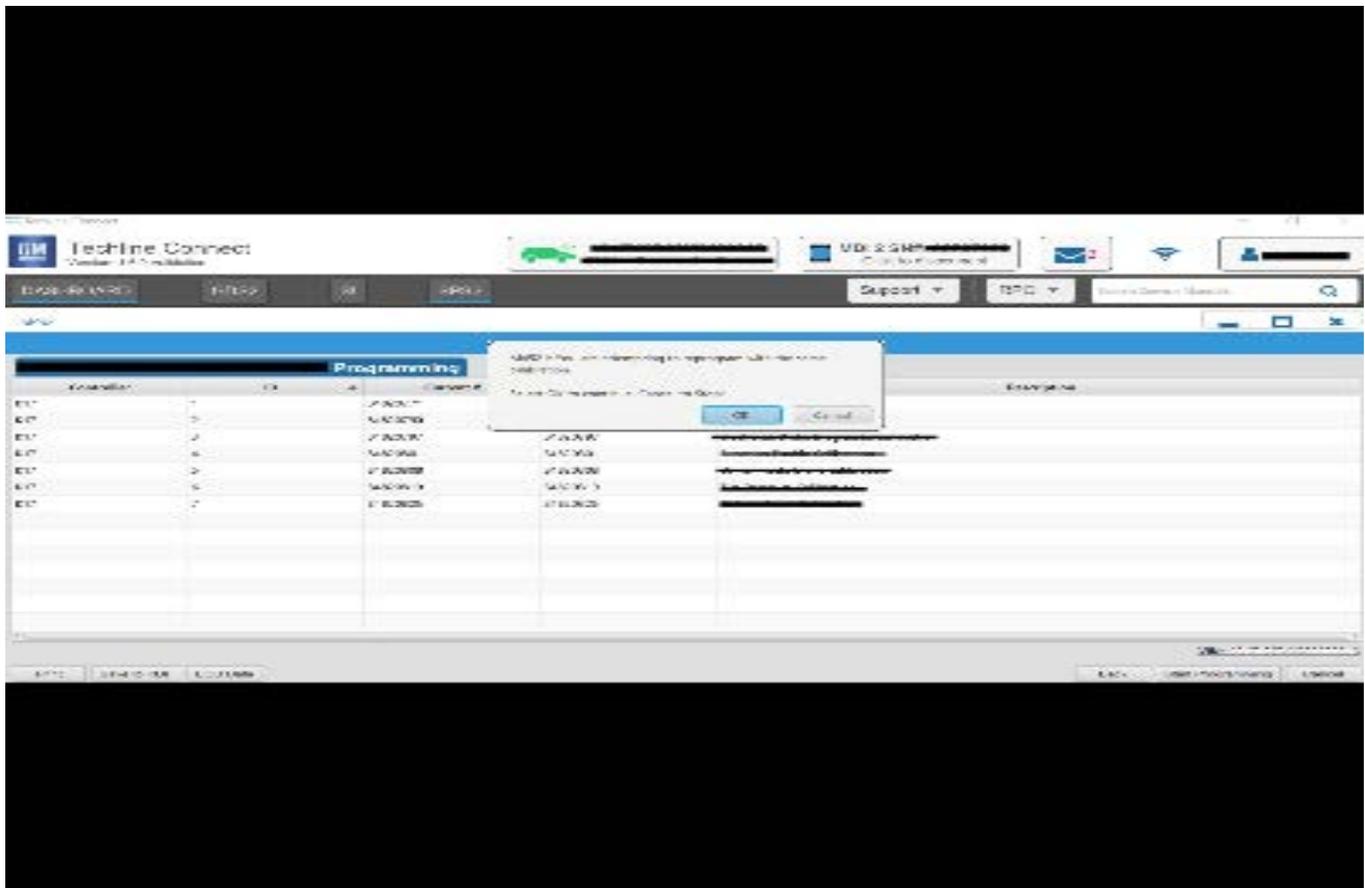
5644477

Important: Techline Connect and TIS2WEB screens shown above.

Important: If the same calibration/software warning is noted on the TLC or SPS Summary screen, select OK and follow screen instructions. After a successful programming event, the WCC is located in the Service

Programming System dialogue box of the SPS Summary screen. No further action is required. Refer to the Warranty section of the bulletin.

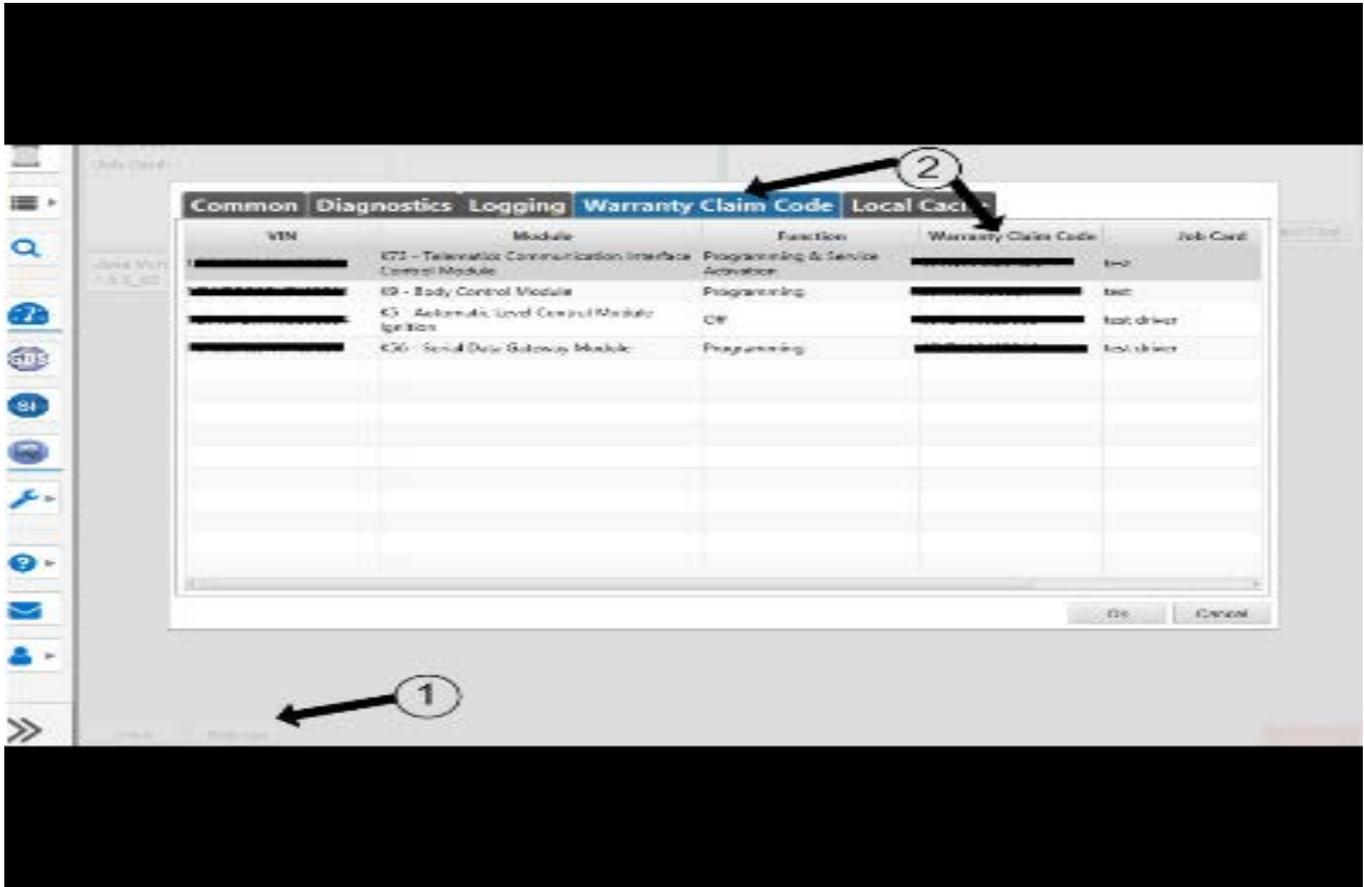
6125774

Warranty Claim Code Information Retrieval

If the Warranty Claim Code was not recorded on the Job Card, the code can be retrieved in the SPS2 system as follows:

The VIN, Warranty Claim Code and Date/Time will be listed on a roster of recent programming events. If the code is retrievable, dealers should resubmit the transaction making sure to include the code in the SPS Warranty Claim Code field.
