WLL0 - Re-Programming DME Control Unit (Workshop Campaign)

Vehicle Type: **Macan (95B)**

Concerns: **DME control unit**

Information: **New DME control unit software that optimizes engine control and exhaust gas post-treatment is available for the Macan.**

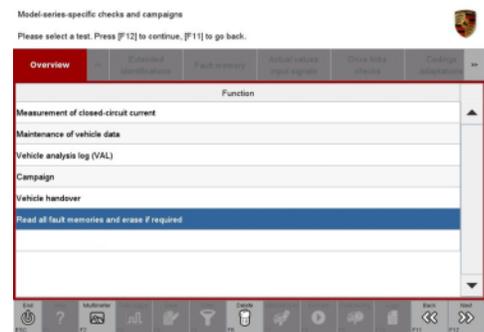
Erase fault memory

- 4 Press •F8" to delete fault memory entries.
- 5 Press •F12" ('Yes') in response to the question as to whether you really want to delete all fault memory entries.

The faults stored in the fault memories of the various control units are deleted.

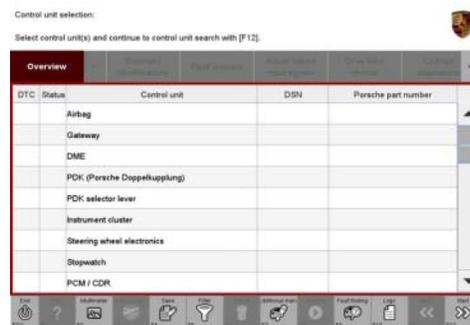
Control unit selection

- Work Procedure: 1 Select the '**DME**' control unit in the control unit selection screen ('Overview' menu) and press •F12" ('Next') to confirm your selection.
- 2 Once the DME control unit has been found and is displayed in the overview, select the '**Maintenance/repairs**' menu.
- 3 Select menu item ⇒ '**Adaptations**' and confirm your selection by pressing •F12" ('Next') ⇒ *DME adaptations*.

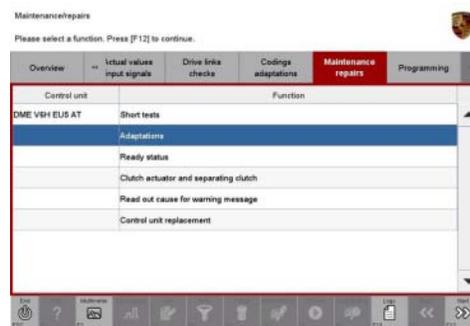
DME adaptations

- 4 Comply with the displayed preconditions and press •F12" ('Next') to confirm ⇒ *Adaptation preconditions*.

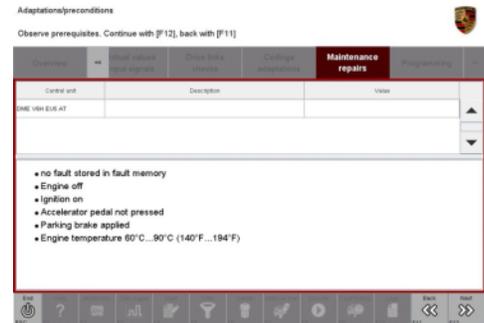
Adaptation preconditions

- 5 Select the ⇒ **'Throttle valve adaptation'** function so that the corresponding text line turns blue and press •F8" ('Start') to start throttle valve adaptation ⇒ *Throttle valve adaptation*.

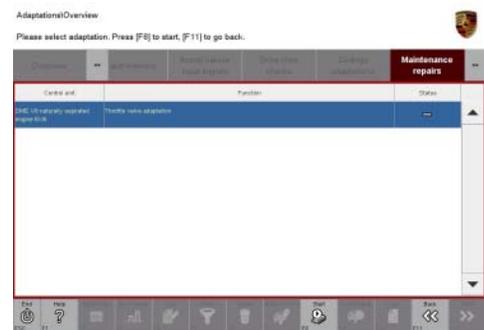
Throttle valve adaptation

- 6 Follow the instructions on the PIWIS Tester while throttle valve adaptation is being performed.
Once throttle valve adaptation is complete, a tick will appear in the "Value" field on the PIWIS Tester display.

If throttle valve adaptation is **not** completed successfully, adaptation must be **repeated**.

- 7 Press •F8" ('Stop') to end throttle valve adaptation.

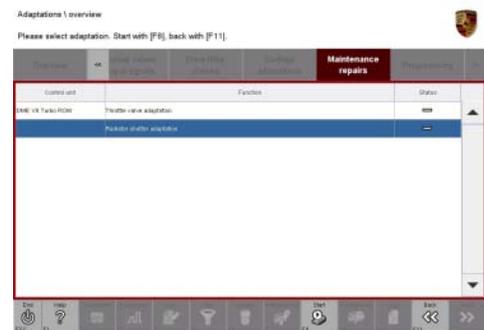
Radiator shutter adaptation

Work Procedure: 1 Select the ⇒ **'Radiator shutter adaptation'** function so that the corresponding text line turns blue and then press •F8" ('Start') to start radiator shutter adaptation ⇒ *Radiator shutter adaptation*.

Once adaptation is complete, a tick will appear in the "Value" field on the PIWIS Tester display.

If radiator shutter adaptation is **not** completed successfully, the **adaptation** must be repeated.

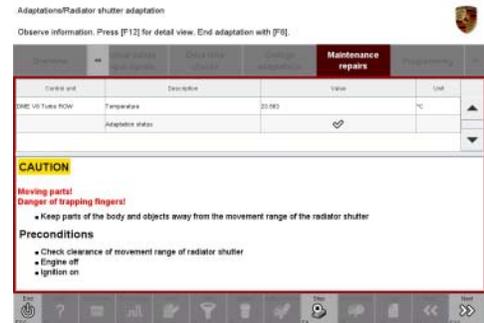
PIWIS instructions

- 2 Follow the instructions on the PIWIS Tester while radiator shutter adaptation is being performed ⇒ *PIWIS instructions*.

- 3 End radiator shutter adaptation by pressing •F8“ ('Stop').
- 4 Press •F11“ ('Back') to return to the start page of the ⇒ **'Maintenance/repairs'** menu.

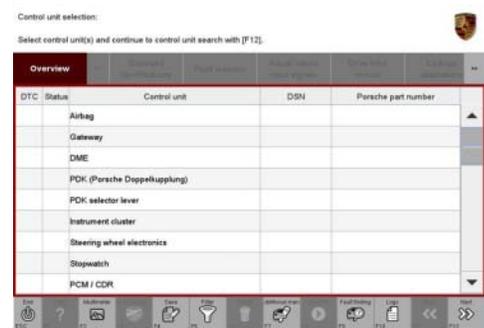
Control unit selection

- 5 Select the ⇒ **'Overview'** menu to return to the control unit selection screen ⇒ *Control unit selection*.

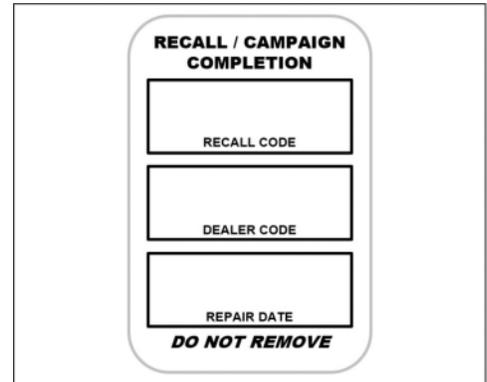
Recall Proof of Completion Label

- 4.1 Fill out the Recall Proof of Completion label ⇒ *Recall Proof of Completion Label* fully and correctly. This includes the recall code “**WLL0**”, your dealer code and the repair date.
- 4.2 Clean the surface in the lower area on the front lid at the left-hand side in direction of travel at which the Recall Proof of Completion label must be attached ⇒ *Proof of Completion Label: specified position (Exemplary illustration — Macan (95B) position accordingly)* **-arrow-** using a suitable cleaning agent and a clean, grease-free and lint-free cloth.
- 4.3 Affix Recall Proof of Completion label in the lower area of the front lid at the lefthand side in direction of travel ⇒ *Proof of Completion Label: specified position (Exemplary illustration — Macan (95B) position accordingly)* **-arrow-**.

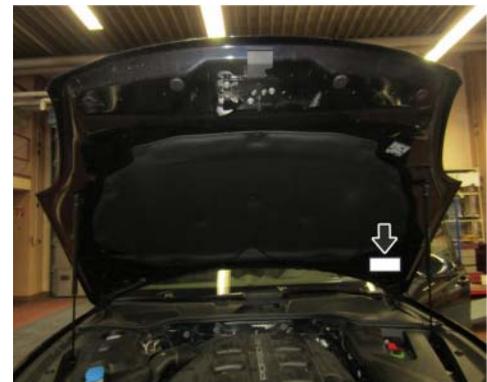
Proof of Completion Label: specified position (Exemplary illustration — Macan (95B) position accordingly)

Exemplary illustration — Macan (95B) position accordingly
- 4.4 Close front lid.
