## Technical product information

<b>Topic</b>	New Flying Spur - Boot open/close function inoperative
<b>Market area</b>	Russische Föderation (5RU),Australia E04 Bentley rest Asia and Australia (6E04),China 796 VW Import Comp. Ltd (Vico), Beijing (6796),Germany E02 Bentley rest Europe (6E02),Japan E03 Bentley Japan (6E03),Korea, (South) E08 Bentley South Korea (6E08),United Arab Emirates E06 Bentley Middle East and Africa (6E06),United Kingdom E01 Bentley UK (6E01),United States E05 Bentley USA and rest America (6E05)
<b>Brand</b>	Bentley
<b>Transaction No.</b>	2060645/4
<b>Level</b>	EH
<b>Status</b>	Released for publishing
<b>Release date</b>	07-Nov-2022

### New Flying Spur

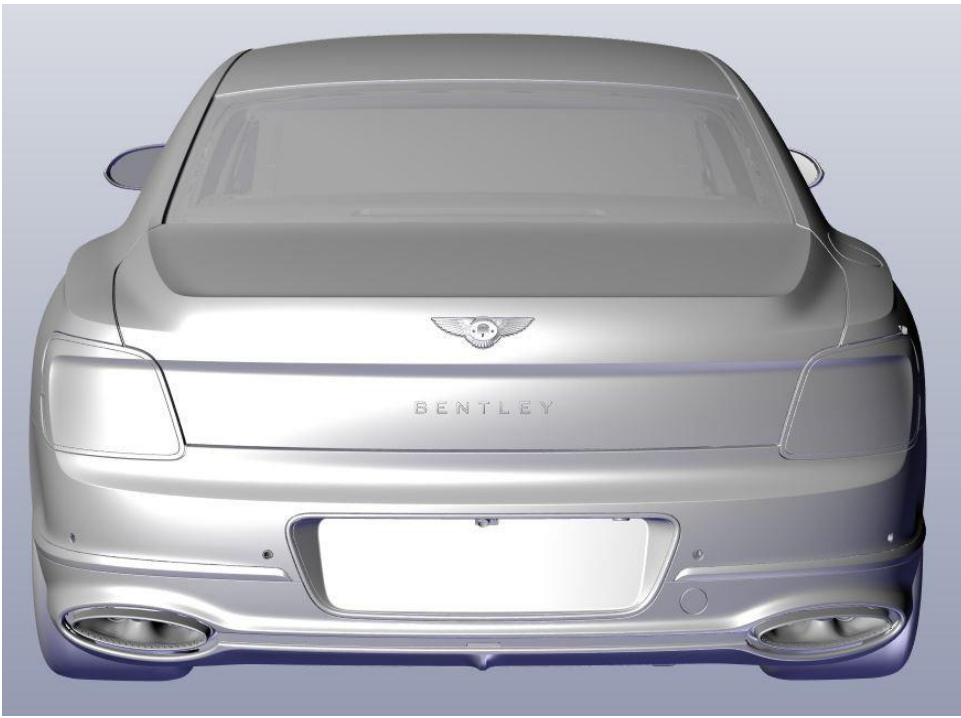
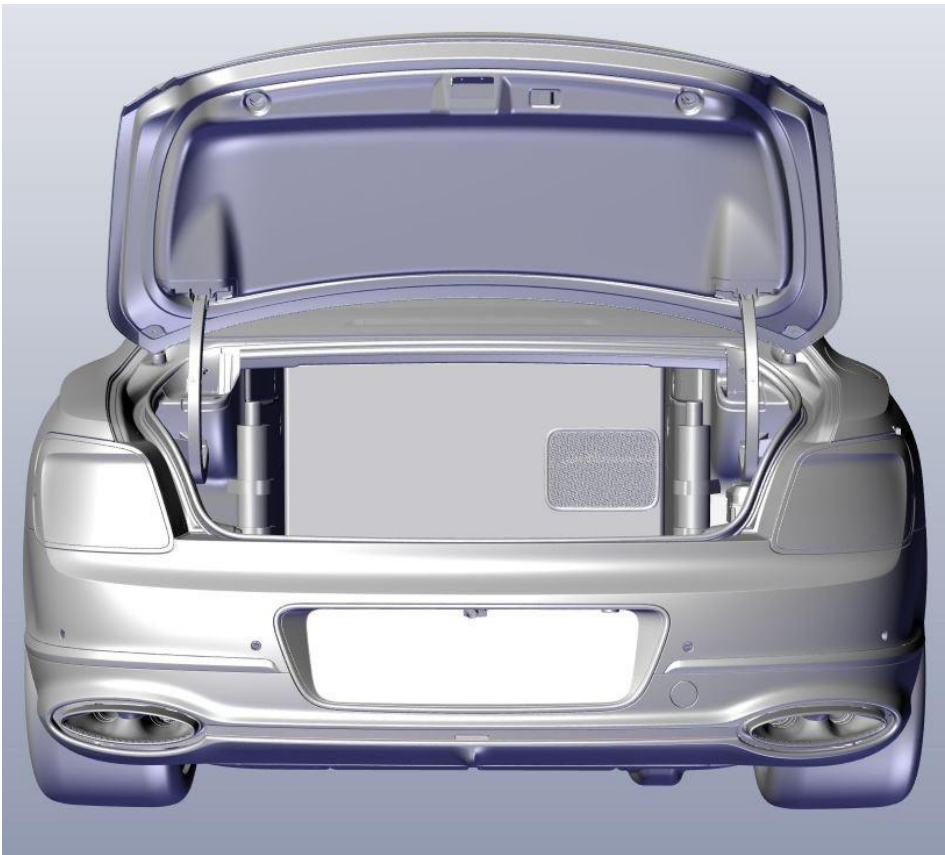
▪  
If any area of the visual inspection is NOK please highlight on the images below
