## **TECHNICAL INSTRUCTIONS**

**LIMITED-SERVICE CAMPAIGN 22TD05**

**Software Update for “Car Finder” Feature**

**CERTAIN 2023 Model Year bZ4X**

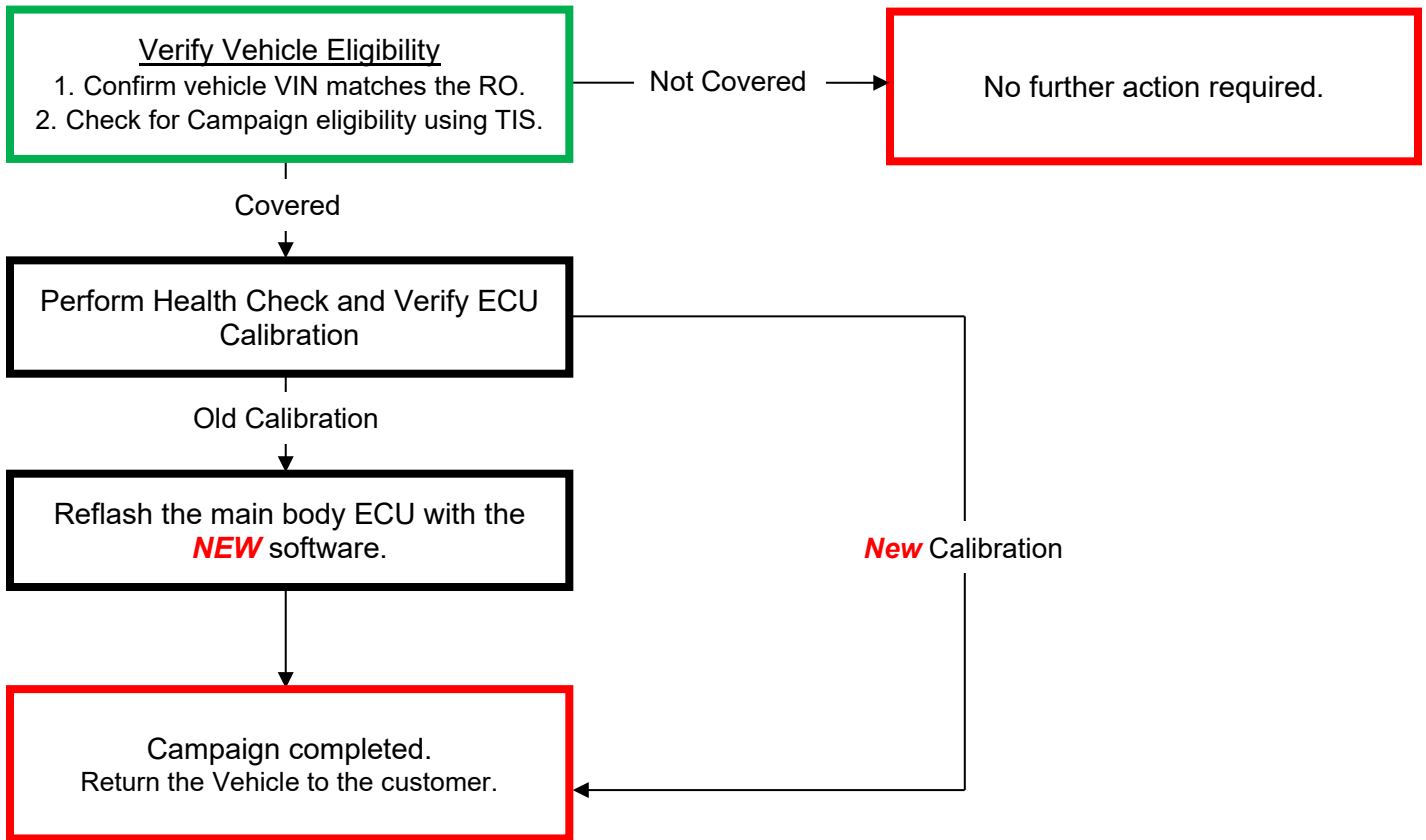
## I. OPERATION FLOW CHART

The flow chart is for reference only. **DO NOT** use it in place of the full technical instructions. Follow **ALL** steps as outlined in the full technical instructions to confirm the campaign is completed correctly.

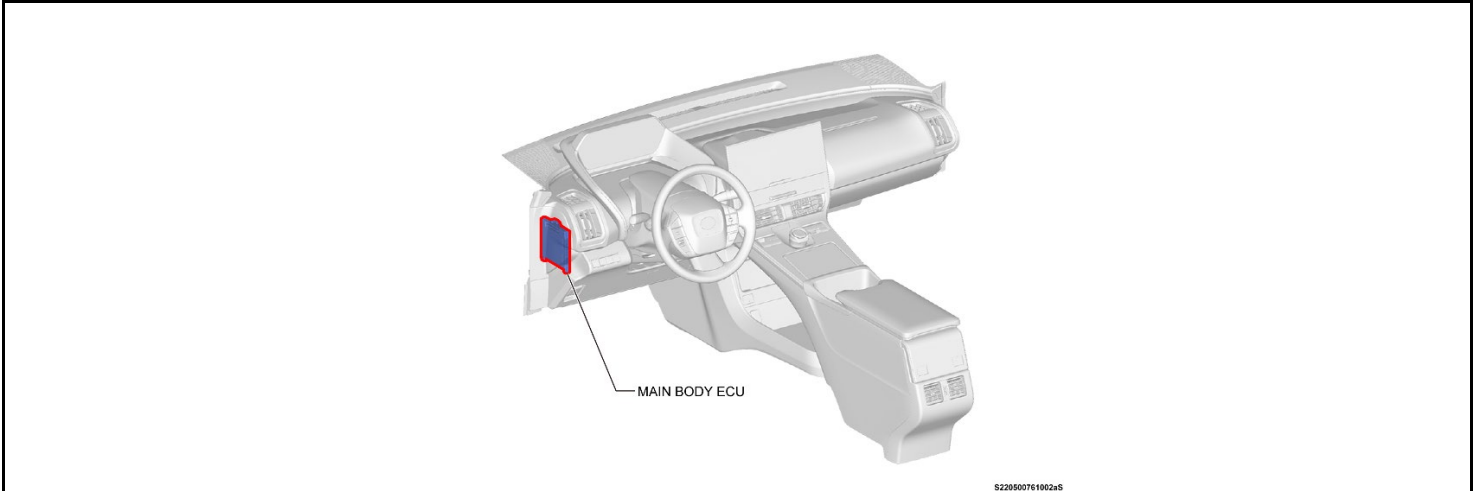
The subject vehicles are equipped with a Body Control Module (BCM) which, among other tasks, controls the operation of the vehicle's exterior lighting. With a subscription to the Toyota One app, the headlamps can be turned on remotely for approximately 60 seconds to help the owner locate their parked vehicle. Under certain conditions, after this feature has been activated, the headlamps and tail lamps may turn off and/or remain off once the vehicle has been turned on. In all cases, the headlamps and tail lamps can be illuminated manually using the headlamp switch.

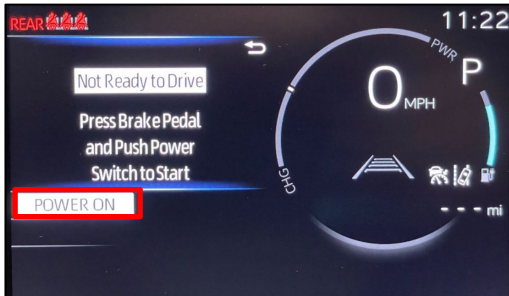
**Hint:** Press power button until "Power on" is displayed on the dash.

- Vehicle in the IG position (READY OFF).
- Transaxle in Park.
- Parking brake engaged.

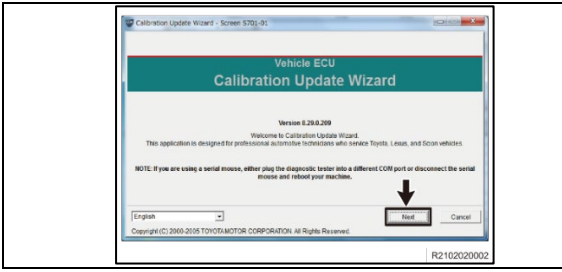
### 3. REFLASH THE MAIN BODY ECU

a) Click yes on the health check results screen, or follow the links on the table above to begin the reflash process.

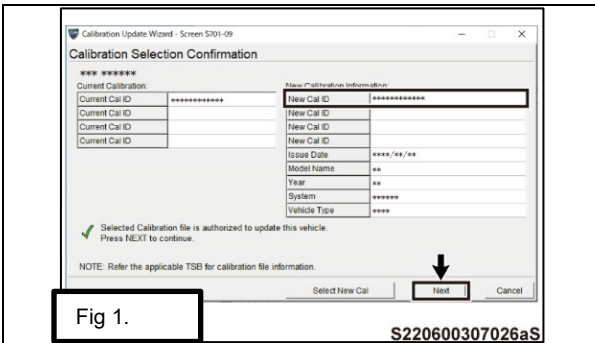
#### 6. CONFIRM THAT "NEW CAL ID" IS CORRECT, AND THEN CLICK ON "NEXT". (FIG 1.)

**Note:** If the incorrect CAL ID file is selected it is not possible to move onto the re calibration. See Fig 2. as example of incorrect Cal ID selected.

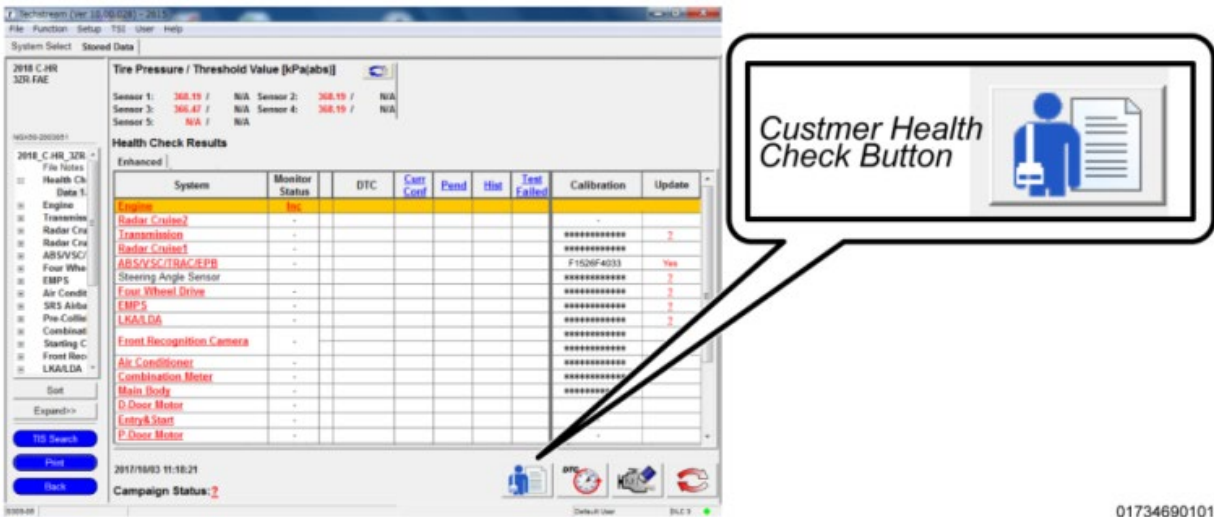
- a. From the Stored Data tab, select the Customer Health Check Report button (TIS will launch when button is pressed).

The screenshot shows the TIS software interface with the 'Health Check Results' table. The table has columns for System, Monitor Status, DTC, Cutt Coef, Pend, Hist, Test Failed, Calibration, and Update. A callout box labeled 'Customer Health Check Button' points to the 'Report' button in the bottom right corner of the interface.

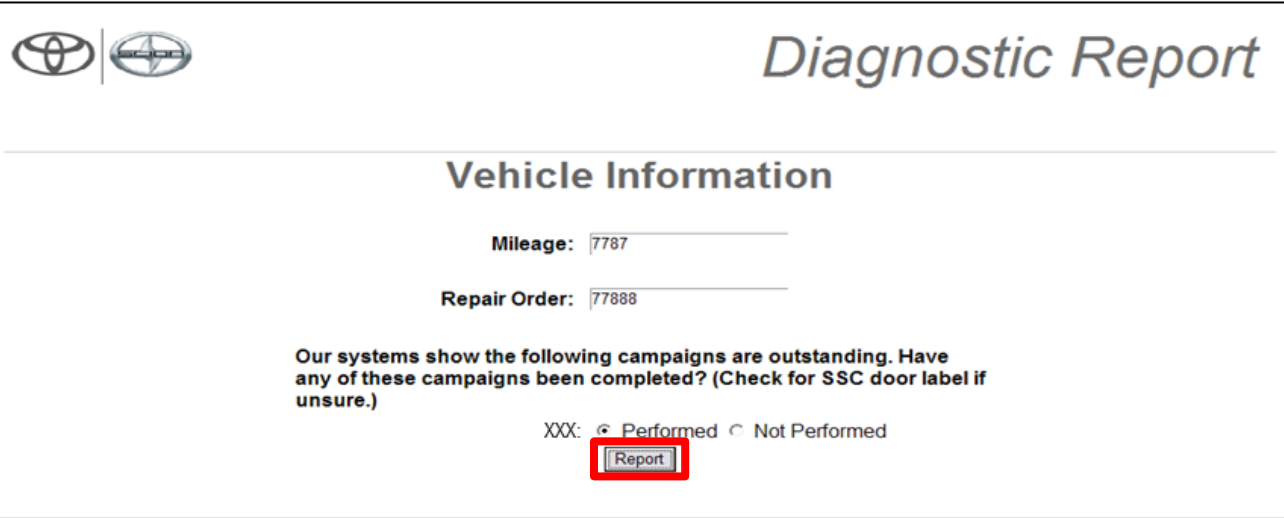
- a) Log in to TIS.
- b) Input Vehicle Mileage and Repair Order number.
- c) Check the "Performed" campaign button for campaign 22TD05.
- d) Select the Report button.

The screenshot shows the Diagnostic Report form. The form displays vehicle information including Mileage (7787) and Repair Order (77888). A red box highlights the 'Report' button.
