## SERVICE PROGRAM BULLETIN

**APPLICABILITY:** 2023 MY Legacy  
2023 MY Outback

**NUMBER:** WRI-22R

**SUBJECT:** Telematics DCM Replacement

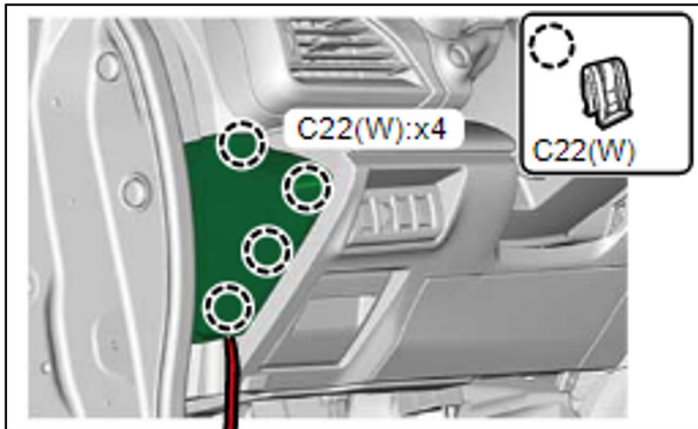
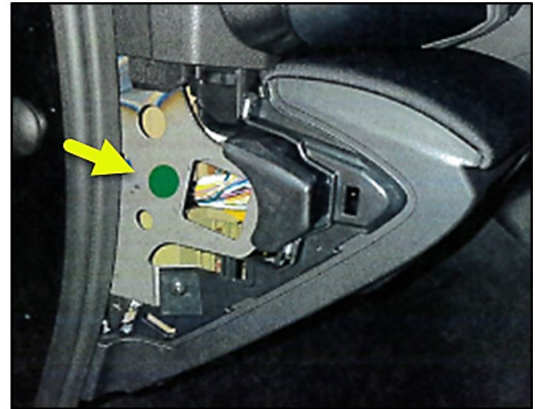
**STEP 3:** Release the four mounting clips securing the driver side instrument panel side cover. Once released, remove the cover.

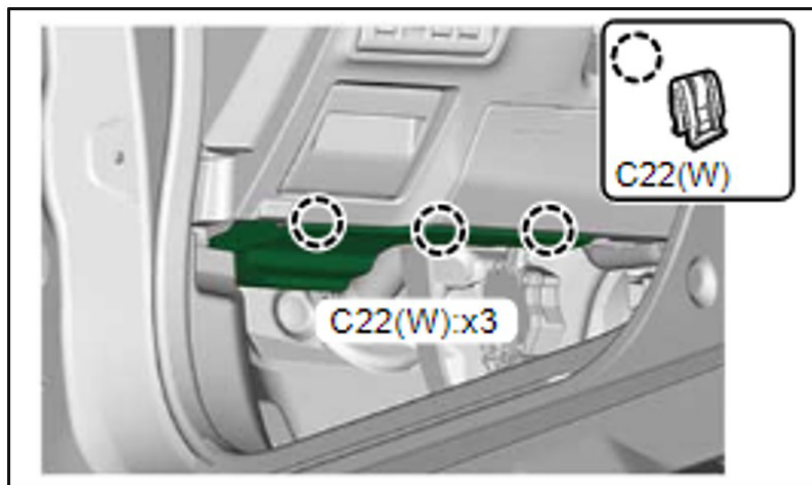
**STEP 4:** Release the three mounting clips securing the driver side front under cover. Once released, remove the cover.

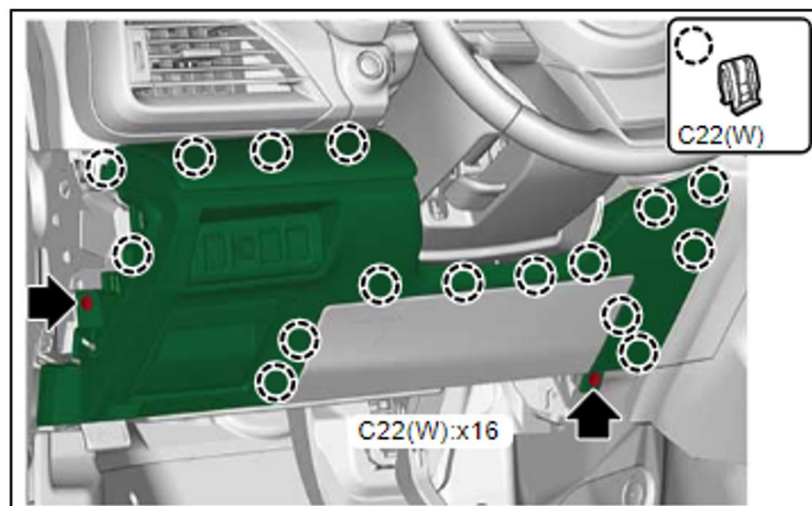
**STEP 5:** Remove the two mounting screws securing the lower driver cover. Once removed, pull the cover in a straight direction toward the rear of the vehicle to release the mounting clips.

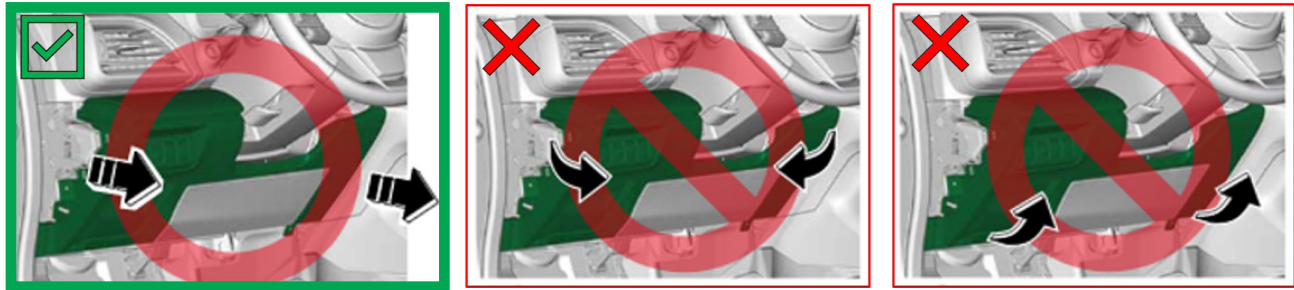
**CAUTION:** When removing the lower driver cover, **ALWAYS** pull the cover in a straight direction. Pulling in a lateral or upward direction may cause damage to the lower driver cover.

CAREFULLY disconnect all electrical connections. Remove the lower driver cover from the vehicle.

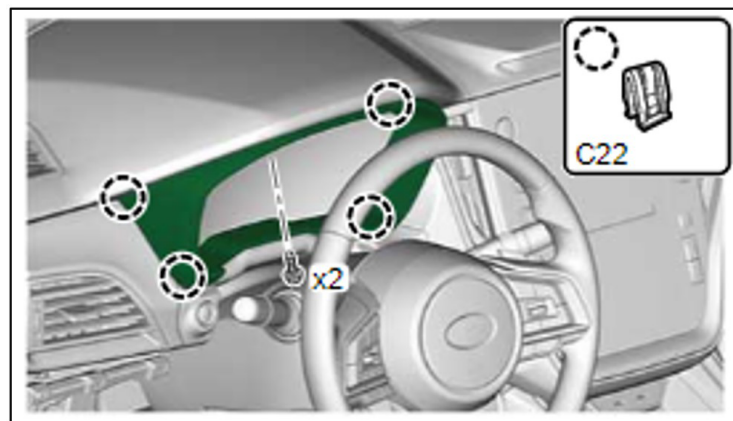
**STEP 6:** Release the steering column lock, adjust the steering wheel to the lowest level and pull it outward to its full extent. Lock the steering in this position. Using a small screwdriver, remove the two mounting screws for the combination meter trim panel. Release the four mounting clips securing the panel. The panel can then be removed.

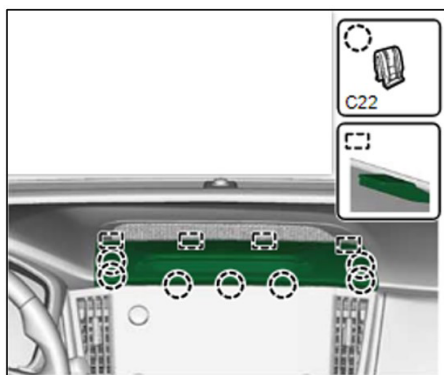
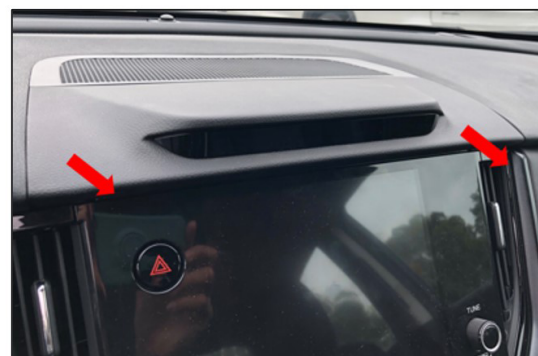
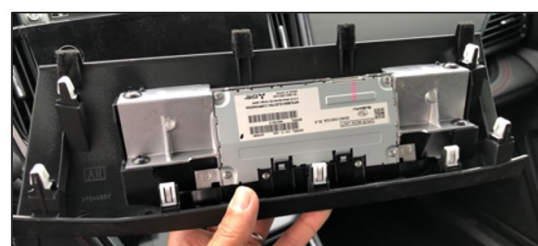
**STEP 7:** Release the 7 mounting clips from the driver monitoring unit. Once released, pull the unit toward the rear of the vehicle in a straight direction. Release the electrical connection and remove the unit from the vehicle.

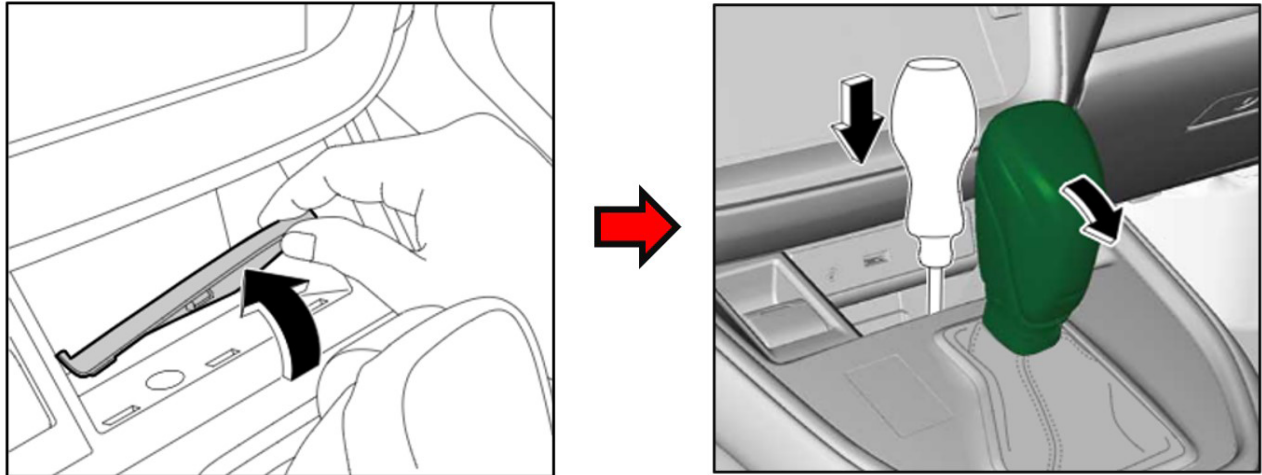
**STEP 8:** Remove the rubber grip mat from the center tray. Using a screwdriver or suitable tool, release the shift lock and shift the lever into the neutral position.

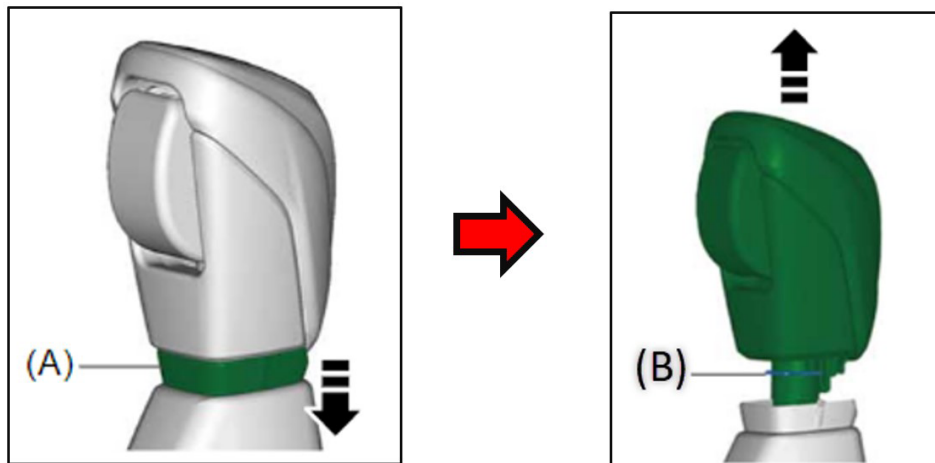
**STEP 9:** Detach clamp (A) from the shift knob. Release clip (B) from the shift knob and remove the knob from the lever. ALWAYS maintain proper shift rod alignment when reinstalling (detailed information can be found in the September 2021 TechTIPS article).

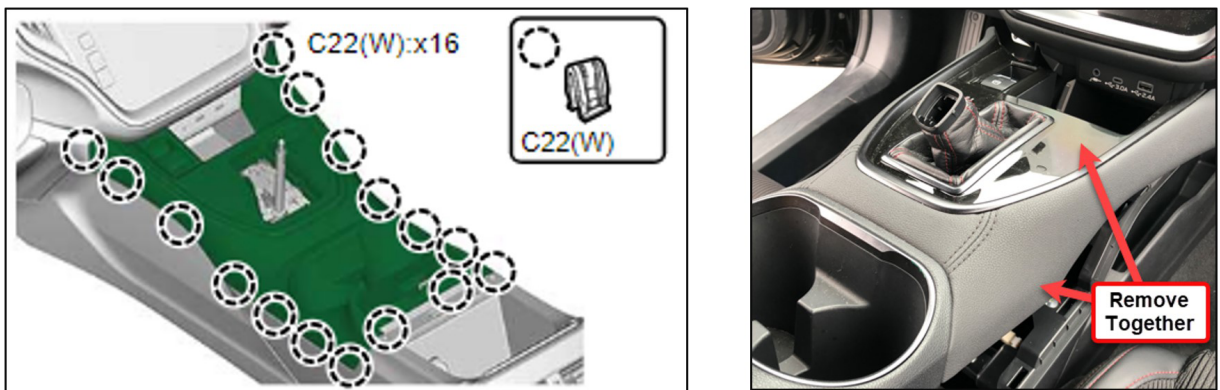
**STEP 10:** Release the center console cover mounting clips and remove the cover with the shift boot/bezel attached.

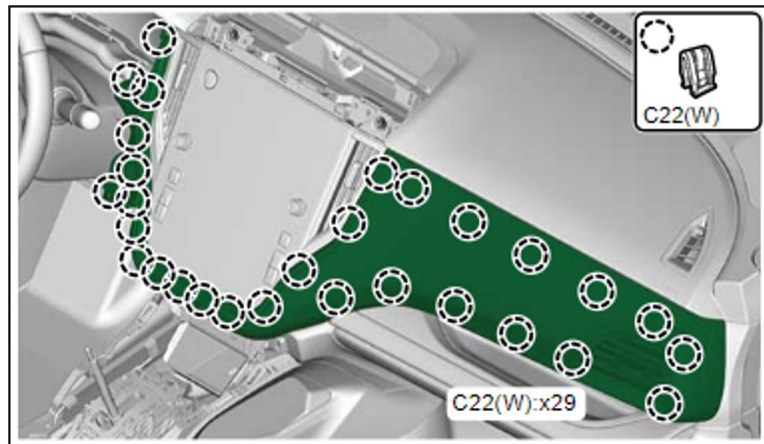
**STEP 11:** Release the mid passenger ornament panel mounting clips and remove the panel.

**NOTE:** Vehicles equipped with push button start will require the push button ignition switch to be disconnected prior to removal.

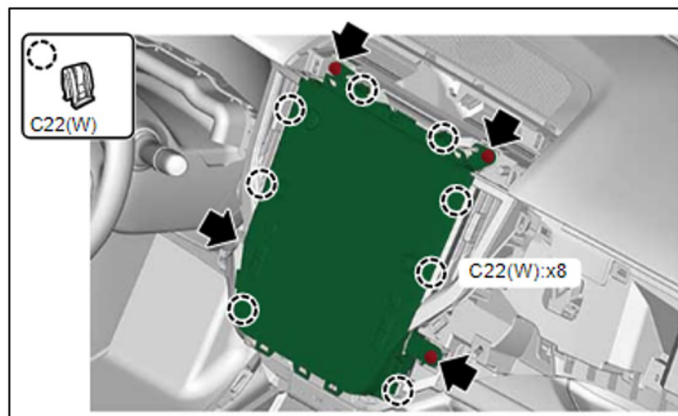
**STEP 12:** Remove the four screws securing the Center Information Display (CID) assembly. Release the mounting clips and CAREFULLY pull the assembly out far enough to disconnect the electrical connections. Once all the connectors are disconnected, the CID assembly can be removed. Use caution when handling, the display can be easily scratched.

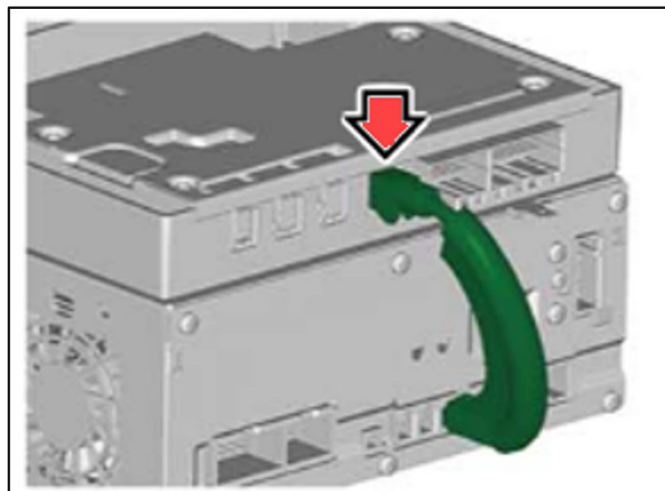
**STEP 13:** Place the CID assembly on a secure flat surface. Disconnect the Data Communication Module (DCM) cable.

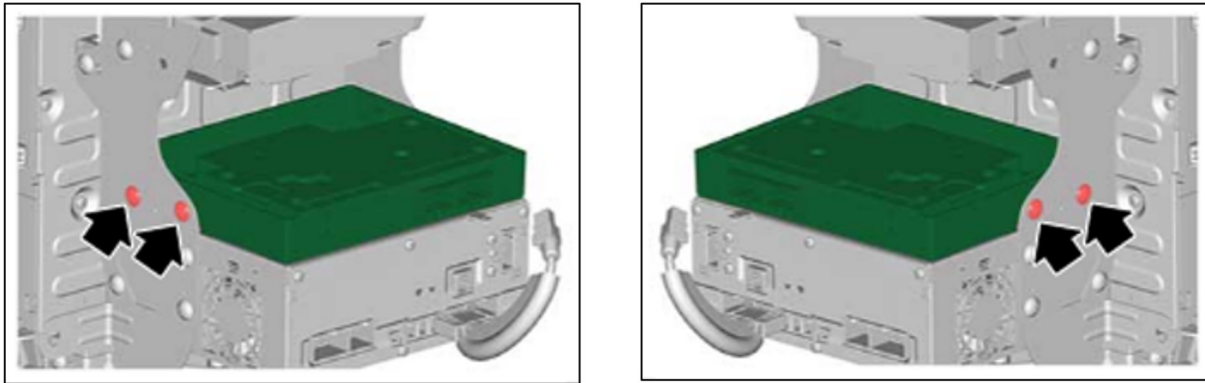
**STEP 14:** Remove the four DCM mounting screws located on the left and right side. The DCM can then be removed.

**CAUTION: DO NOT apply any impact to the CID assembly or DCM during this process.**

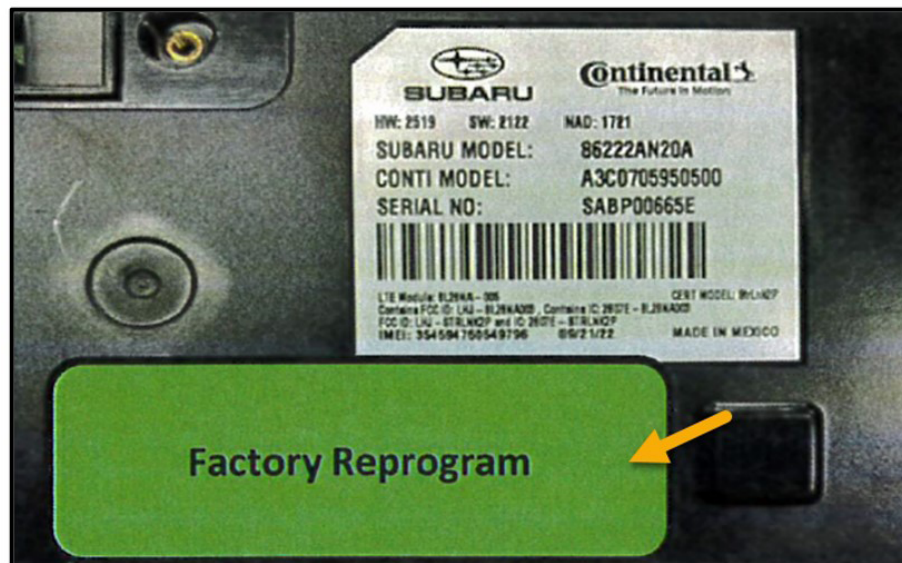
**STEP 15:** Remove and properly recycle the **Lithium-ion** back-up battery from the original DCM. Further detail on proper battery recycling and disposal can be found on Subarunet. Refer to: <https://www.subarunet.com/home/communications/view/726115>

**NOTE:** If a **GREEN** sticker is present, STOP. This vehicle has the latest DCM, and is not affected by the WRI-22 service program.
